Tree Inventory & Protection Plan

Prepared for: Byron Equities

1 Rosetta Street. Georgetown, ON. L7G 3P1

March 11, 2021

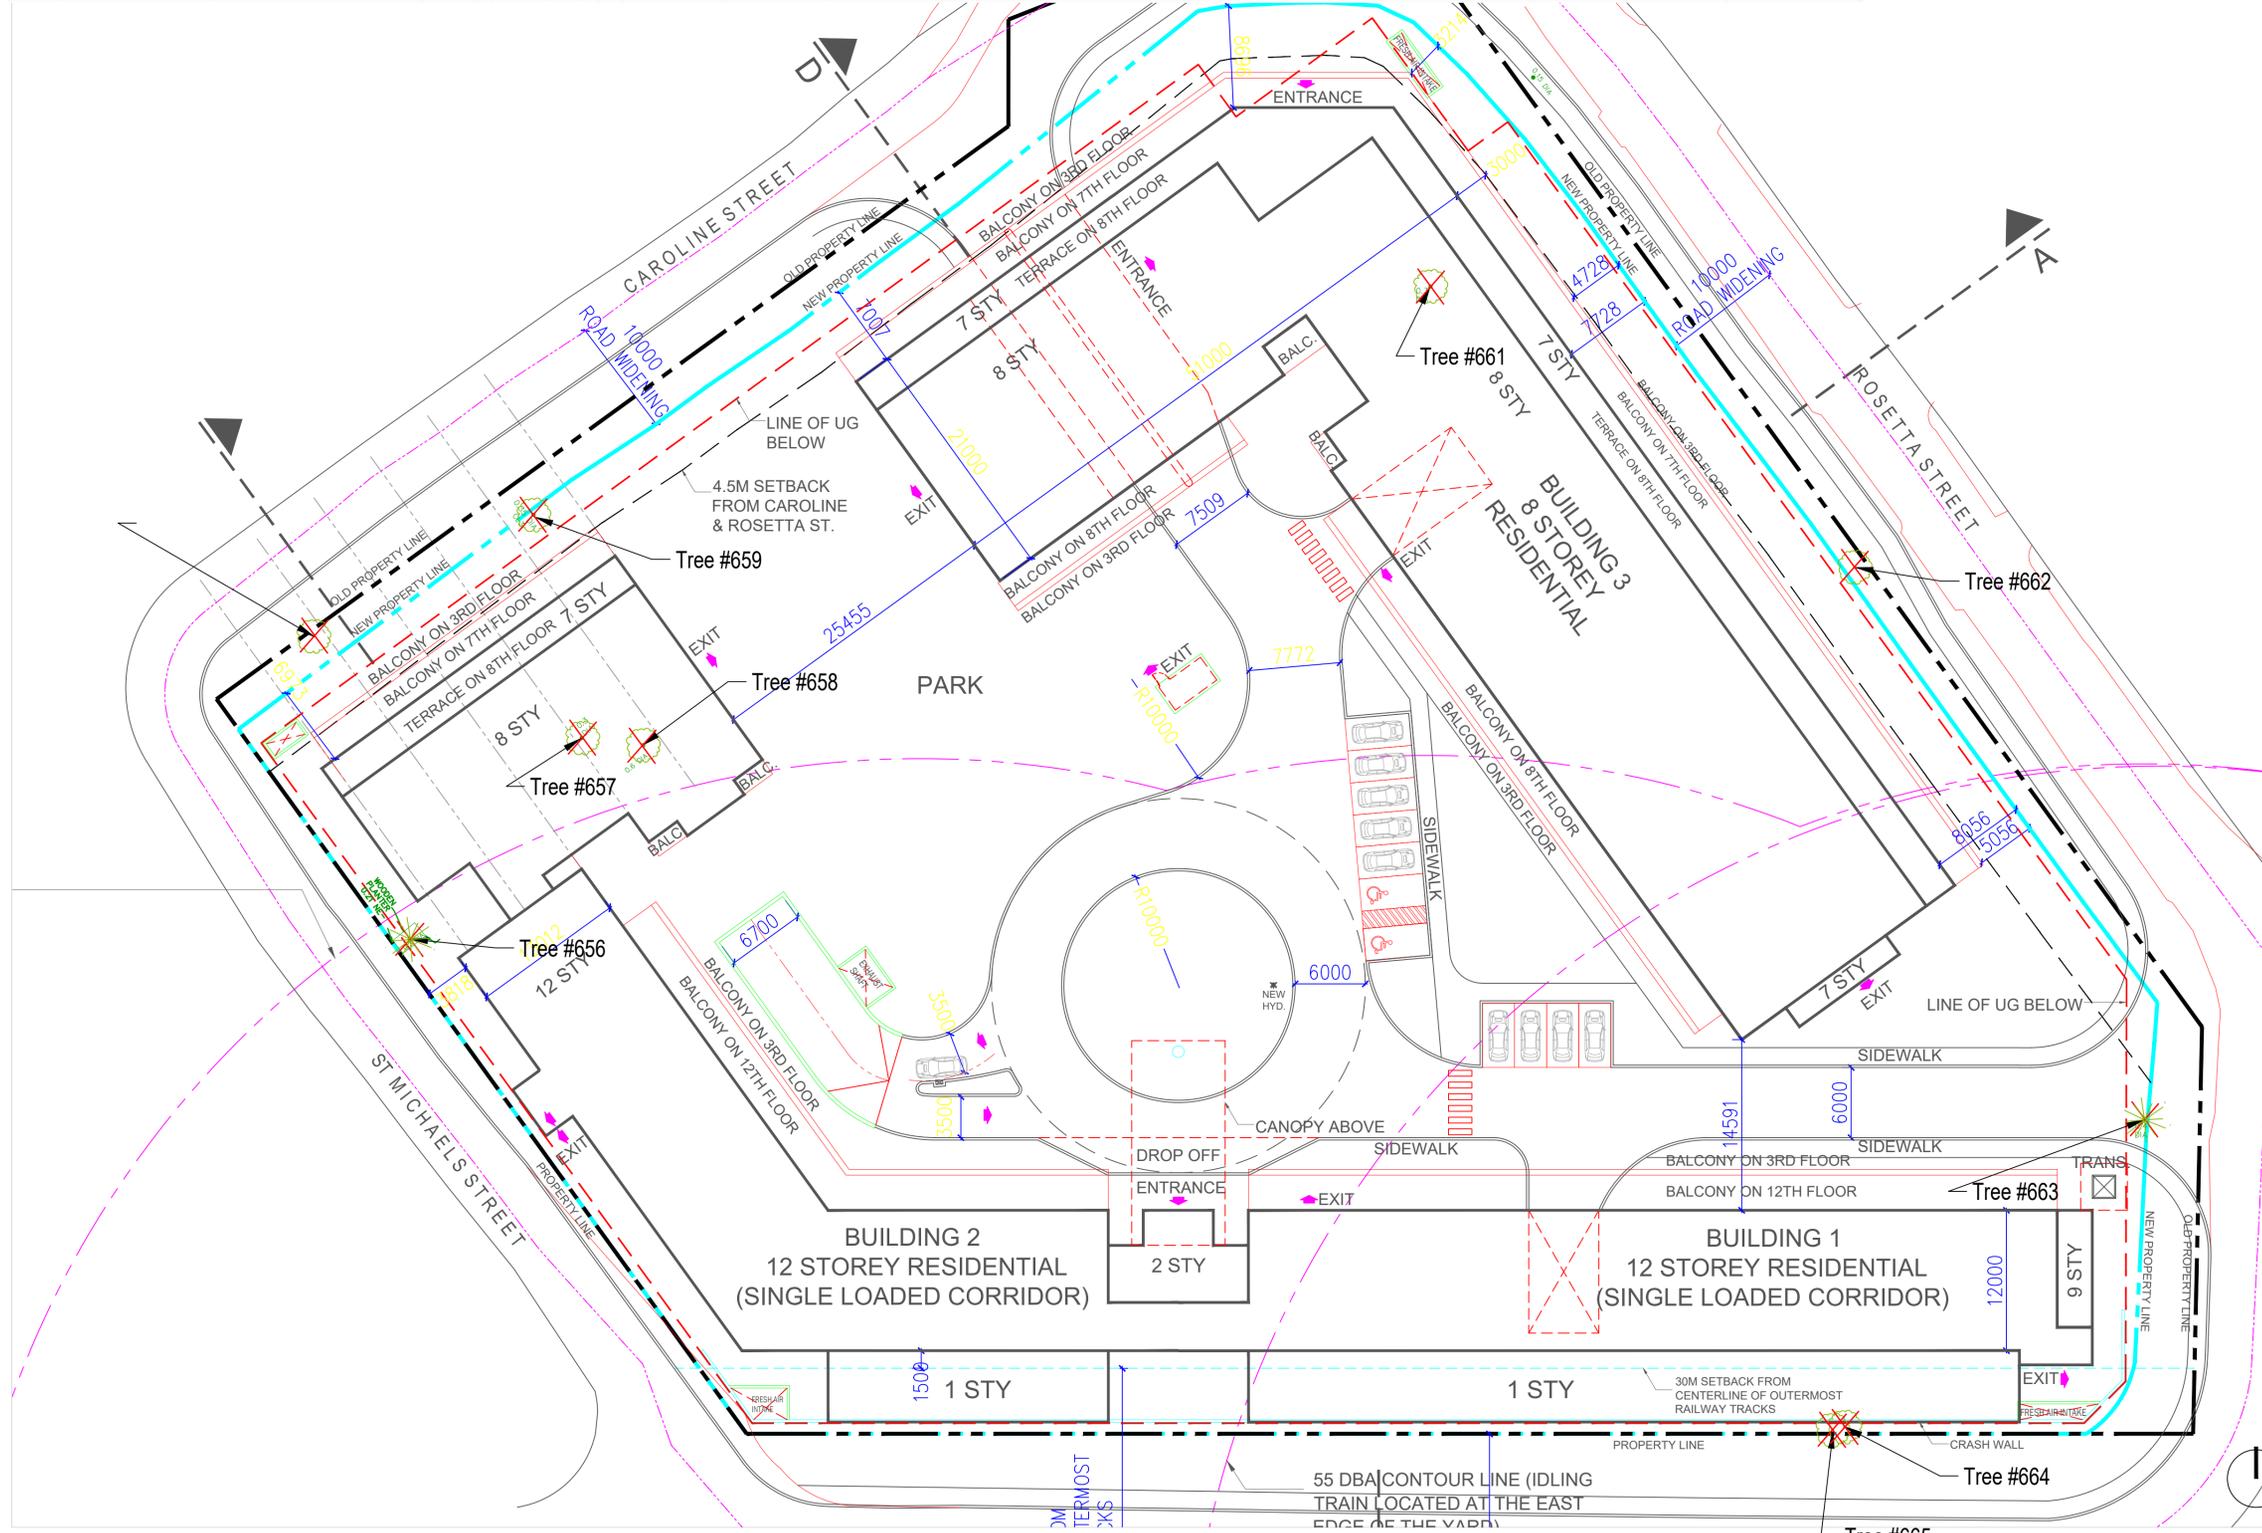
Project	Sheet
Tree Inventory Protection Plan	TP-1
Date	11.03.2021
Scale	1:300

In the case of 1 Rosetta Street, 0 trees can be preserved on site. See Tree Inventory Protection Plan Drawing TP-1 in appendix 2 for details.

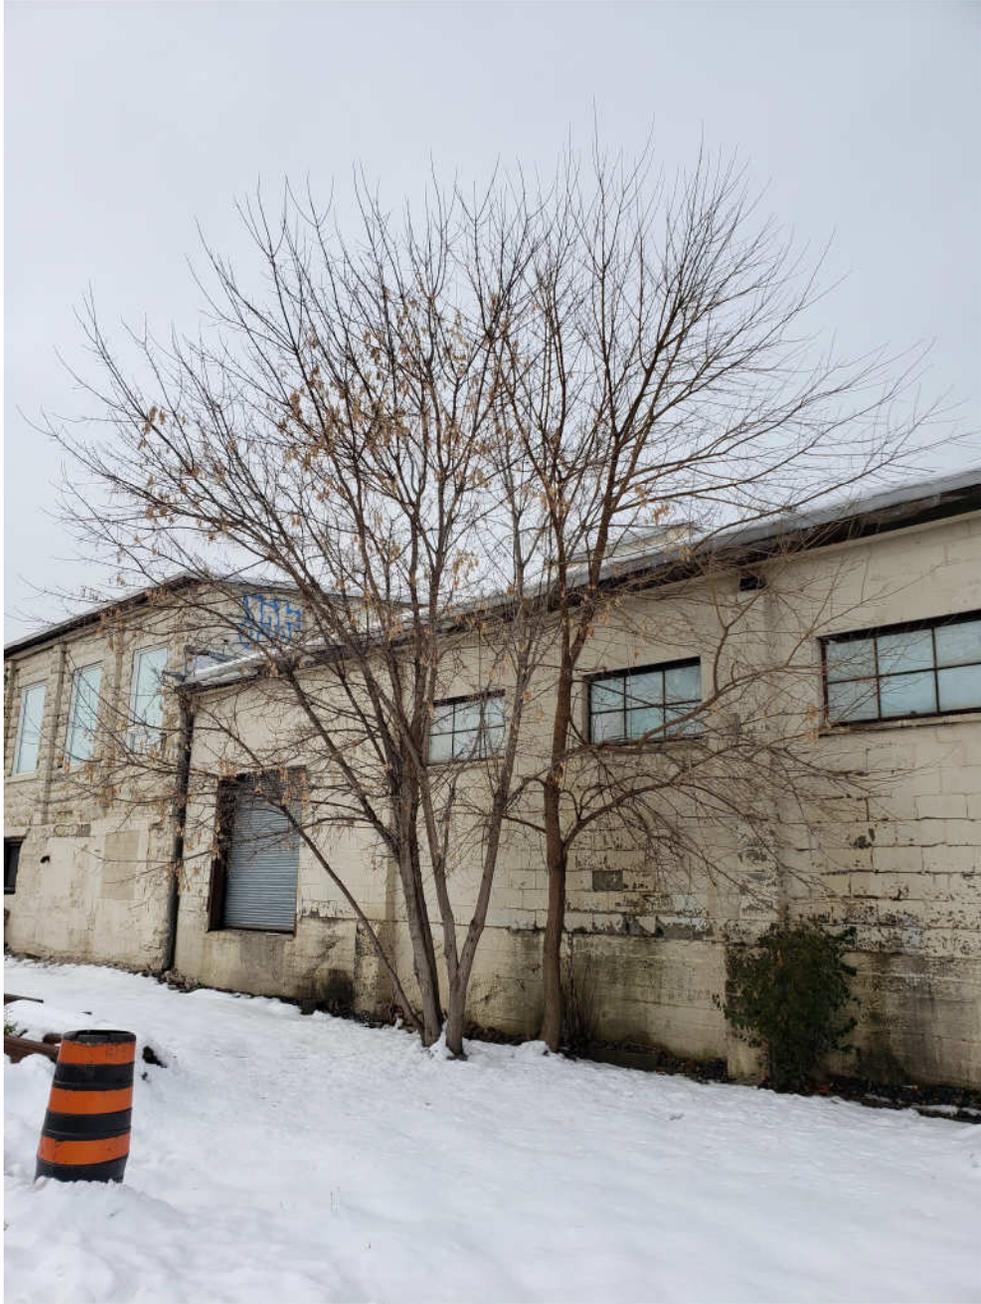
Tree 664 - 665

663	Colorado Spruce	Picea pungens	43								2	Average	Average		Remove	3	-	-
664	Manitoba Maple	Acer negundo	11	x	11	x	11	x	11	x	3	Average	Average	Multi-stem	Remove	1.8	-	-
665	White Mulberry	Morus alba	17								2	Average	Average		Remove	1.8	-	-

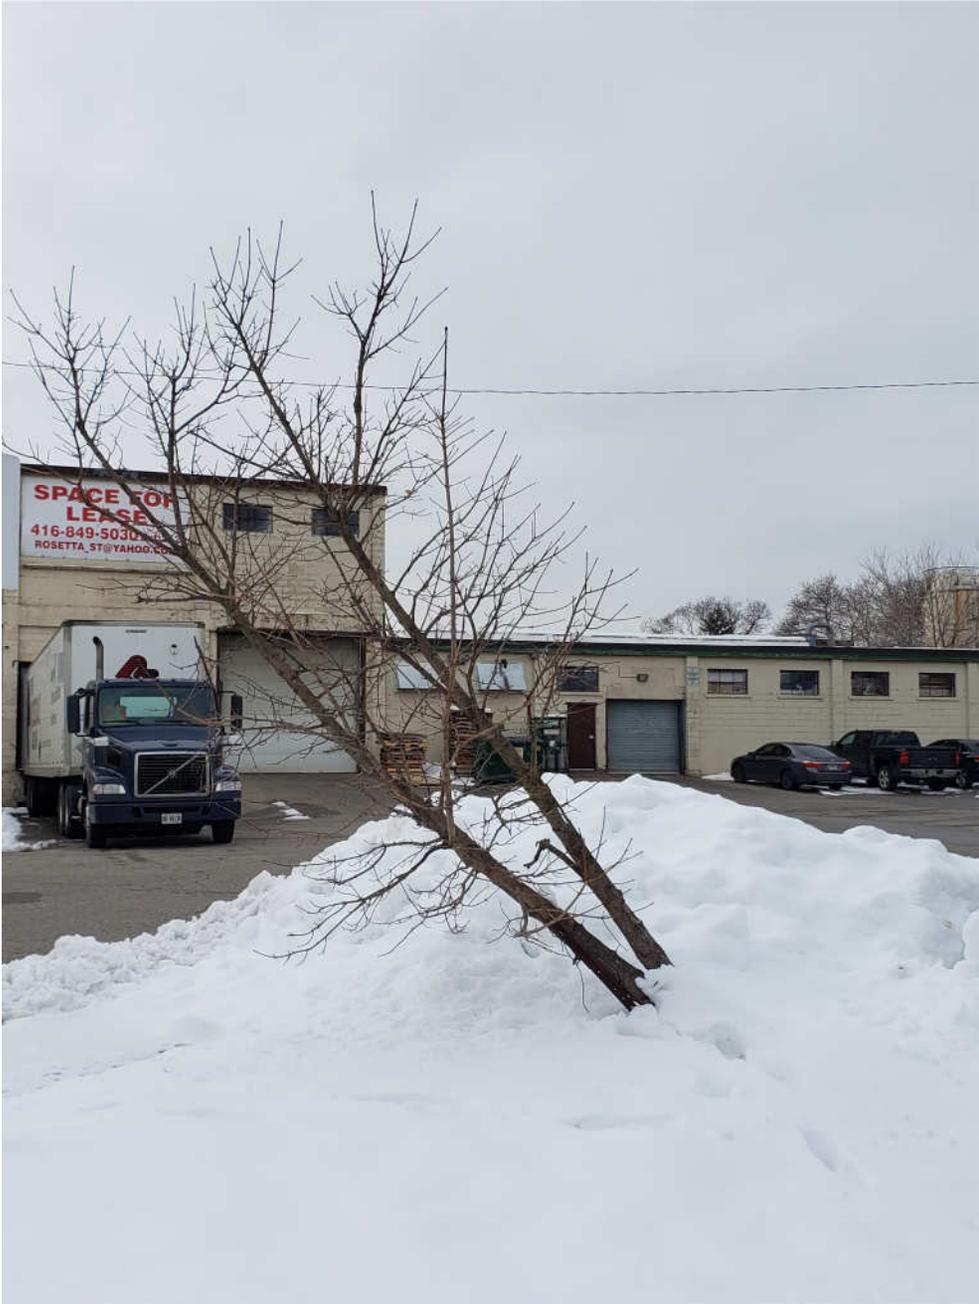
Tree 662

Tag #	Common Name	Botanical Name	Diameter at Breast Height (cm)								Crown Radius (m)	Health Condition	Structural Condition	Notes	Recommendations Based on Site Plan	Minimum TPZ (m)	Proposed TPZ (m)	Replacement Ratio
656	Colorado Spruce	Picea pungens	32								2.5	Average	Average		Remove	2.4	-	-
657	Sweet Cherry	Prunus avium	28								3.5	Average	Average	Co-dominant	Remove	1.8	-	-
658	Manitoba Maple	Acer negundo	22	x	20	x	15	x	20		4	Poor	Poor	Grown from stump of previously failed tree	Remove	1.8	-	-
659	Black Locust	Robinia pseudoacacia	68	x	40						5	Average/Poor	Average/Poor	Co-dominant, some breakage and some deadwood	Remove	4.2	-	-
660	Norway Maple	Acer platanoides	54								5	Average	Average		Remove	3.6	-	-
661	Manitoba Maple	Acer negundo	28	x	16	x	14				3	Average	Poor	Leaning heavy north, growing out of side of building	Remove	1.8	-	-
662	Norway Maple	Acer platanoides	10	x	9						1	Poor	Poor	Been hit over by a car, leaning heavy	Remove	1.2	-	-
