# **Phase One Environmental Site Assessment (ESA)**

**97 Bower Street, Acton, Ontario**

2402401

September 27, 2024

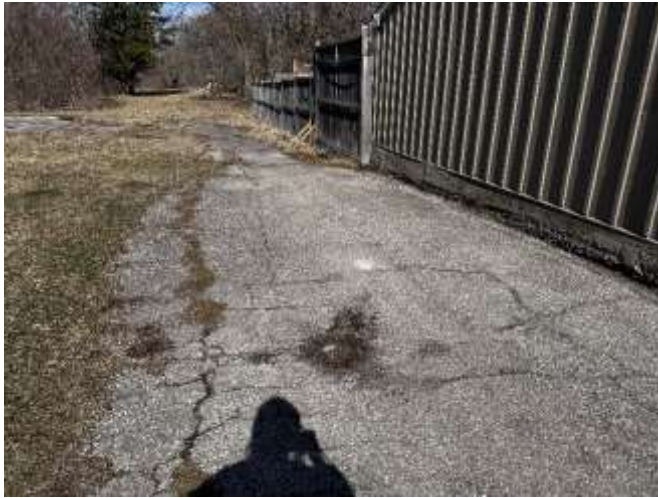
**Photograph 5**

Photo depicts location of previously installed BH1/MW1 on the asphalt-paved driveway on the southern portion of the property.

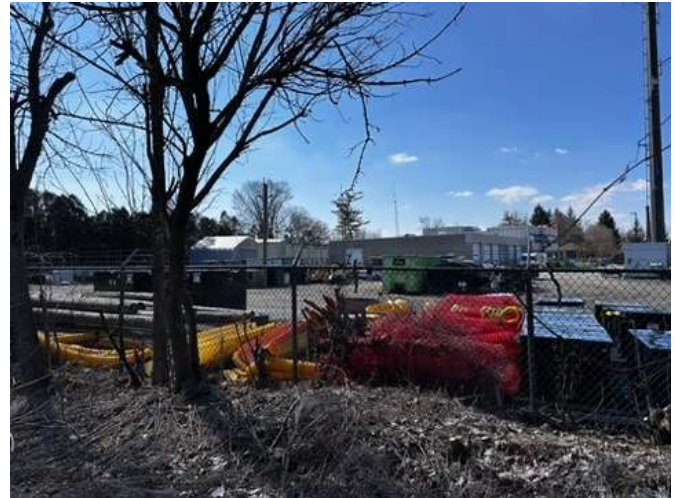
**Photograph 6**

Photo depicts view of 43 Alice Street, adjacent to the Phase One Property to the southwest.

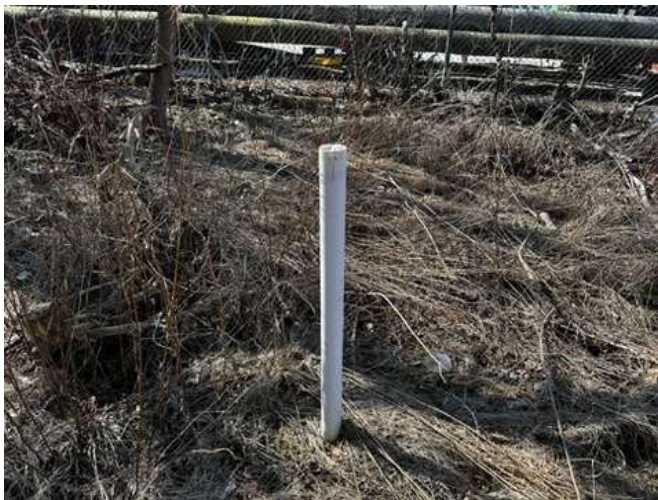
**Photograph 7**

Photo depicts location of previously installed MW7 on the southwest portion of the property.

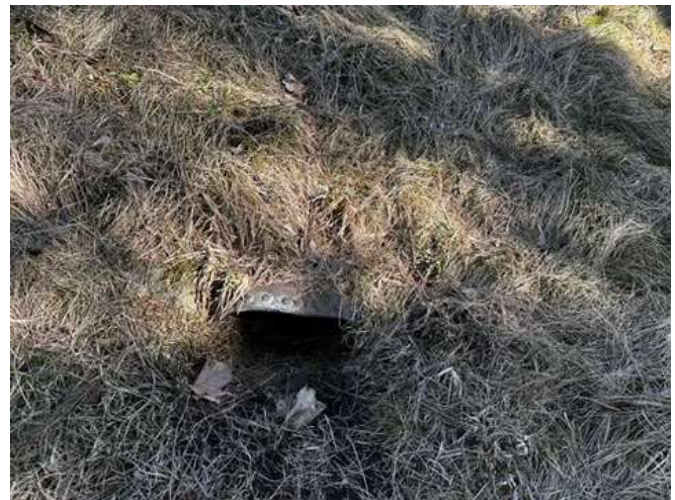
**Photograph 8**

| Photograph # | Description |
|---|---|
| <b>Photograph 8</b> | Photo depicts underground pipe found in the vicinity of the former building on the central portion of the property. |

An underground pipe was observed in the vicinity of the former 2-storey building in the central portion of the property. However, in previous investigations, it was reported that a heating oil UST formerly existed at the west side of the former northern 2-storey building on the Phase One Property.

Photo depicts underground pipe found in the vicinity of the former building on the central portion of the property.

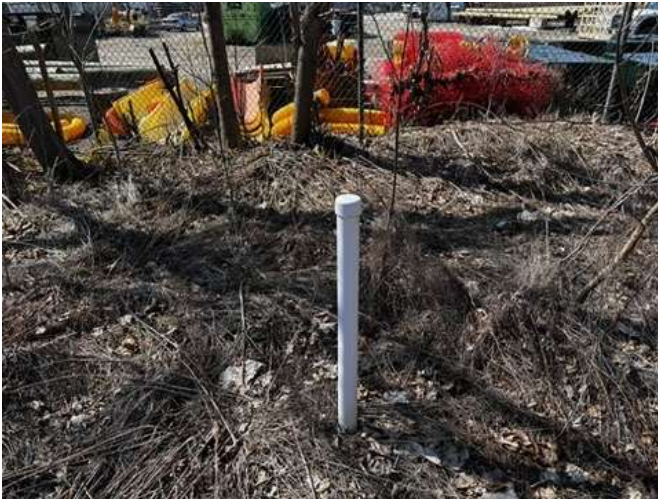
**Photograph 9**

Photo depicts location of previously installed MW8 on the west portion of the property.

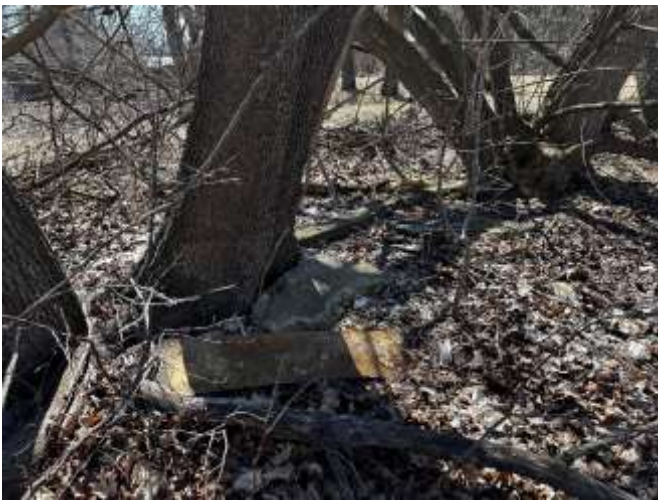
**Photograph 11**

| Photograph # | Description |
|---|---|
| <b>Photograph 11</b> | Photo depicts concrete/metal debris found in the vicinity of the former building on the central portion of the property. |

There was no evidence of stressed vegetation or surficial staining identified on the Phase One Property during our Site reconnaissance on March 28, 2024. However, various debris including concrete and metal remnants (likely associated with building demolition activities) were observed in the vicinity of the former 2-storey building on the central portion of the property.

Photo depicts concrete/metal debris found in the vicinity of the former building on the central portion of the property.

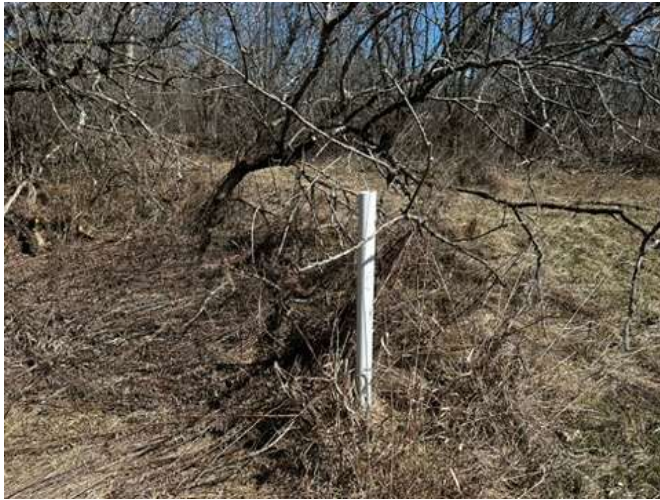
**Photograph 13**

Photo depicts location of previously installed MW9 on the northwest portion of the property.

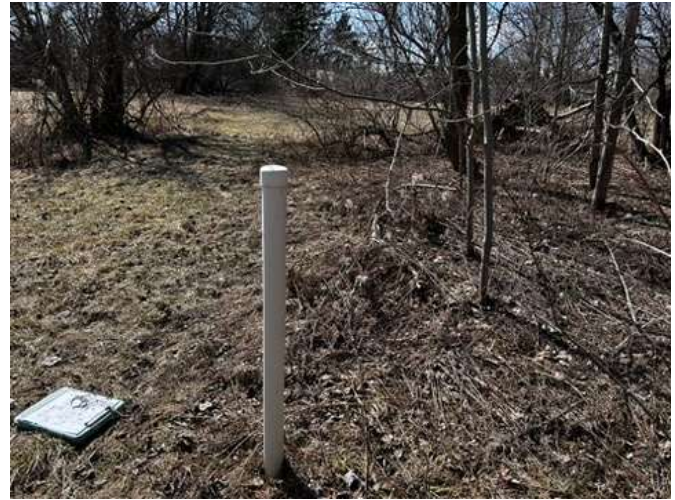
**Photograph 14**

Photo depicts location of previously installed MW10 on the north portion of the property.

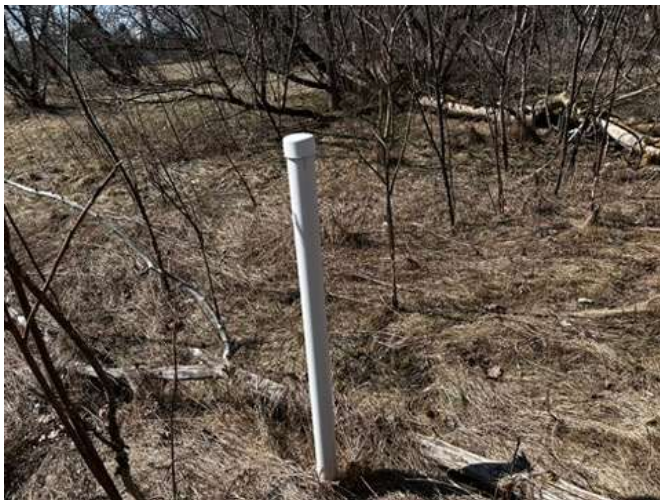
**Photograph 15**

Photo depicts location of previously installed MW11 on the north portion of the property.

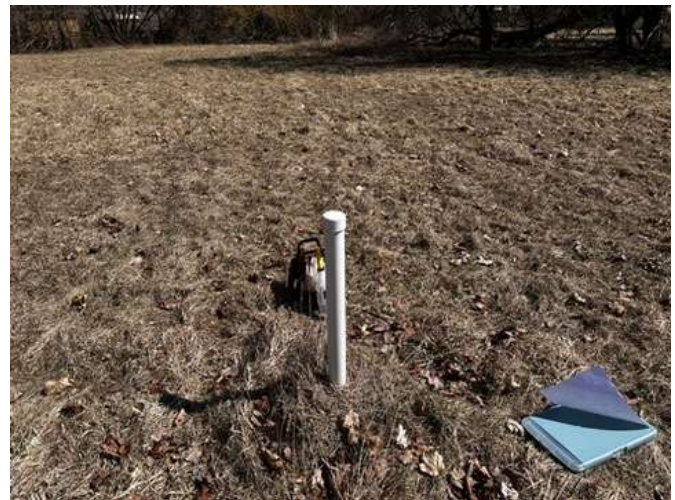
**Photograph 16**

Photo depicts location of previously installed MW5 on the north portion of the property.

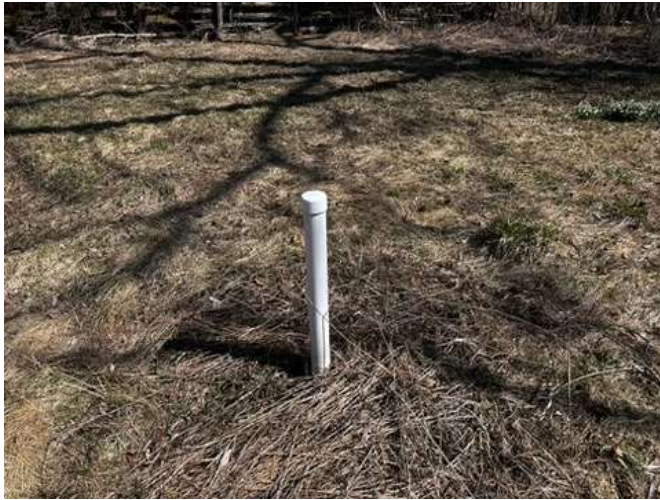
**Photograph 17**

Photo depicts location of previously installed MW4 on the east portion of the property.
