Reference No. 2507-S174

**Re: Slope Stability Assessment
9094 Regional Road 25
Town of Halton Hills**

BOREHOLE AND CROSS-SECTION LOCATION PLAN

SITE: 9094 REGIONAL ROAD 25, TOWN OF HALTON HILLS

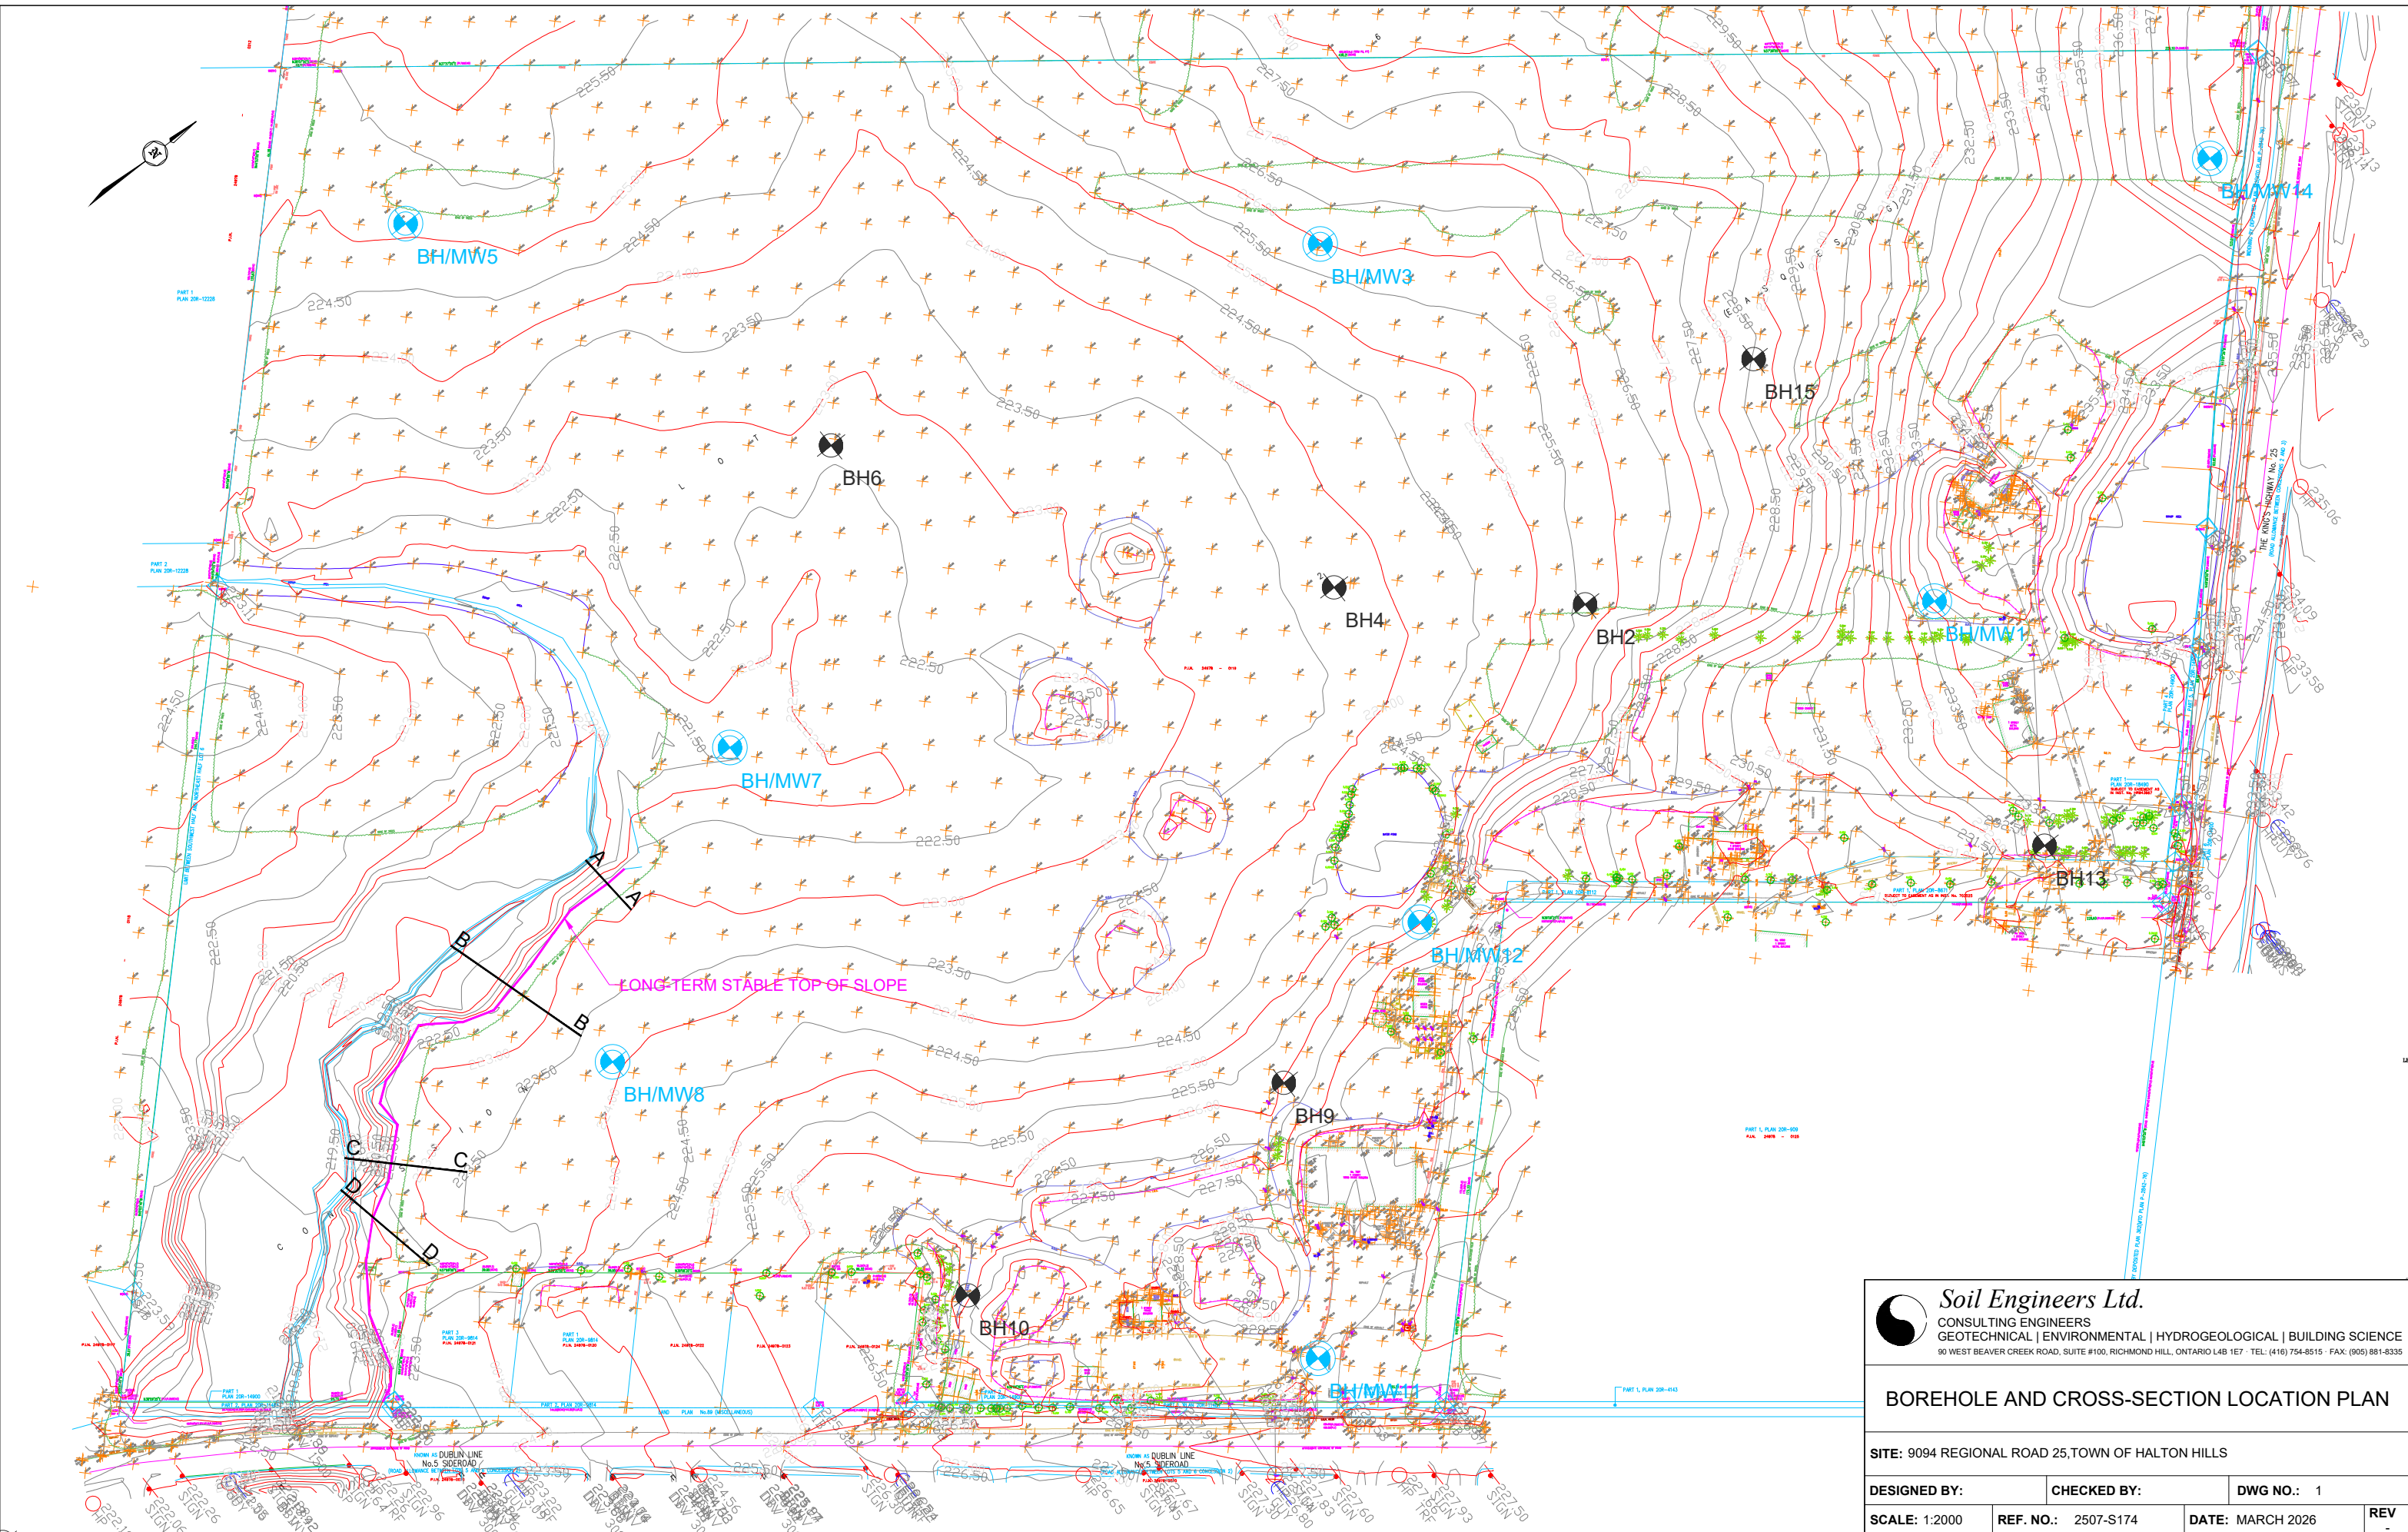
Four sections, Cross-Section A-A to D-D, inclusive, were selected for the analysis at the steepest and/or tallest portions of the east valley slope; the locations of the cross-sections are shown on Drawing No. 1, enclosed.

The LTSTOS, incorporating the stable slope gradient and TEA, where applicable, is established on Drawing No. 1. The application of the TEA may not be apparent where the flood plain is greater than 5 m.

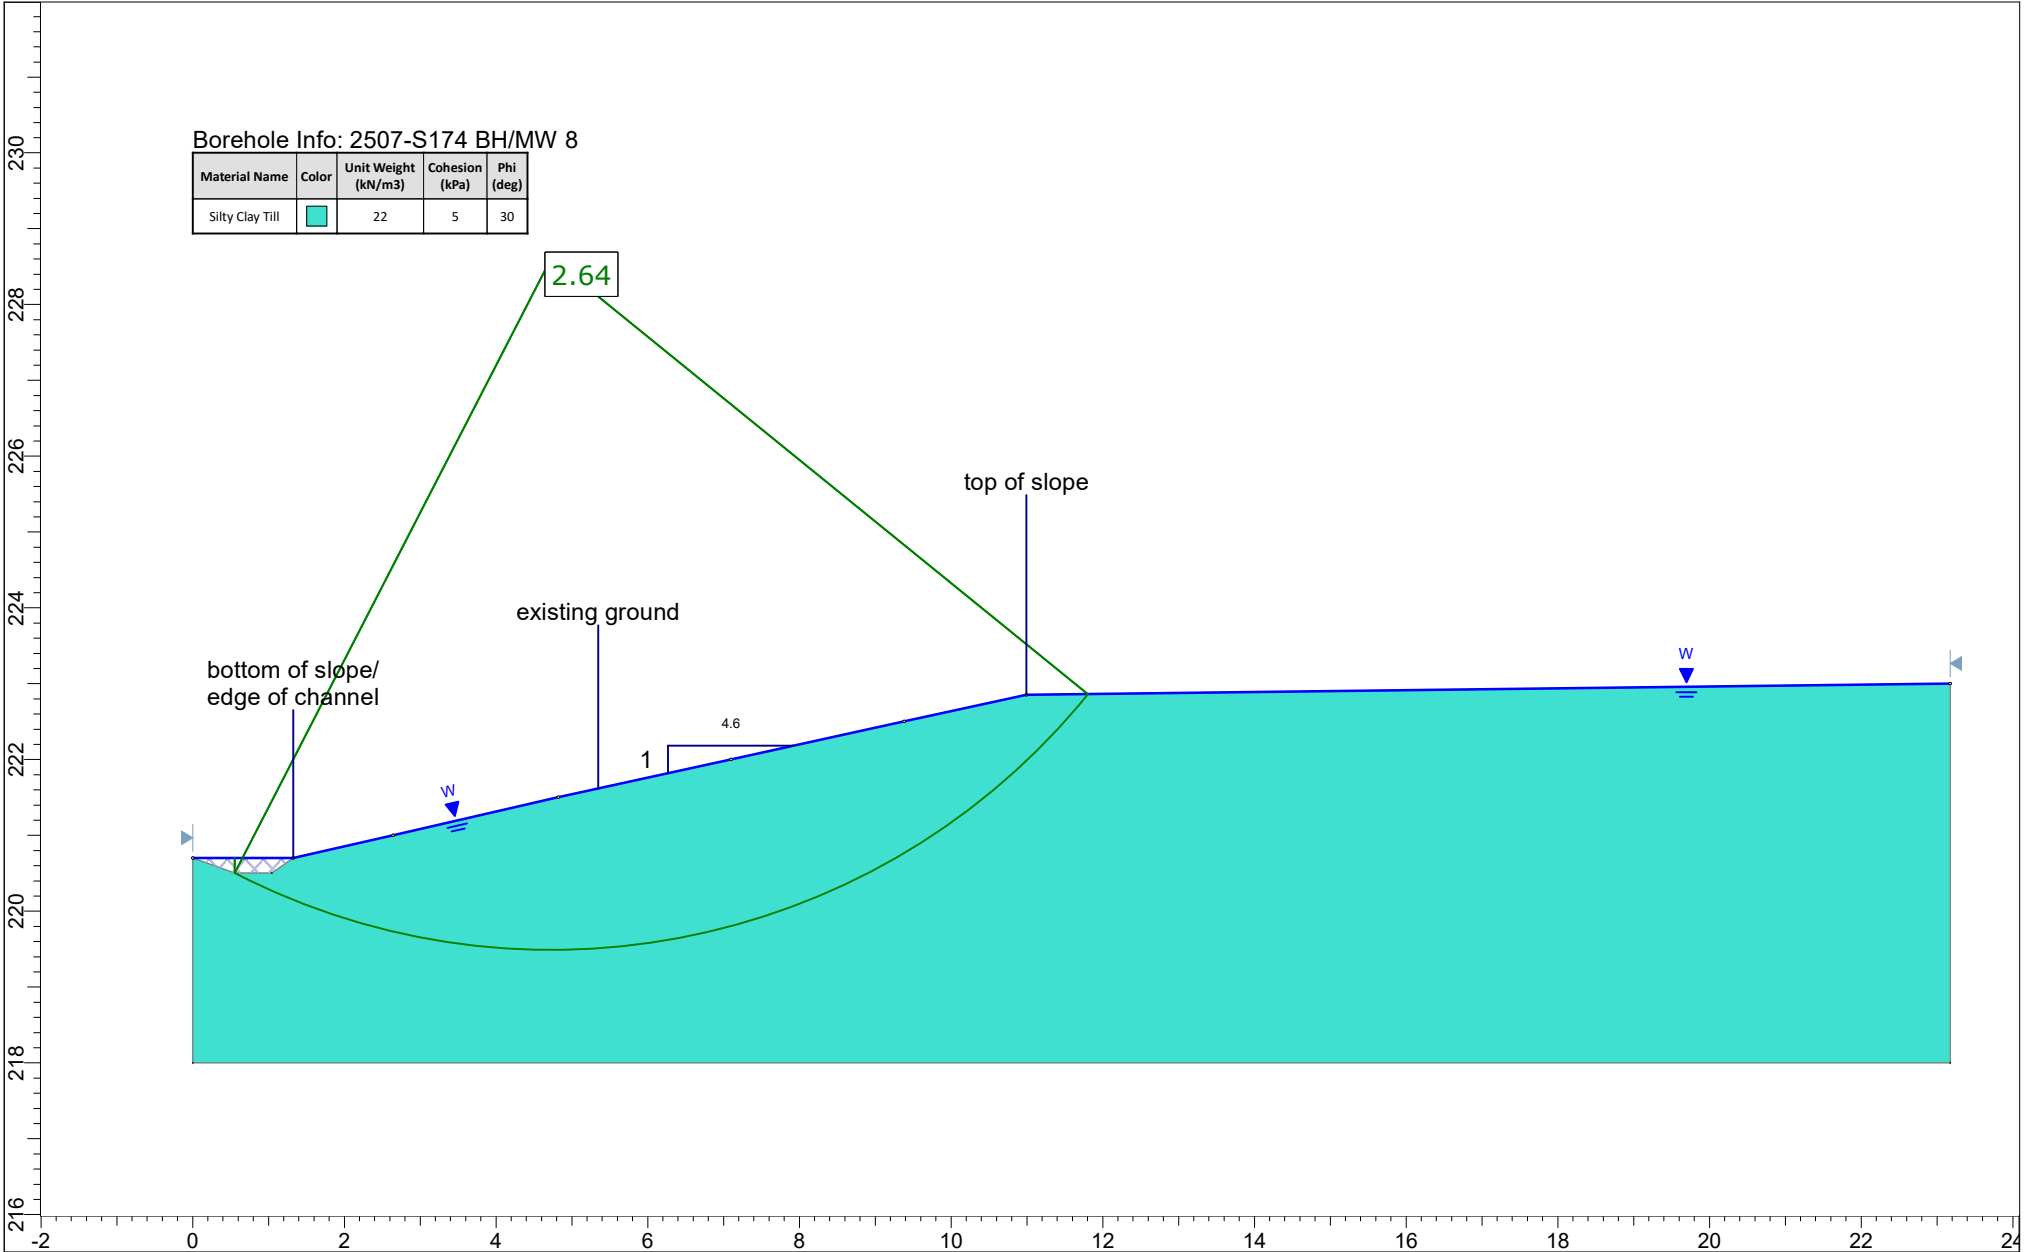
Project Title		Cross-Section A-A		Load Case		Existing Condition	
Location		9094 Regional Road 25, Town of Halton Hills					
Drawn By	HWY	Checked By	KH	Scale	1:100	Revision	-
Date	March 2026			Reference No.	2507-S174	Drawing No.	2A

The slope stability analysis results indicate that the existing slope at Cross-Sections A-A, B-B, and C-C has a minimum factor of safety (FOS) of 1.67 to 2.64, which satisfies the Ontario Ministry of Natural Resources (OMNR) and CH guideline requirements for active land use (minimum FOS 1.5) as well as the accepted minimum FOS of 1.3 under high groundwater condition. The existing slope at Cross-Section D-D, with a resulting FOS of 1.27, failed to meet the minimum OMNR or CH requirement.

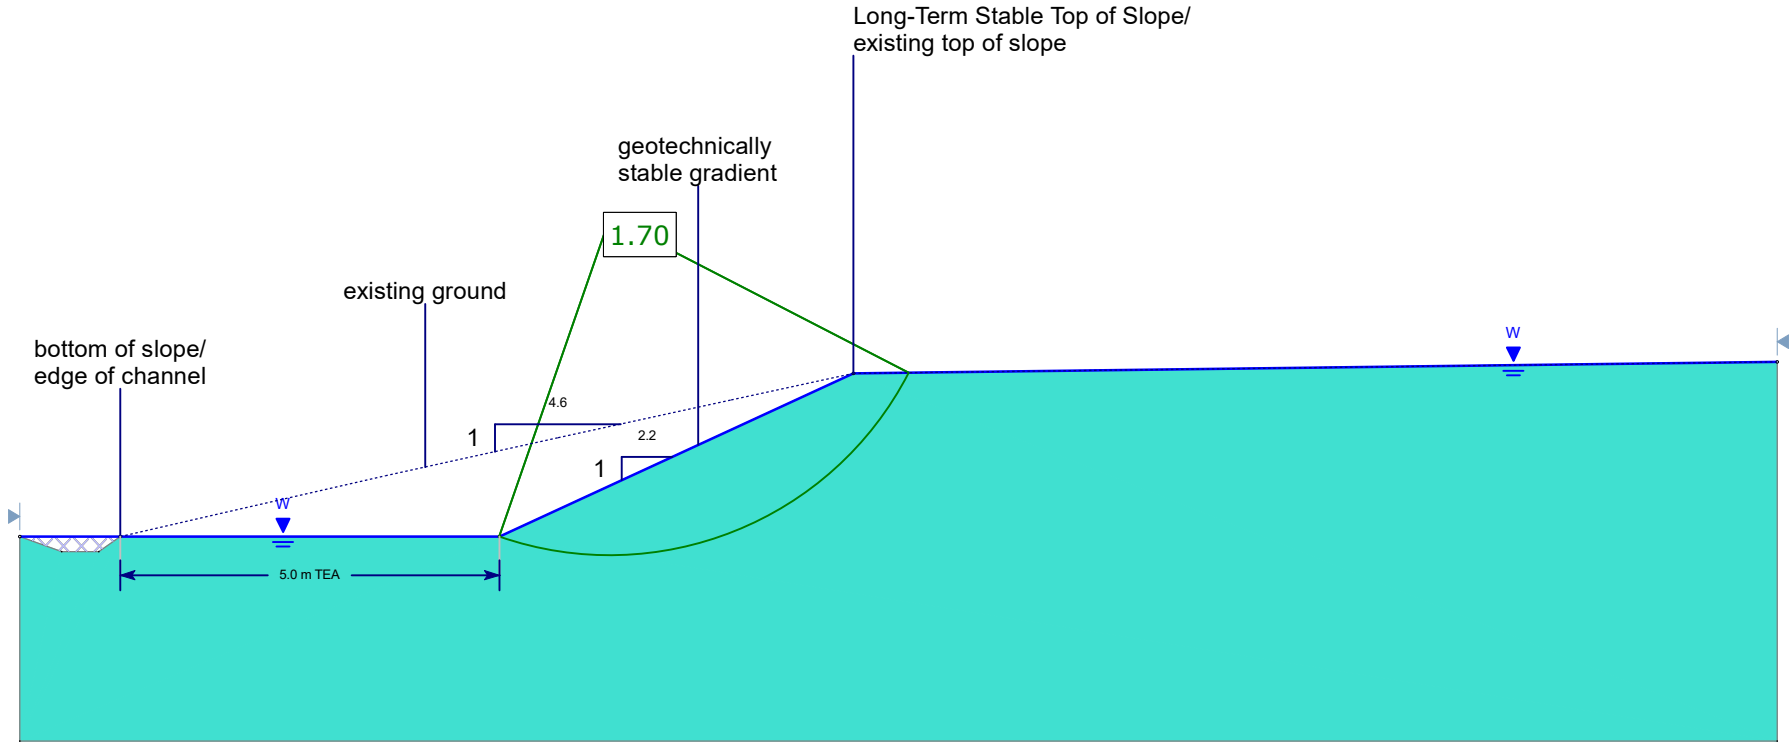
Project Title		Cross-Section A-A		Load Case		Geotechnically Stable Condition	
Location		9094 Regional Road 25, Town of Halton Hills					
Drawn By	HWY	Checked By	KH	Scale	1:100	Revision	-
Date	March 2026			Reference No.	2507-S174	Drawing No.	2B

A 5.0 m Toe Erosion Allowance (TEA) was recommended by GEO Morphix Ltd. to be applied from the edge of channel bank. In view that the watercourse is located at the base of slope at Cross-Sections A-A and D-D, the cross-sections were remodelled with the incorporation of the TEA and a stable gradient of 2.2 to 2.3H:1V. The remodelled slopes yield a resulting FOS of greater than 1.5, which satisfies the OMNR and CH requirements. The slope stability results are presented on Drawing Nos. 2A to 5B, and are summarized in the table below.
