# APPENDIX C2

# Enviroscan Report

Site address: 530 Guelph Street Halton Hills ON  
Project #: 25050800644  
P.O. #: 159688  
Requested by: Eleanor Goolab  
Date Completed: 5/15/2025 3:22:20 PM

## Cope Report - 1991 527016 ONTARIO LTD 530 Guelph Street (Norval) Halton Hills ON L0P1K0

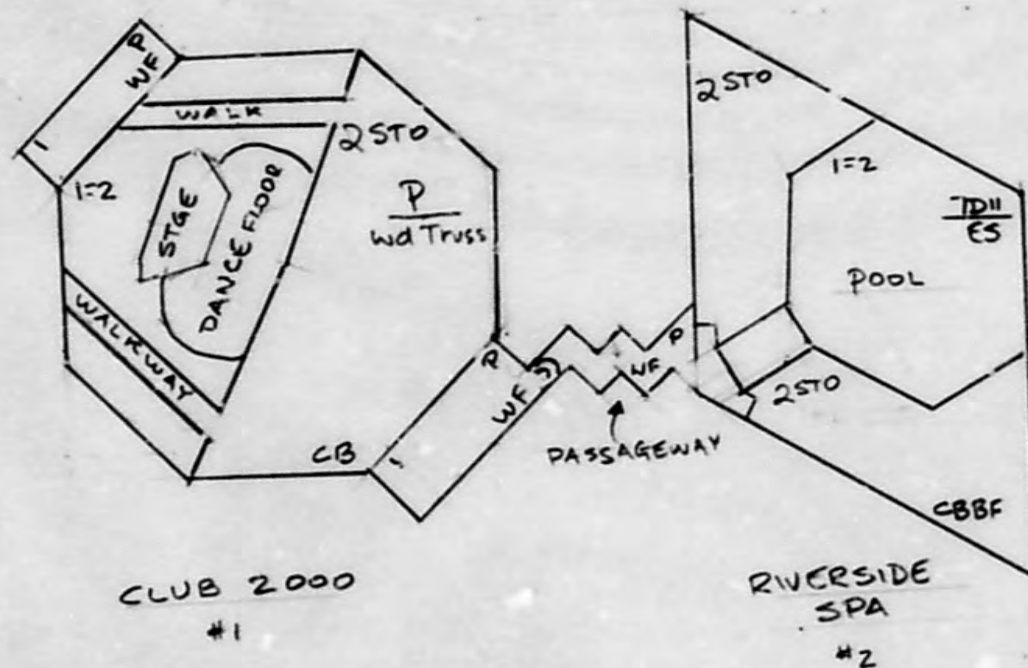
## Siteplan Report - 1989 527016 ONTARIO LTD 530 Guelph Street (Norval) Halton Hills ON L0P1K0

APPROX 183m (600') TO  
PUBLIC HYDRANT  
AT LOUISA STREET

APPROX 183m (600')  
TO PUBLIC FIRE  
HYDRANT IN WINSTON  
CHURCHILL BLVD

150mm (6")  
FIRE DEPT  
SUCTION  
CONNECTION  
TO RIVER
