October 1, 2025 [*Revised March 30, 2026*]

ARBORIST REPORT
 9094 Regional Road 25, Halton Hills, Ontario

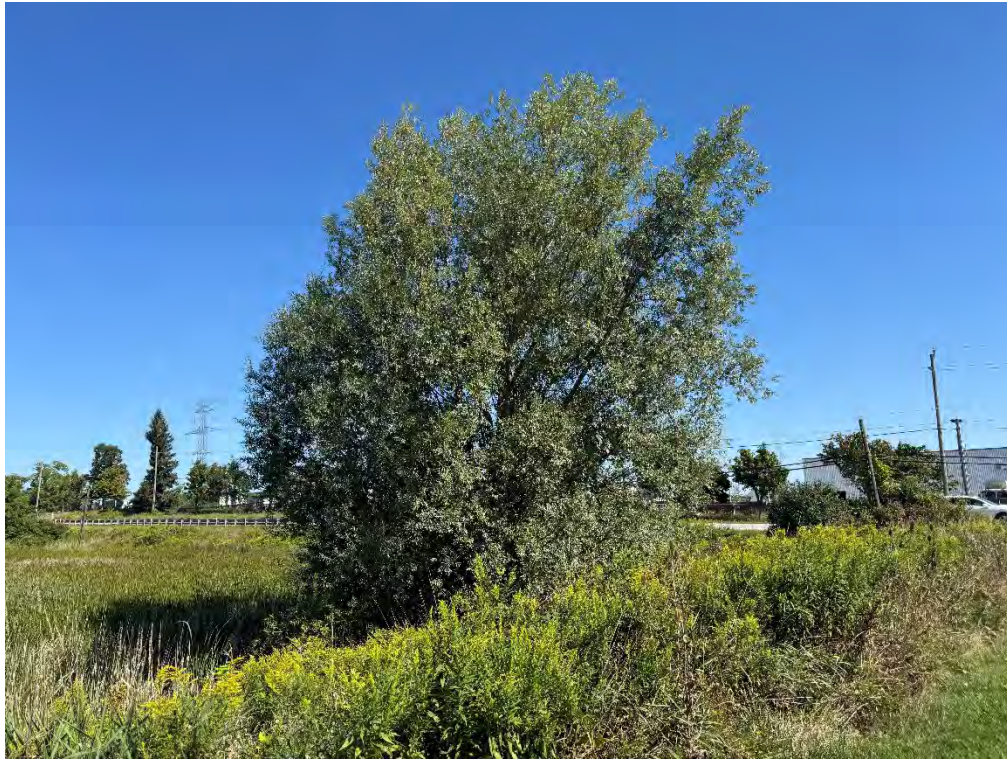
Tree 701

Tree #	Ownership	Common Name	Botanical Name	DBH (CM)	Condition	Compensation Trees Required	Comments	Recommendation
701	Private	Russian Olive	Elaeagnus angustifolia	66	F	6		Remove due to construction
702	Private	White Pine	Pinus strobus	78	F	7		Remove due to construction
703	Private	White Pine	Pinus strobus	54	F/P	5	3.0 metre vertical cavity starting at base on north side of tree	Remove due to construction
704	Private	Black Walnut	Juglans nigra	18	F	1		Remove due to construction
705	Private	Sugar Maple	Acer saccharum	46	F	4		Remove due to construction
706	Private	Norway Maple	Acer platanoides	38	F	3	Minor deadwood throughout, mildew disease evident	Remove due to construction
707	Private	Colorado Blue Spruce	Picea pungens var. glauca	48	F	4		Remove due to construction
708	Private	White Pine	Pinus strobus	80	F	8	Minor deadwood throughout	Remove due to construction
709	Private	Ornamental Pear	Pyrus calleryana	37	F	3	Minor deadwood throughout	Remove due to construction

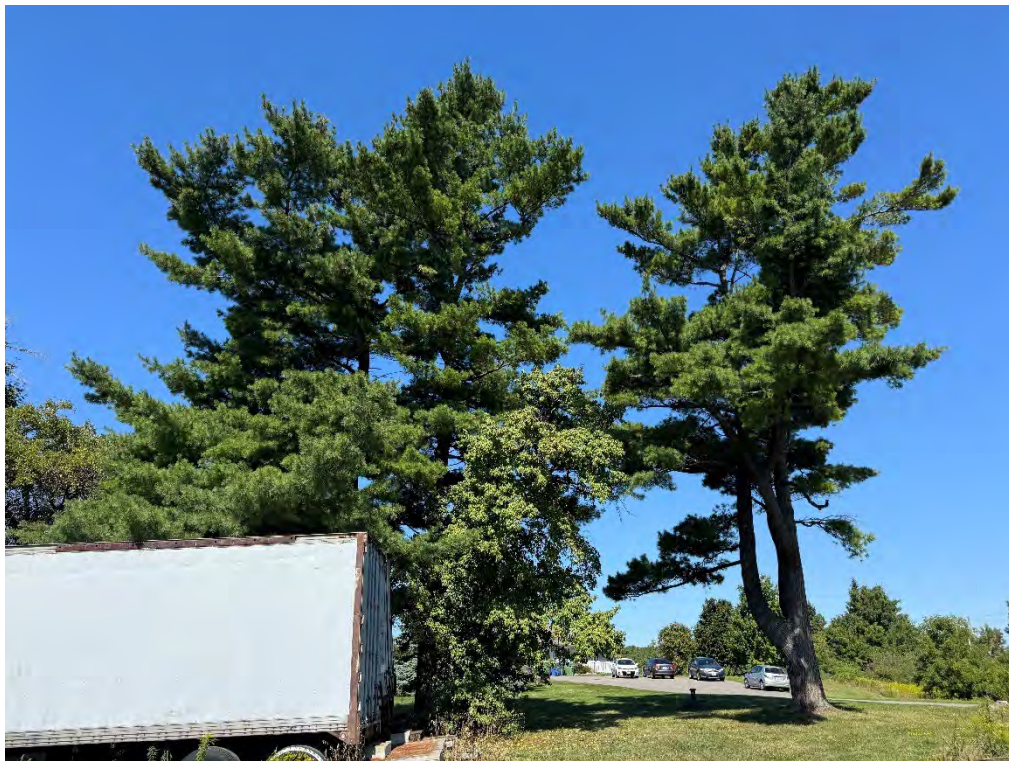
Trees 708 – 711

710	Private	White Pine	Pinus strobus	56	F	5	Minor deadwood throughout	Remove due to construction
711	Private	White Pine	Pinus strobus	72	F	7	Minor deadwood throughout	Remove due to construction

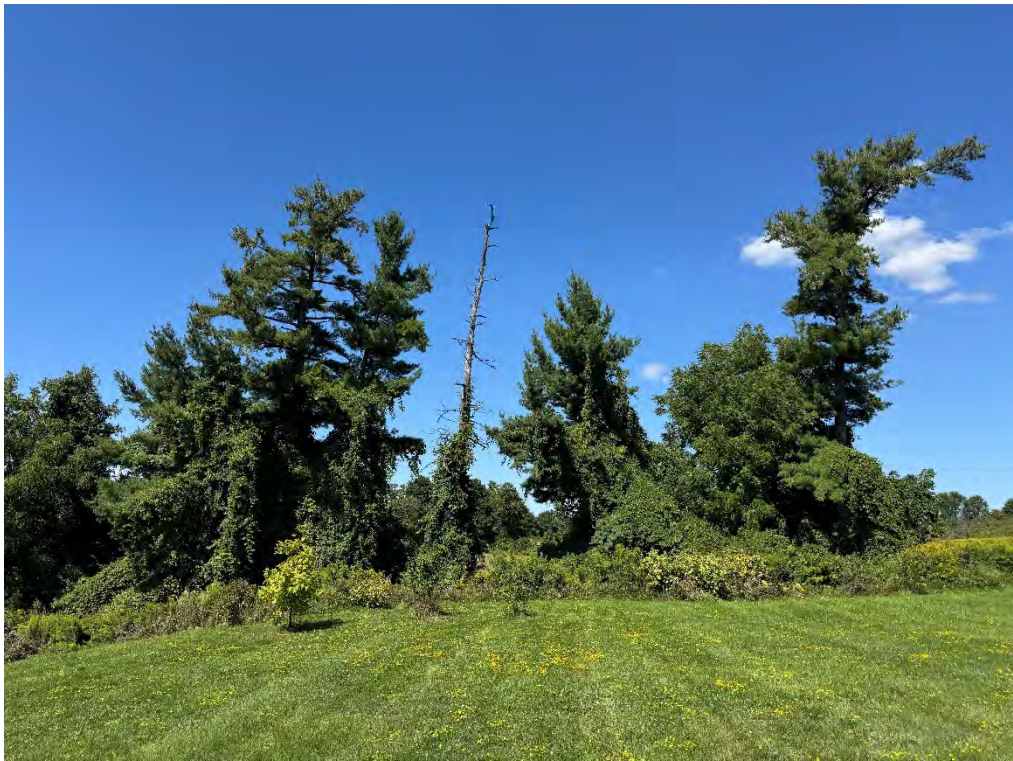
Trees 720 – 728

712	Private	Flowering Crabapple Tree	Malus Sp.	42	F	4	Minor deadwood throughout	Remove due to construction
713	Private	Sugar Maple	Acer saccharum	23	F	2		Remove due to construction
714	Private	White Pine	Pinus strobus	65	D	-	Tree is 100% dead	Remove due to construction
715	Private	White Pine	Pinus strobus	64	F	6	Moderate deadwood throughout	Remove due to construction
716	Private	White Pine	Pinus strobus	63	F/P	6	Moderate deadwood throughout	Remove due to construction
717	Private	White Pine	Pinus strobus	57	D	-	Tree is 100% dead	Remove due to construction
718	Private	White Pine	Pinus strobus	58	F	5	Minor deadwood throughout	Remove due to construction
719	Private	White Pine	Pinus strobus	81	P/D	-	Co-dominant at 3.0 metres, one main limb is 100% dead	Remove due to construction
720	Private	White Pine	Pinus strobus	~98	F	9	Minor deadwood throughout, vines growing throughout	Remove due to construction
721	Private	Shagbark Hickory	Carya ovata	20	F	2	Vines growing throughout	Remove due to construction

722	Private	White Pine	Pinus strobus	~87	F/P	8	Internal rot evident, vines growing throughout, minor deadwood throughout, multiple contorted limbs	Remove due to construction
723	Private	Black Walnut	Juglans nigra	40	F	4	Vines growing throughout	Remove due to construction
724	Private	White Pine	Pinus strobus	~82	F	8	Minor deadwood throughout, vines growing throughout	Remove due to construction

725	Private	White Pine	Pinus strobus	69	F	6	Minor deadwood throughout, vines growing throughout	Remove due to construction
726	Private	White Pine	Pinus strobus	~65	D	-	Tree is 100% dead	Remove due to construction
727	Private	White Pine	Pinus strobus	49	F	4	Minor deadwood throughout, vines growing throughout	Remove due to construction
728	Private	White Pine	Pinus strobus	79	F	7	Minor deadwood throughout, vines growing throughout	Remove due to construction
729	Private	Black Walnut	Juglans nigra	24	F	2	Vines growing throughout	Remove due to construction
730	Private	Burr Oak	Quercus macrocarpa	29	F/P	2	Vines growing throughout	Remove due to construction
731	Private	Burr Oak	Quercus macrocarpa	25	F/P	2	Vines growing throughout	Remove due to construction
732	Private	Black Walnut	Juglans nigra	52	F/G	5	Minor deadwood throughout	Remove due to construction
733	Private	Burr Oak	Quercus macrocarpa	25	F	2		Retain

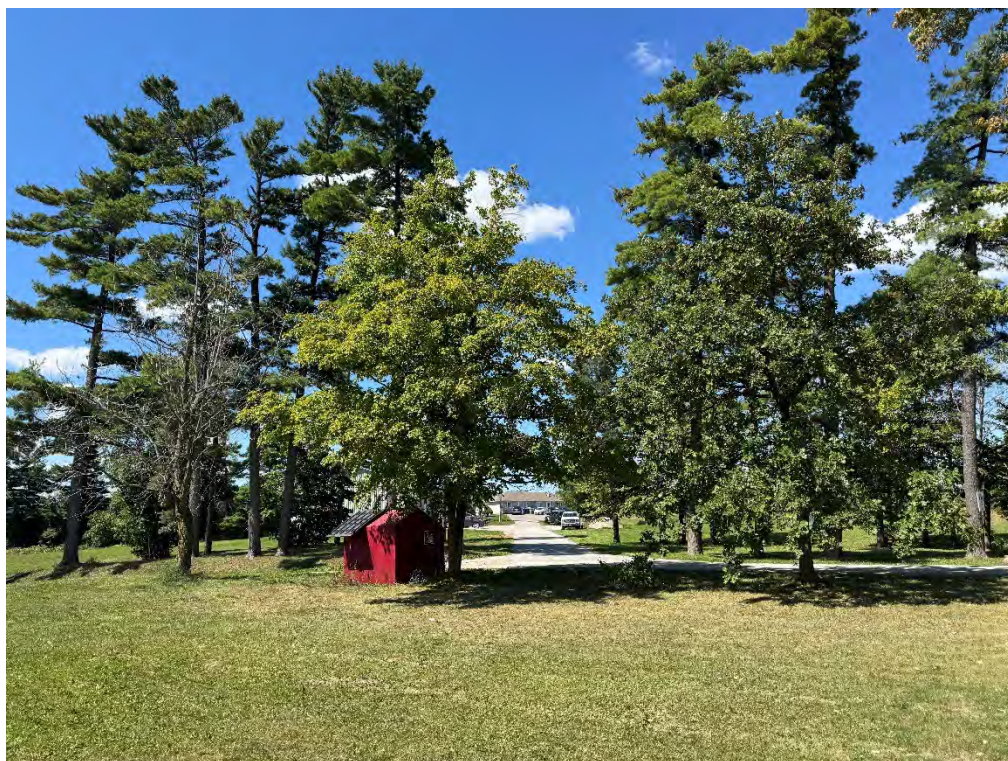
Trees 754 – 756

754	Private	Silver Maple	Acer saccharinum	40	P/D	-	Significant deadwood throughout, tree is 99% dead	Remove due to condition
755	Private	Red Maple	Acer rubrum	23	F	2	2 stem at 1.1 metres	Retain
756	Private	Burr Oak	Quercus macrocarpa	26	F	2	Minor deadwood throughout	Retain
757	Private	Silver Maple	Acer saccharinum	63	F	6	Minor deadwood throughout	Retain
758	Private	White Pine	Pinus strobus	55	F	5	Mild lean, minor deadwood throughout	Retain
759	Private	Black Walnut	Juglans nigra	38	F	3		Retain
760	Private	White Pine	Pinus strobus	41	F	4		Retain
761	Private	White Pine	Pinus strobus	49	P	-	Minor deadwood throughout, elevated canopy	Remove due to construction
762	Private	White Pine	Pinus strobus	27	F	2	Minor deadwood throughout	Remove due to construction
763	Private	White Pine	Pinus strobus	48	F	4	Minor deadwood throughout	Remove due to construction
764	Private	White Pine	Pinus strobus	46	F	4		Remove due to construction

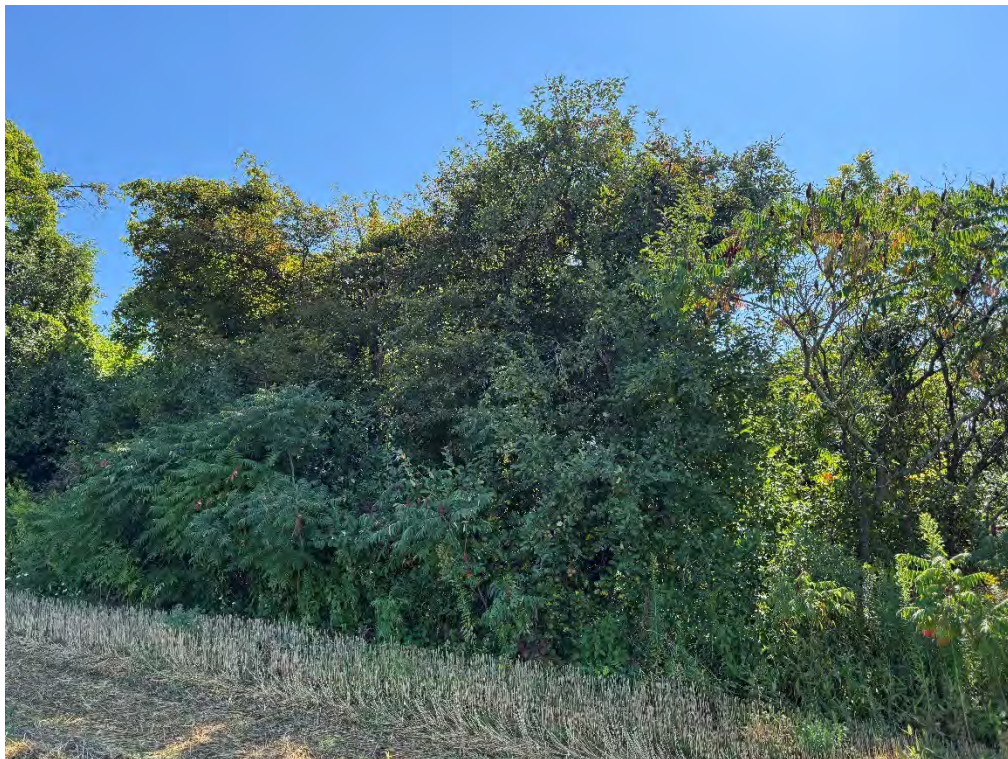
Trees 797 – 799

789	Town	Burr Oak	Quercus macrocarpa	28	F	2	Minor deadwood throughout, vines growing throughout	Remove due to construction
790	Town	Balsam Fir	Abies balsamea	48	F	4	Co-dominant at 1.2 metres	Remove due to construction
791	Town	Balsam Fir	Abies balsamea	42	F/P	4	2 stem at 1.1 metres, moderate deadwood throughout	Retain
792	Town	Balsam Fir	Abies balsamea	~51	F/P	5	2 stem at 1.3 metres, moderate deadwood throughout	Retain
793	Town	Elm Sp.	Ulmus Sp.	20	F/P	2		Retain
794	Town	Black Walnut	Juglans nigra	76	F	7	Vines growing throughout	Retain
795	Private	Black Walnut	Juglans nigra	19	F	1	2 stem at 0.5 metres, vines growing throughout	Remove due to construction
796	Private	Flowering Crabapple Tree	Malus Sp.	~88	P	-	Moderate deadwood throughout, major limb failure previously, water shoots throughout, vines growing throughout	Remove due to construction
797	Private	Flowering Crabapple Tree	Malus Sp.	26	F/P	2	Moderate deadwood throughout, internal rot evident	Remove due to construction

798	Private	Flowering Crabapple Tree	Malus Sp.	18	P	-	Main limb dead, internal rot evident	Remove due to construction
799	Private	Flowering Crabapple Tree	Malus Sp.	32	P	-	Major limb previously failed, internal rot evident, water shoots throughout	Remove due to construction

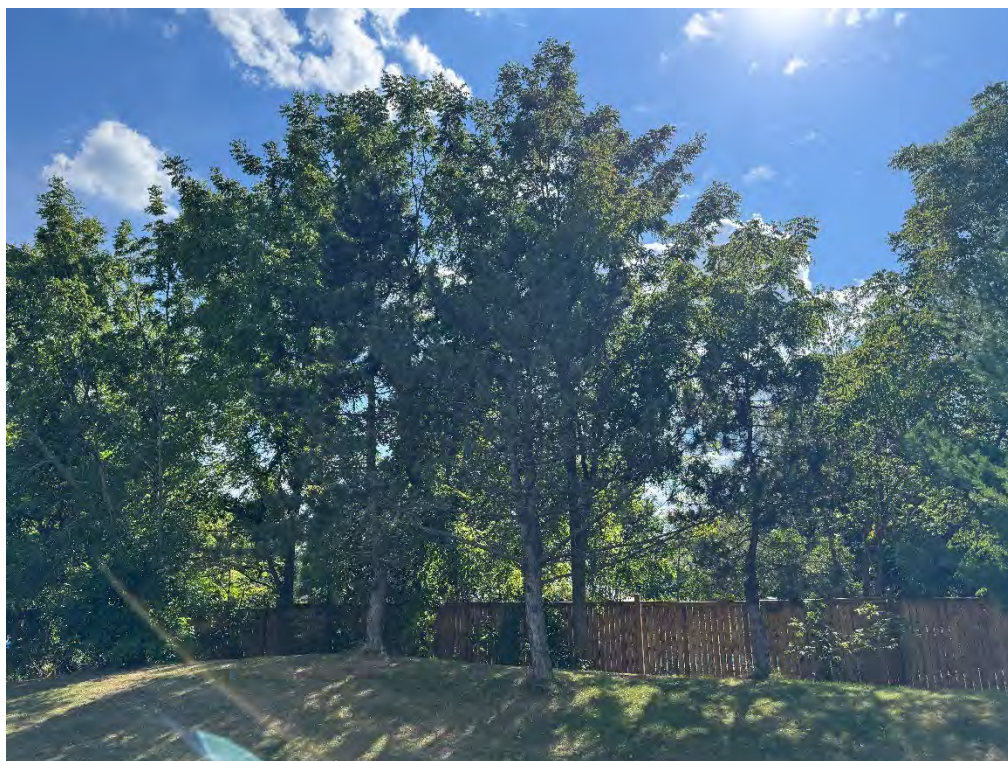
Trees 856 – 861

854	Private	White Pine	Pinus strobus	16	F/G	1		Retain
855	Private	Black Walnut	Juglans nigra	31	F	3	Moderate deadwood throughout	Retain
856	Private	Austrian Pine	Pinus nigra	20	F/P	2	Main leader previously failed	Retain

857	Private	Austrian Pine	Pinus nigra	31	P	-	Significant deadwood throughout	Retain
858	Private	Austrian Pine	Pinus nigra	30	F/P	3	Moderate to significant deadwood throughout	Retain
859	Private	Black Walnut	Juglans nigra	37	F	3	Minor deadwood throughout	Retain
860	Private	Black Walnut	Juglans nigra	40	F	4	Minor deadwood throughout	Retain
861	Private	Black Walnut	Juglans nigra	34	F	3	Minor deadwood throughout	Retain
862	Private	Black Walnut	Juglans nigra	33	F	3	Minor deadwood throughout	Retain
863	Private	Black Walnut	Juglans nigra	18	F	1	Minor deadwood throughout	Retain
864	Private	Black Walnut	Juglans nigra	51	F	5	Minor deadwood throughout	Retain
865	Private	Black Walnut	Juglans nigra	36	F	3	Minor deadwood throughout	Retain
866	Town	Black Walnut	Juglans nigra	54	F	5	Minor deadwood throughout	Retain
867	Town	Black Walnut	Juglans nigra	16	F	1	Minor deadwood throughout	Retain
868	Town	Black Walnut	Juglans nigra	18	F	1	Minor deadwood throughout	Retain

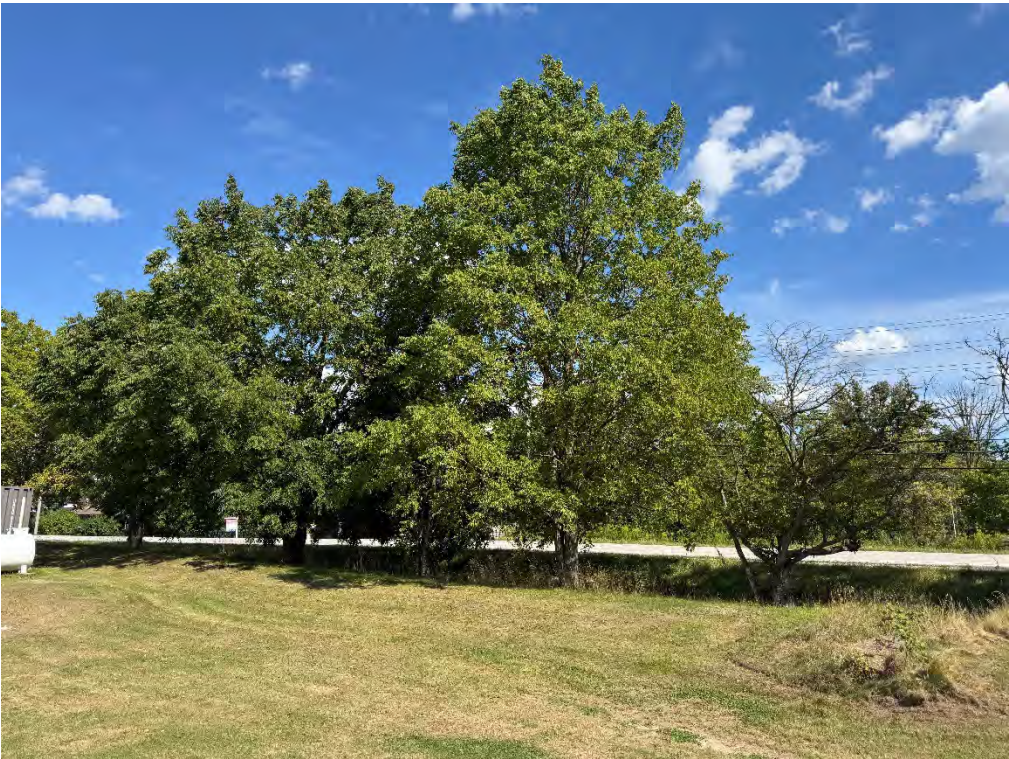
Trees 873 – 876

872	Town	Black Walnut	Juglans nigra	21	F	2	2 stem at base, moderate deadwood throughout	Retain
873	Town	Flowering Crabapple Tree	Malus Sp.	17	P	-	Multiple limbs previously failed, significant deadwood throughout	Retain
874	Town	Black Walnut	Juglans nigra	35	F	3	Minor to moderate deadwood throughout	Remove due to construction
875	Town	Butternut	Juglans cinerea	18	F/P	1	Moderate to significant deadwood throughout, 3 stem at base, moderate to heavy canker throughout, tree is in decline	Remove due to construction
876	Town	Black Walnut	Juglans nigra	40	F	4	Minor deadwood throughout, 3 stems at 0.5 metres	Remove due to construction
877	Town	Black Walnut	Juglans nigra	24	F	2	Muti-stem, minor deadwood throughout	Remove due to construction
878	Private	Norway Maple	Acer platanoides	16	F	1	Minor deadwood throughout, mildew disease evident	Remove due to construction
879	Town	Black Walnut	Juglans nigra	30	F	3	Minor deadwood throughout	Retain

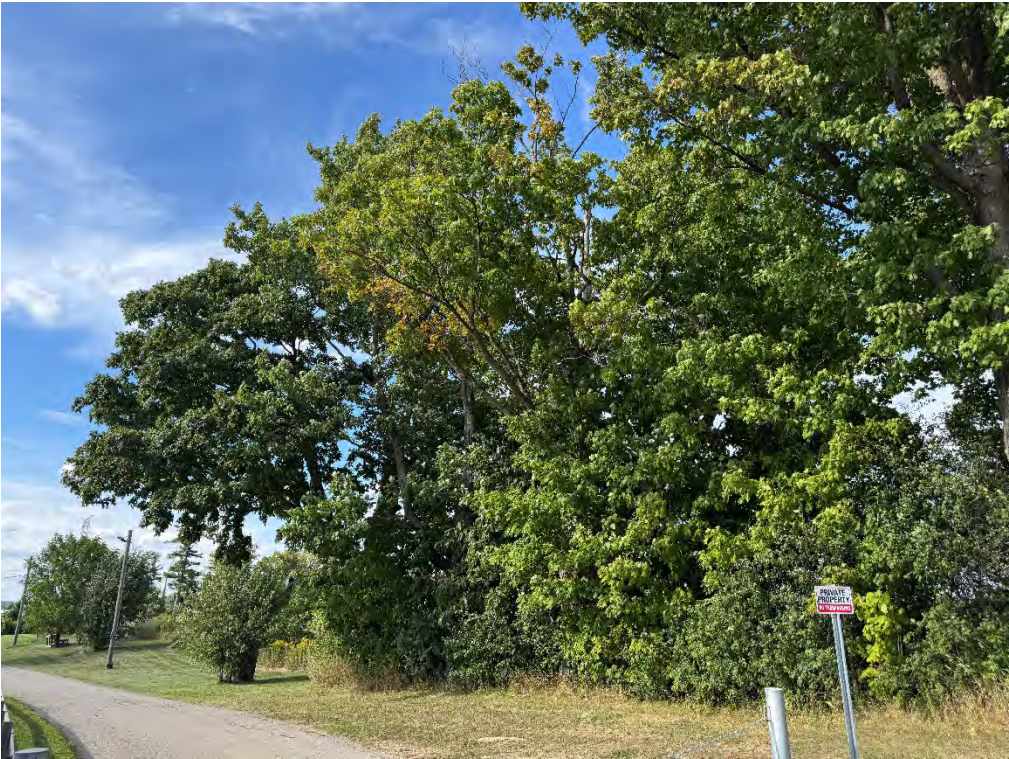
Trees 897 – 899

893	Private	Austrian Pine	<i>Pinus nigra</i>	35	F	3	Minor deadwood throughout	Remove due to construction
894	Private	Black Locust	<i>Robinia pseudoacacia</i>	17	F	1	Minor deadwood throughout	Remove due to construction
895	Private	Black Locust	<i>Robinia pseudoacacia</i>	18	F	1		Remove due to construction
896	Private	Black Walnut	<i>Juglans nigra</i>	16	F	1		Retain
897	Private	Sugar Maple	<i>Acer saccharum</i>	71	F/P	7	Multiple previous limb failures, multiple cavity's throughout, suspected rot column throughout	Retain
898	Private	Red Maple	<i>Acer rubrum</i>	66	F	6	Minor deadwood throughout	Retain

899	Private	Sugar Maple	Acer saccharum	82	P	-	Moderate deadwood throughout, main leader dead with rot column, internal rot evident, tree is structural hazard	Remove due to condition
900	Private	Sugar Maple	Acer saccharum	72	F	7	Minor deadwood throughout	Remove due to construction
901	Private	Sugar Maple	Acer saccharum	68	F	6		Retain
902	Private	Sugar Maple	Acer saccharum	63	F	6	Minor deadwood throughout	Retain
903	Private	Sugar Maple	Acer saccharum	71	F	7	Minor deadwood throughout	Retain
904	Private	Black Walnut	Juglans nigra	19	F	1	2 stem at 0.2 metres	Retain
905	Private	Basswood	Tilia americana	17	F	1	Minor deadwood throughout	Retain
906	Private	Basswood	Tilia americana	18	F	1	Minor deadwood throughout	Retain
907	Private	Basswood	Tilia americana	15	F/P	1	Elevated canopy, minor deadwood throughout	Retain
908	Private	Basswood	Tilia americana	17	F	1	Minor deadwood throughout	Retain
909	Private	Basswood	Tilia americana	16	F	1	Minor deadwood throughout	Retain

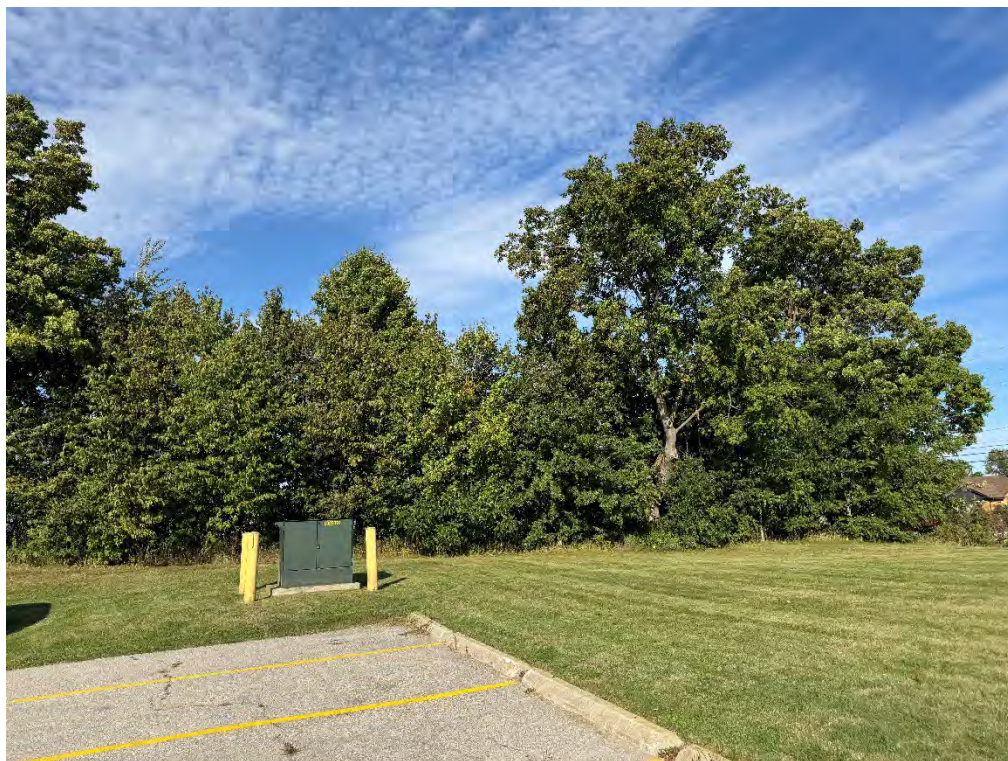
Trees 904 – 922

910	Private	Basswood	Tilia americana	14	F	1		Retain
911	Private	Sugar Maple	Acer saccharum	24	F	2	Minor deadwood throughout	Retain
912	Private	Black Walnut	Juglans nigra	15	F	1	Minor deadwood throughout	Retain
913	Private	Basswood	Tilia americana	17	F	1	Multi-stem	Retain

914	Private	Basswood	Tilia americana	22	F	2	Multi-stem, minor deadwood throughout	Retain
915	Private	Red Maple	Acer rubrum	83	P/D	-	Main limb previously failed, internal rot evident, tree is 70% dead, structural hazard	Remove due to condition
916	Private	Basswood	Tilia americana	18	F	1	Multi-stem	Retain
917	Private	Black Walnut	Juglans nigra	17	F	1		Retain
918	Private	Cherry Sp.	Prunus Sp.	21	F	2	Minor deadwood throughout	Retain
919	Private	Black Walnut	Juglans nigra	14	F	1	Minor deadwood throughout	Retain
920	Boundary - Town and Private	Red Maple	Acer rubrum	82	F	8	Minor deadwood throughout	Retain
921	Private	Black Walnut	Juglans nigra	20	F	2		Retain
922	Town	Burr Oak	Quercus macrocarpa	12	F	1	Minor deadwood throughout	Retain
923	Town	Butternut	Juglans cinerea	20	P/D	-	2 stem at base, larger stem 100% dead, smaller stem 60% dead dying from top	Retain
O1	Boundary - Neighbour and Private	Norway Spruce	Picea abies	61	F	6		Retain

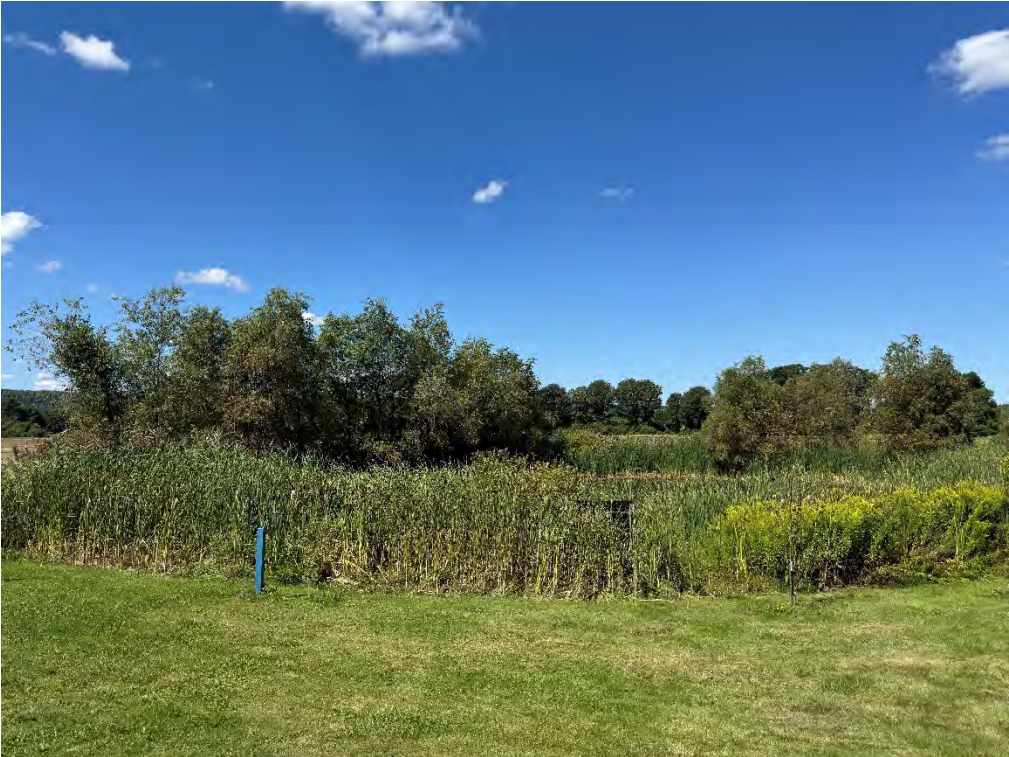
Tree A

O6	Neighbour	Silver Maple	Acer saccharinum	94	F	9	Minor deadwood throughout, multiple previous limb failures, internal rot evident	Retain
O7	Private	Ash Sp.	Fraxinus Sp.	62	F	6		Retain
O8	Private	Horse Chestnut	Aesculus hippocastanum	48	F	4	Minor to moderate deadwood throughout	Retain
O9	Private	Red Oak	Quercus rubra	58	F	5	Moderate deadwood throughout	Retain
O10	Private	Ornamental Pear	Pyrus calleryana	23	F/P	2	Moderate to significant deadwood throughout	Retain
O11	Private	Ornamental Pear	Pyrus calleryana	22	P	-	Significant deadwood throughout	Retain
O12	Private	White Mulberry	Morus alba	19	F	1		Retain
O13	Private	Red Maple	Acer rubrum	33	D	-	Tree is 100% dead	Retain
A	Private	Black Willow	Salix nigra	5-15	F	28	~28 stems growing within pond	Remove due to construction
