# Sixteen Mile Creek Fluvial Geomorphology Assessment and Critical Redside Dace Habitat Delineation

## Scoped Subwatershed Study

9094 Regional Road 25  
Halton Hills, ON

GEO Morphix Project No. 25111

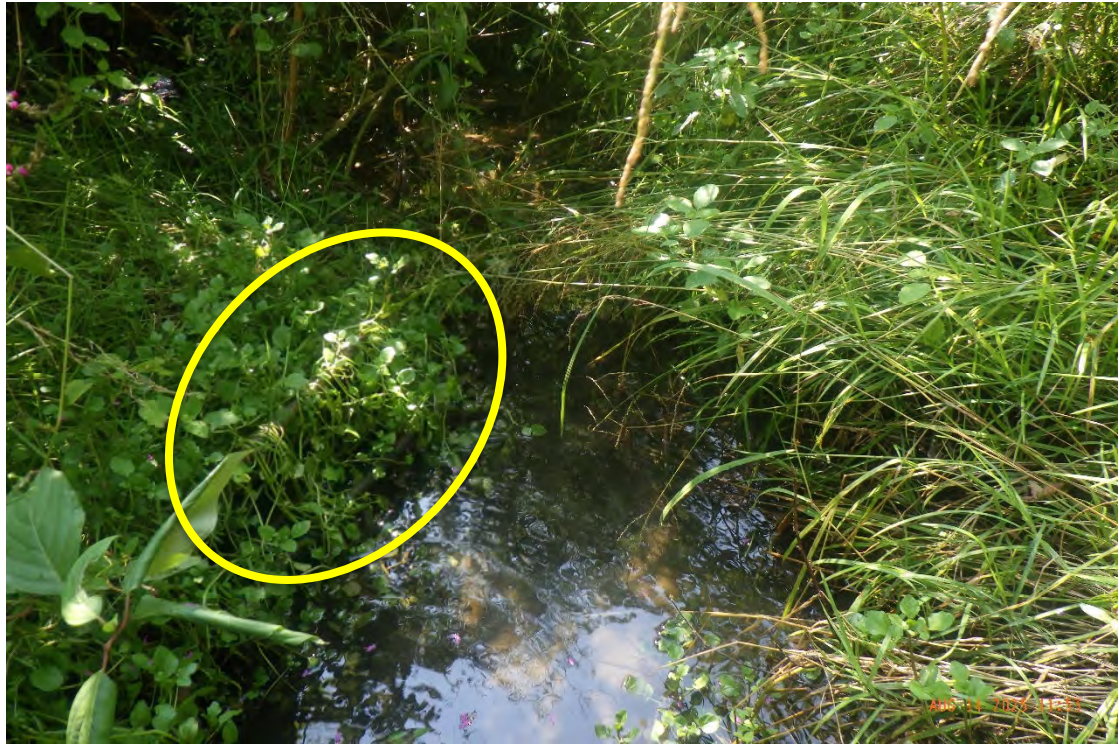
Photo 1  
Tributary of Sixteen Mile Creek, Halton Hills  
Reach N-2-D

Photo of **Reach N-2-D** facing downstream. Watercress (circled) was frequently observed throughout the reach.

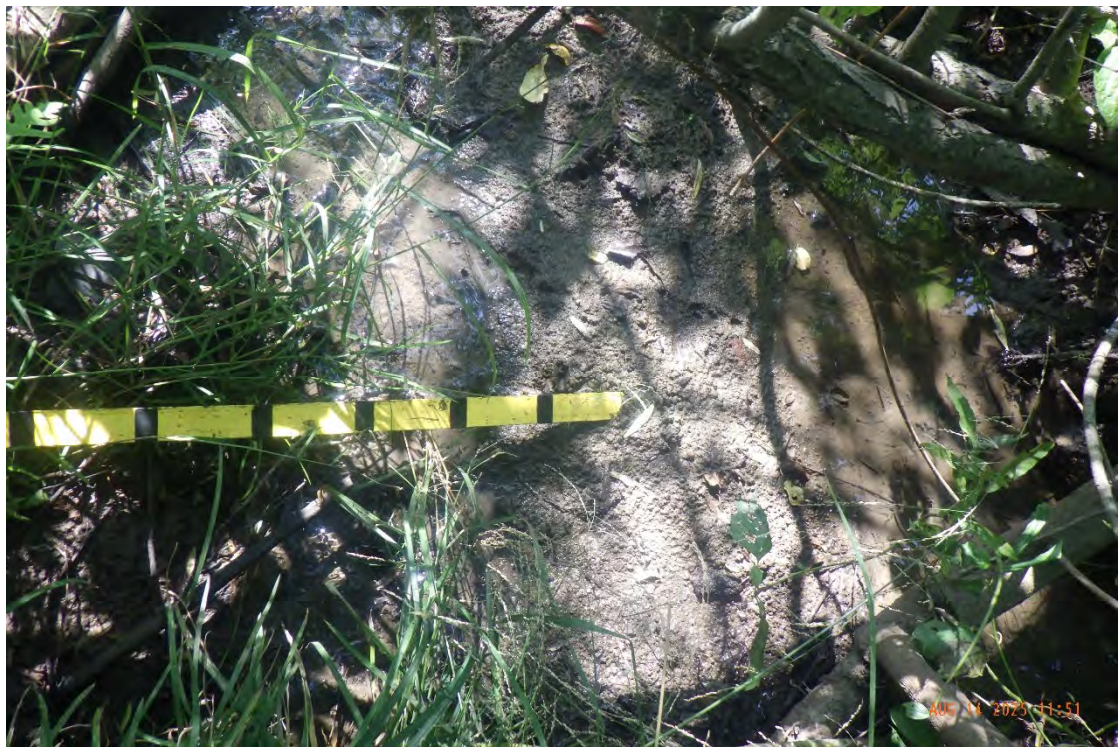
Photo 2  
Tributary of Sixteen Mile Creek  
Reach N-2-D

The bed and bank substrate in **Reach N-2-D** was primarily comprised of clay- and silt-textured materials.

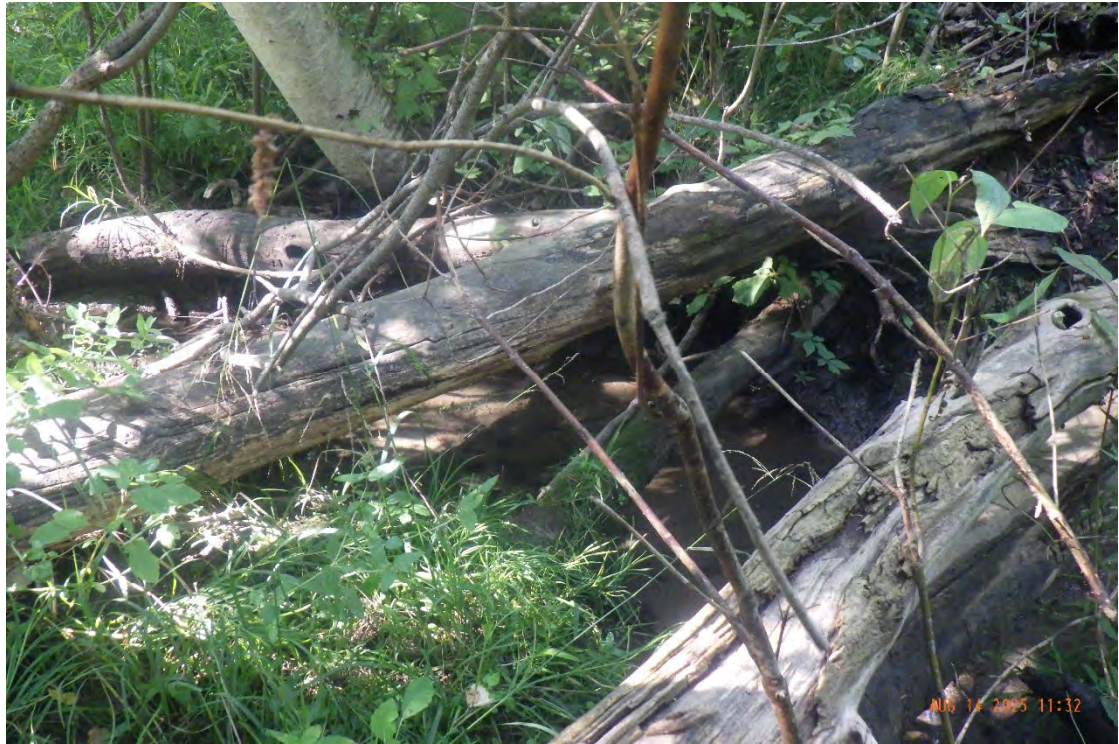
**Photo 3**  
Tributary of Sixteen Mile Creek  
**Reach N-2-D**

Photo of **Reach N-2-D** facing downstream. Woody debris and fallen trees of various ages were common throughout the reach.

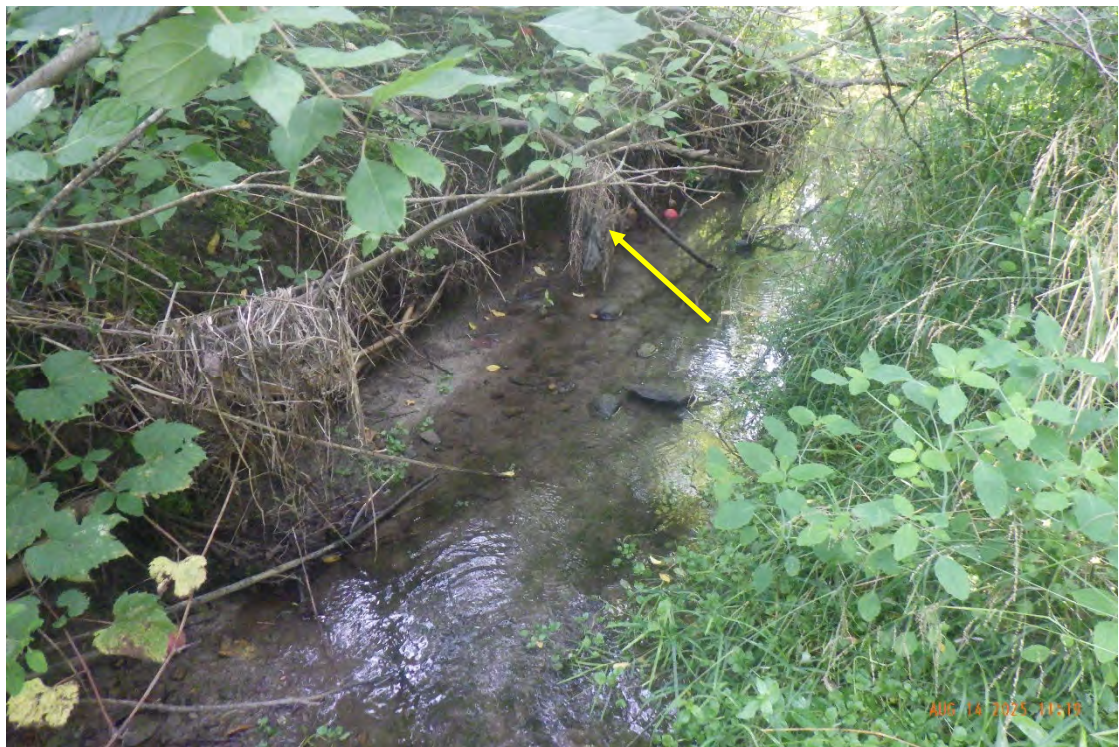
**Photo 4**  
Tributary of Sixteen Mile Creek  
**Reach N-2-D**

Photo of **Reach N-2-D** facing downstream. Undercutting was present along the left bank (indicated by arrow).

- A 5 m toe erosion allowance was recommended for **Reach N-2-D** and was to be applied from the channel bank where it is within 15 m of the valley slope. This is to be reviewed in tandem with the geotechnical slope stability assessment prepared by Soil Engineers Ltd (2026).

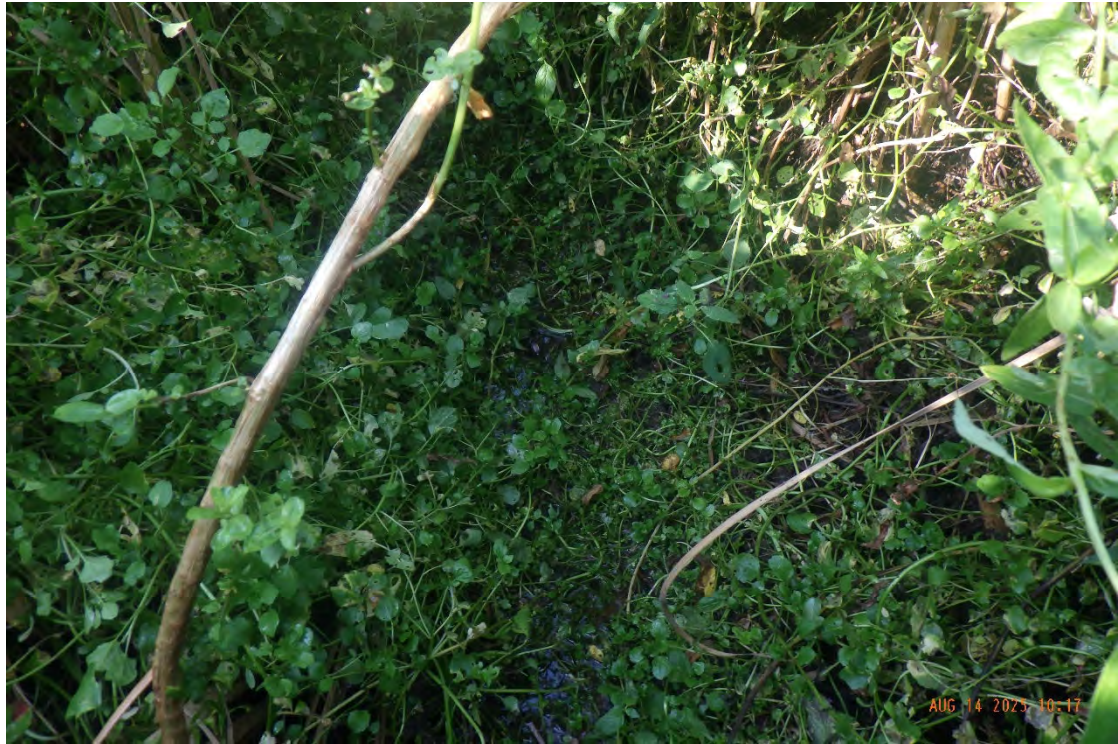
**Photo 5**  
Tributary of Sixteen Mile Creek  
Reach N-2-Da

Photo of **Reach N-2-Da** facing downstream. Watercress was prevalent throughout the reach.

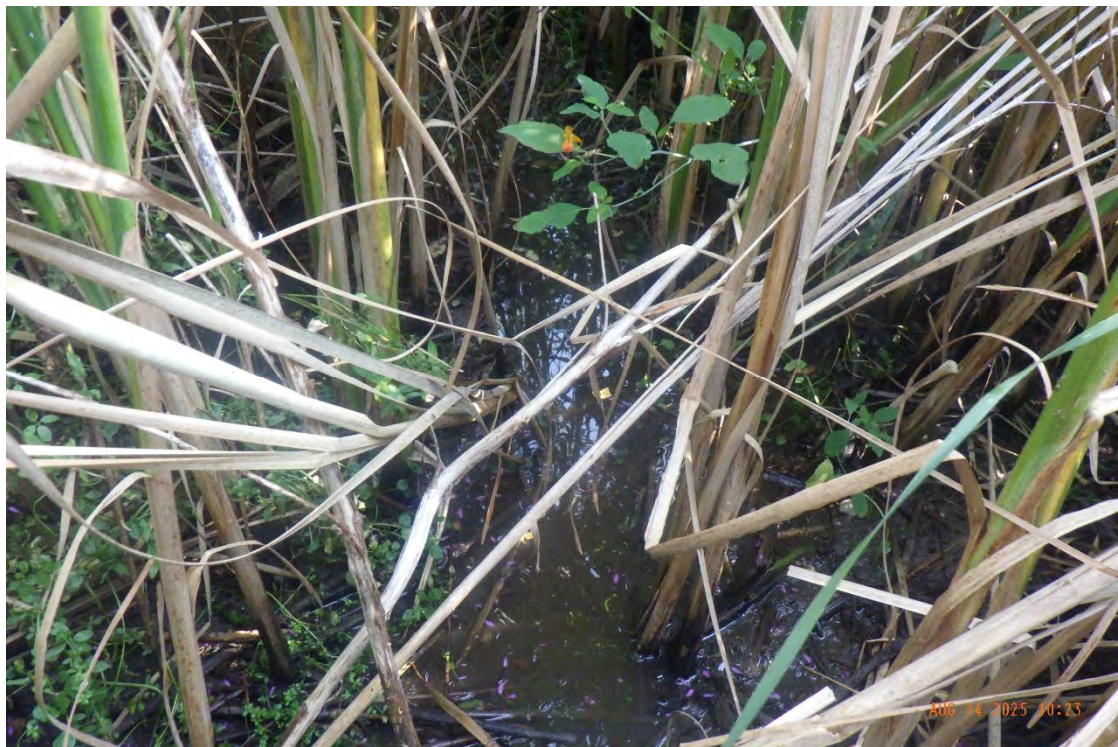
**Photo 6**  
Tributary of Sixteen Mile Creek  
Reach N-2-Da

Vegetation was mainly comprised of wetland-type plants that encroached into the low-flow channel. Agricultural fields flanked the reach.

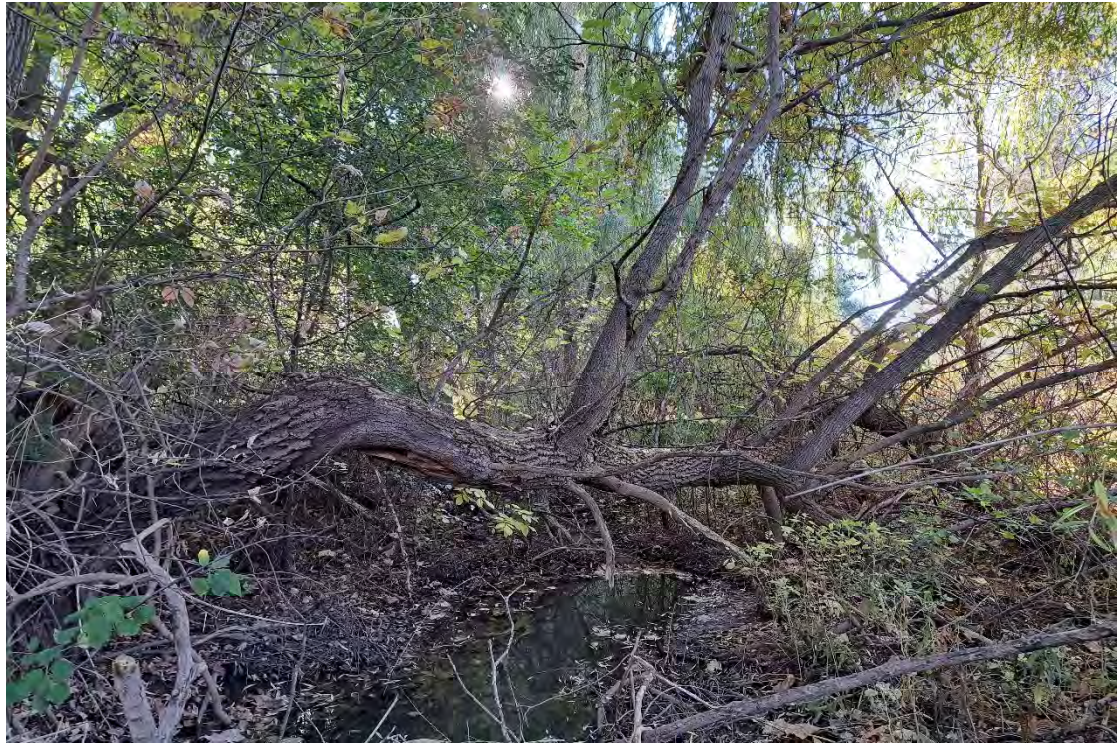
**Photo 8**  
Tributary of Sixteen Mile Creek  
**Reach N-2-C**

Photo of **Reach N-2-C** facing downstream. Woody debris and fallen trees were found throughout the reach.

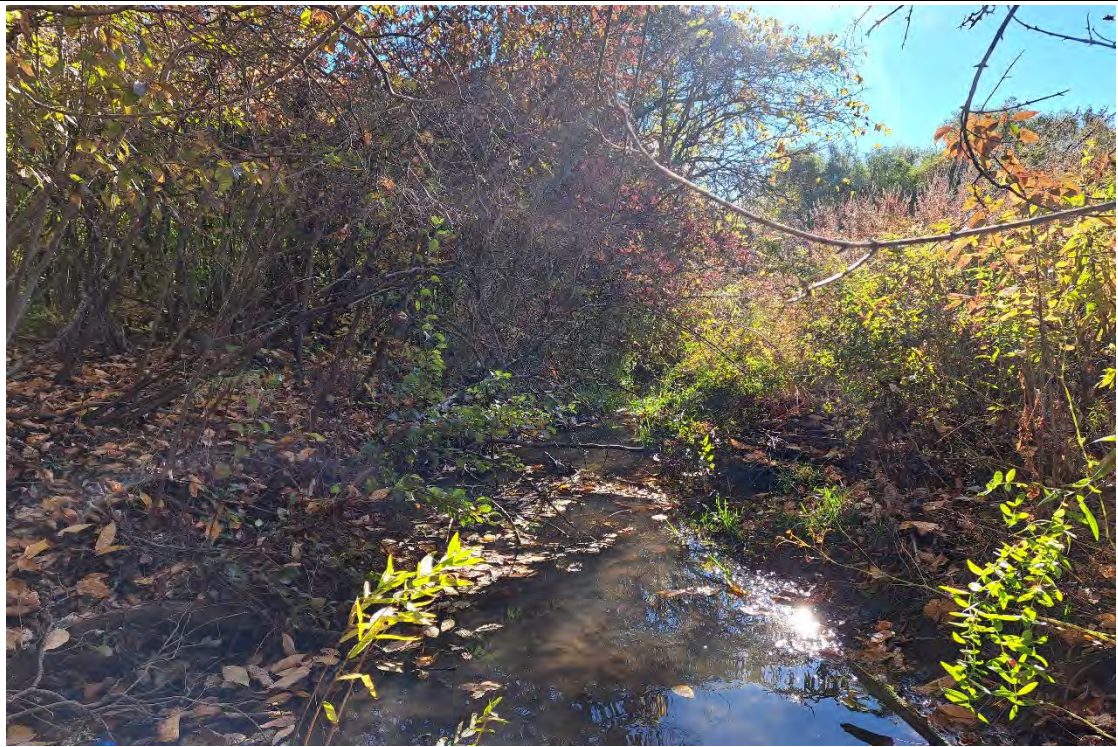
**Photo 9**  
Tributary of Sixteen Mile Creek  
**Reach N-2-C**

Photo of **Reach N-2-C** facing downstream. Riparian vegetation consisted of grasses, shrubs, and mature trees.

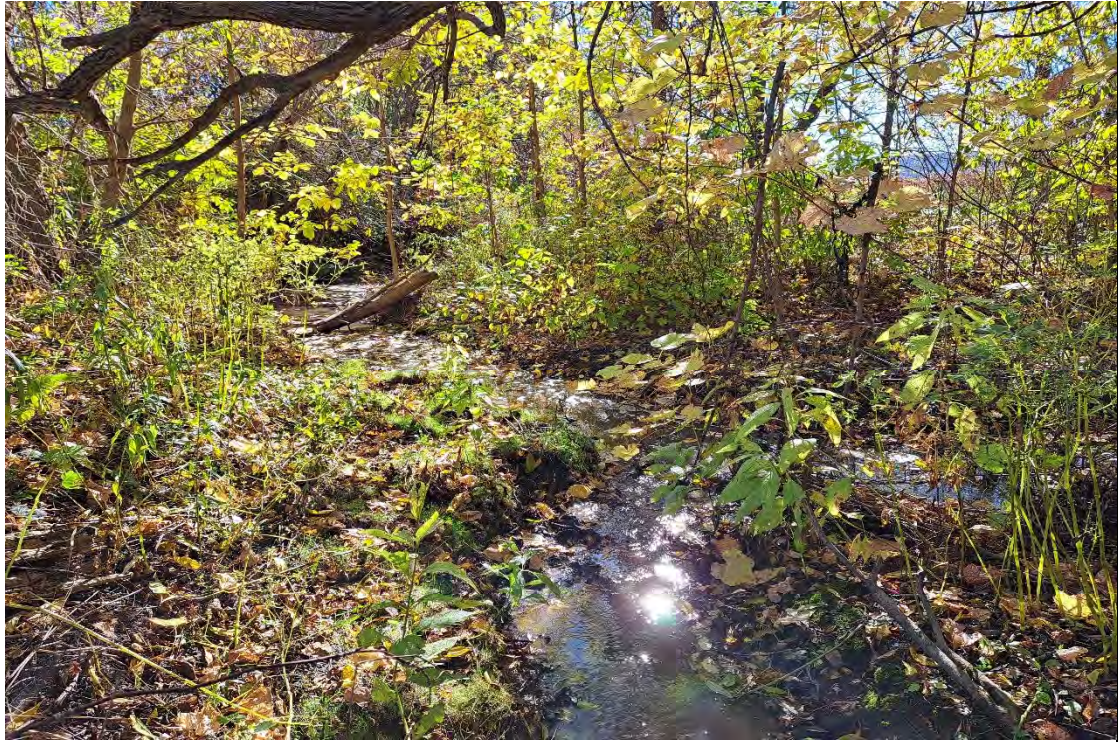
**Photo 10**  
Tributary of Sixteen Mile Creek  
**Reach N-2-C**

Photo of **Reach N-2-C** facing downstream at the confluence with an adjacent tributary. The reach had an average bankfull width and depth of 1.96 m and 0.21 m, respectively.

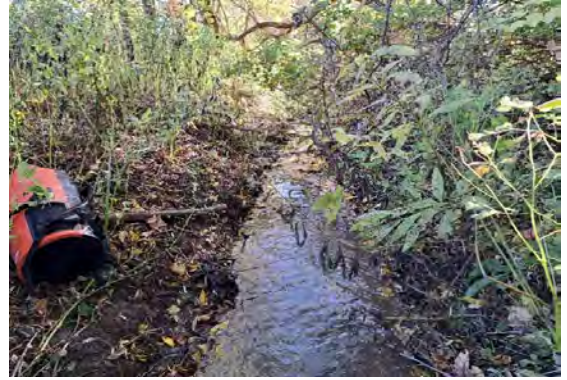
Photograph at cross section 6 (looking downstream)

The subject reach was characterized by a straight channel set within a partially confined wooded and grassy valley. Dominant riparian vegetation consisted of mature trees and established shrubs, which provided limited cover over the channel. Channel bed morphology was characterized by pool and run geomorphic units. The channel exhibited evidence of systematic widening. For example channel banks were generally vegetated with some mature roots exposed and multiple leaning/fallen trees observed. The channel also displayed multiple indicators associated with good channel health. For example the channel was characterized by a variable bed morphology (i.e., pools and runs) with diverse flow conditions and habitat refuge potential.
