Re: **Review of Watercourse Constraint Ranking for Watercourse Reaches 'C-1' and 'C-2', Vision Georgetown Secondary Plan Area, Town of Halton Hills**

Re: Vision Georgetown – Tributary C Realignment Alternative near 10512 8th Line

Re: Vision Georgetown (South) Subwatershed Study and Secondary Plan, Tributary C Management – Constraint Ranking and Realignment Alternatives
CH File: MPR 634

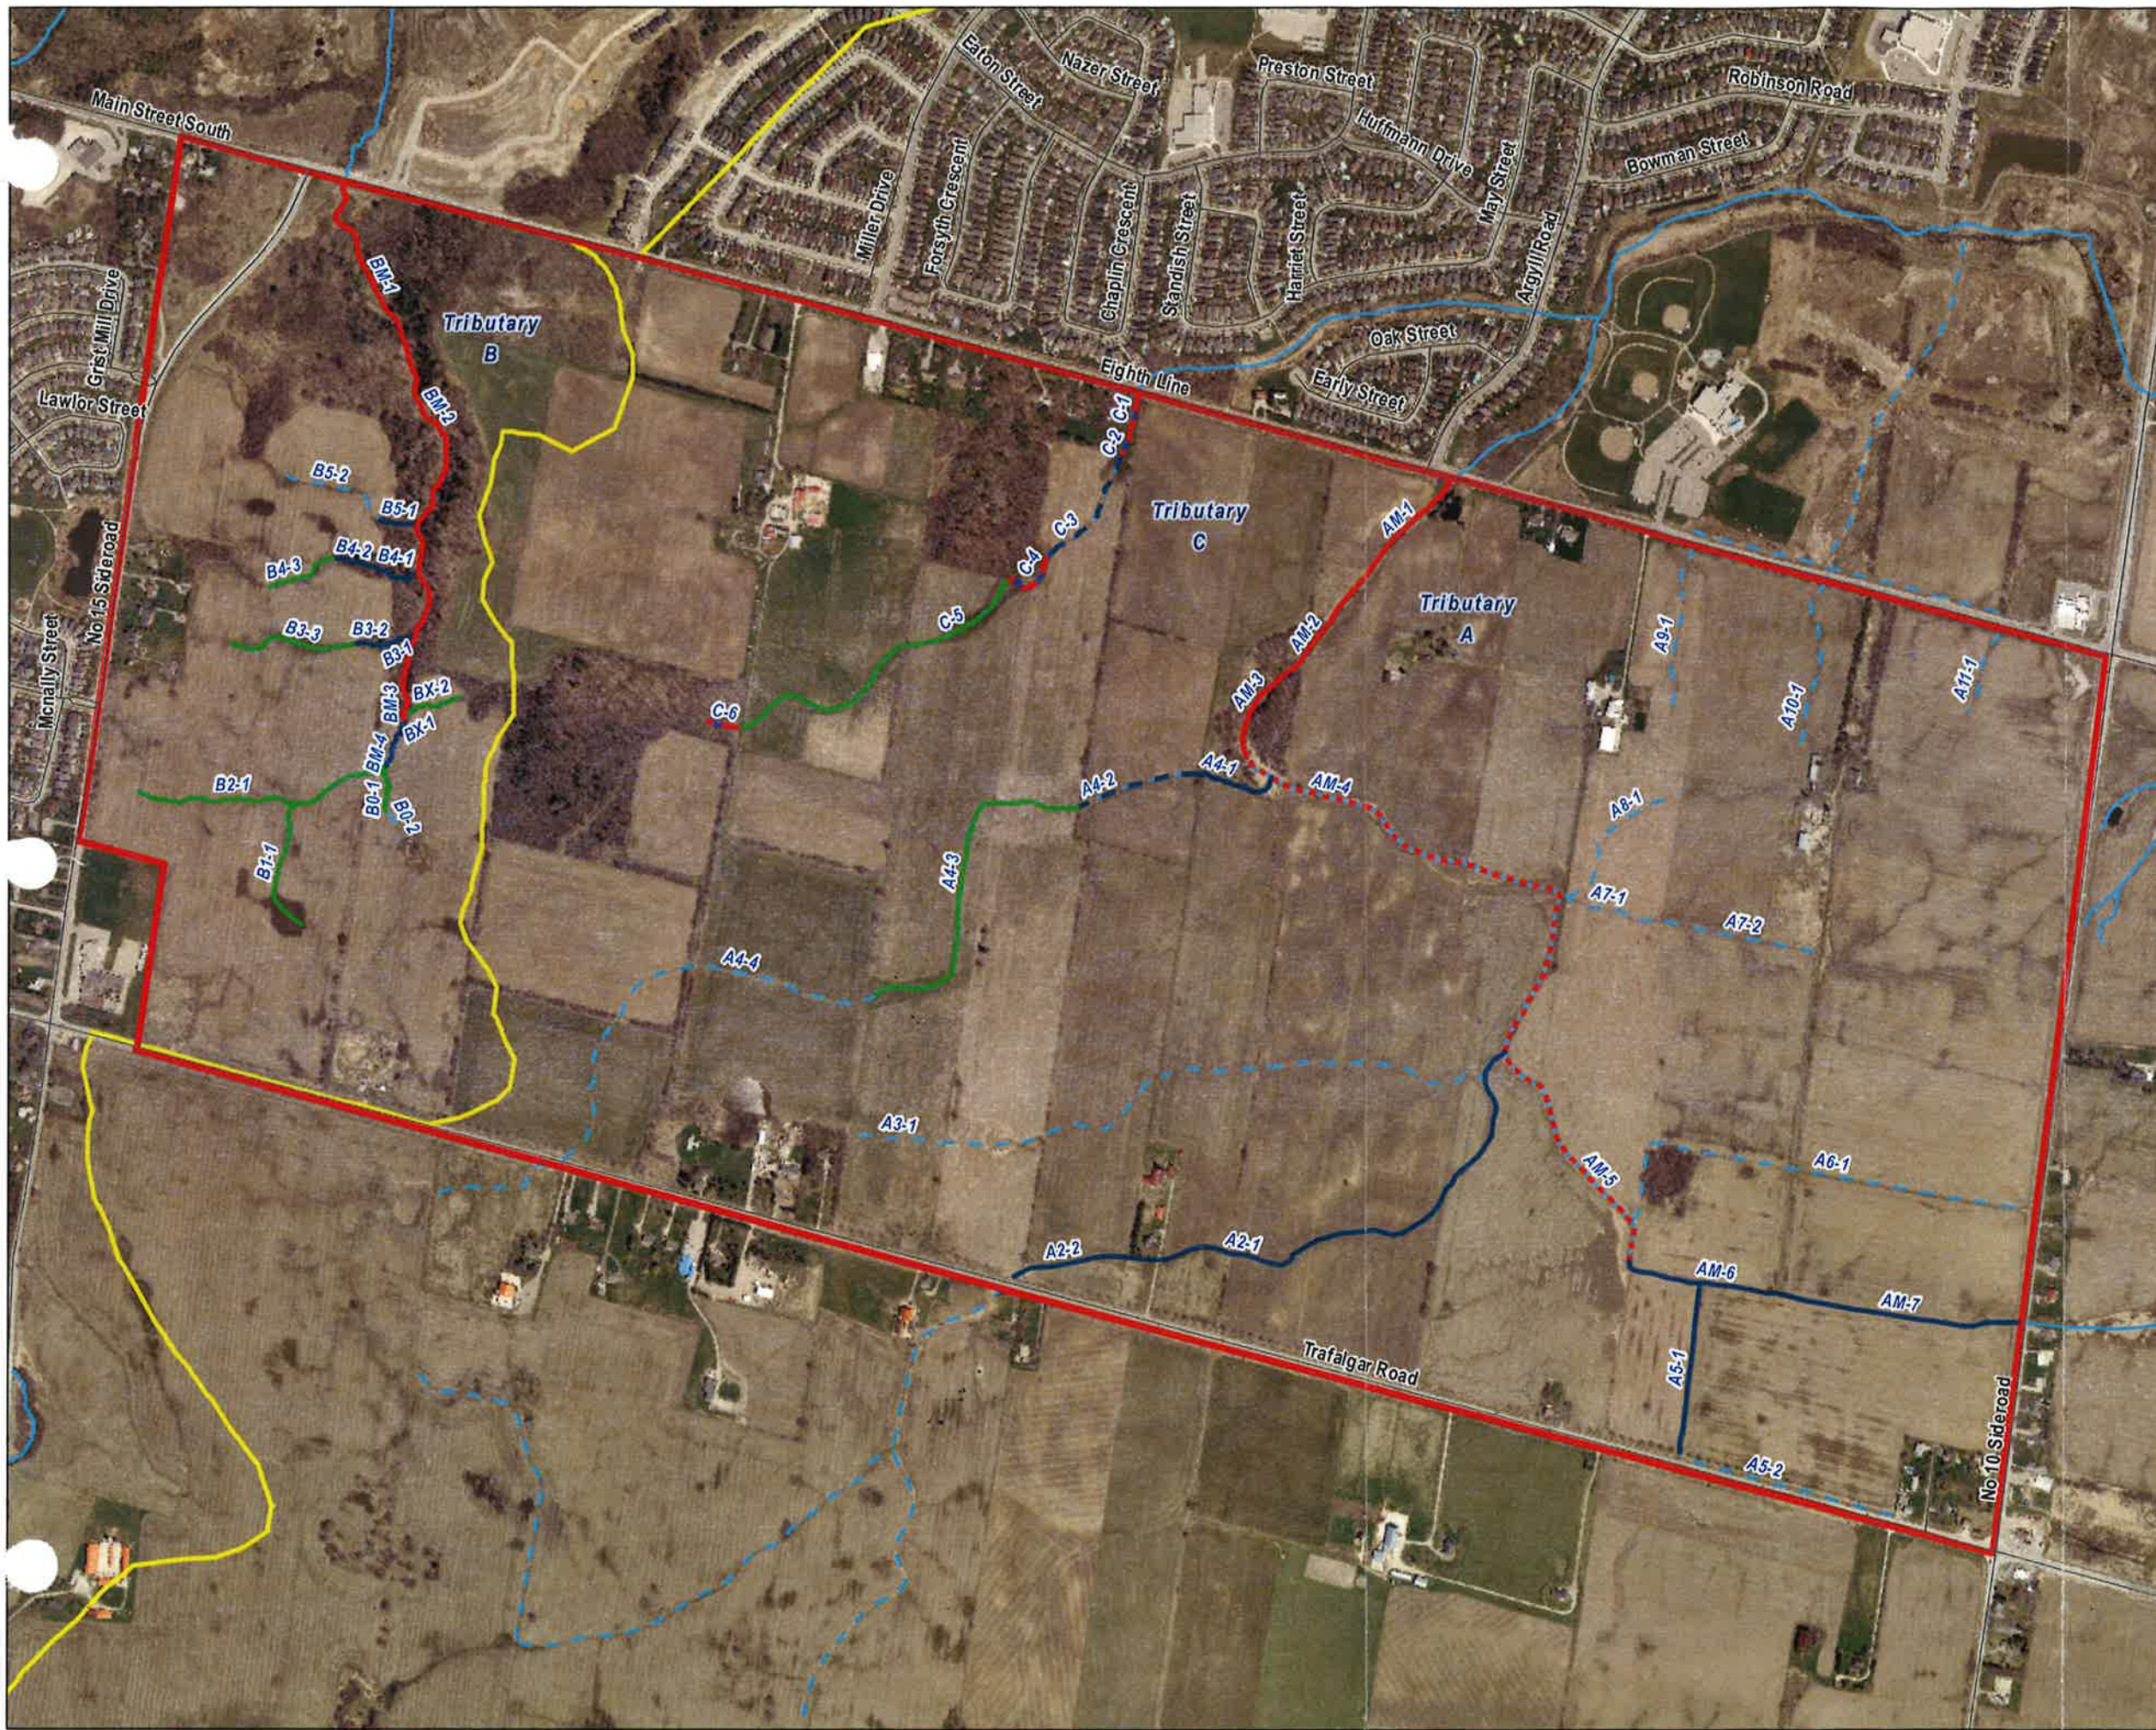
Watercourse Characterization for Management

The subject watercourse reaches 'C1' and 'C2' are located toward the terminus of Tributary 'C', and immediately upstream of Eighth Line. Tributary 'C' is the second tributary in the study area that is within the Sixteen Mile Creek watershed, conveying flows across Eighth Line. It confluences with Tributary 'A' approximately 500m downstream of Eighth Line and then crosses Side Road 10. As part of the May 2017 Subwatershed Study, Tributary 'C' has been subdivided into six (6) stream reaches for the watercourse constraint ranking (ref. Figure 5.9.1 attached).

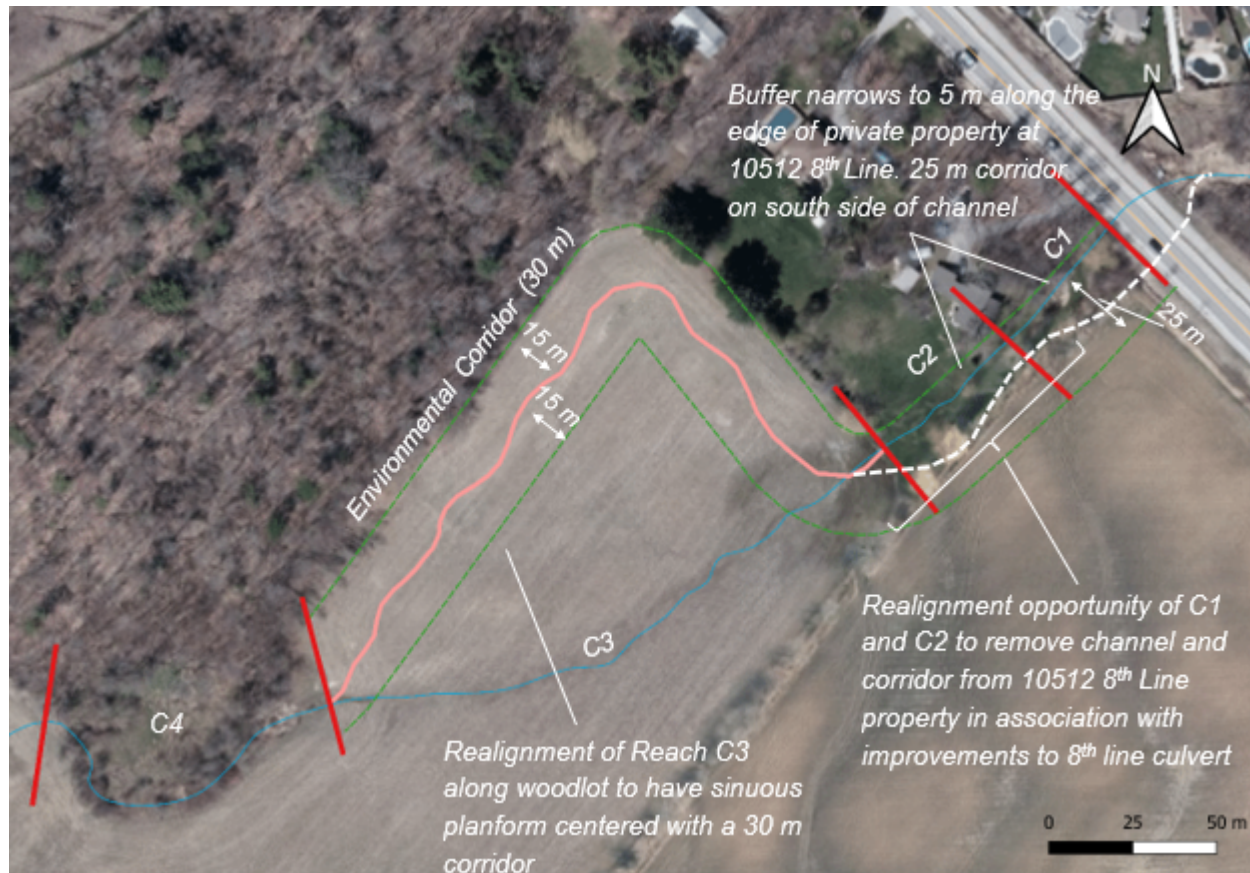
Figure 1: Plan view of the proposed realignment of reach C3, centered along a 30 m-wide environmental corridor contiguous with an existing woodlot.

- *New Channel Corridor (Figure 1)* – The construction of a defined environmental corridor would create a functional development setback and establish terrestrial and hydrological connectivity from C4 to C1. The length of open channel would increase from approximately 200 m to approximately 425 m. The new channel would be roughly centred along the 30 m-wide corridor. The proposed open channel corridor would establish a restoration and enhancement area of approximately 6,000 m² that would be part of the NHS.
- *Sinuuous planform* – The construction of a defined channel along reach C3 would increase longitudinal habitat connectivity from C4 to C1. A more sinuous planform would increase the

channel length (decrease channel gradient) and provide for improved aquatic and terrestrial habitat functions. The channel would be approximately centered along the environmental corridor, with a buffer of approximately 15 m on either side. Based on an investigation of surrogate reaches within the Sixteen Mile Creek watershed, meandering channels are not common within similarly sized headwater subwatersheds. The establishment of a 30 m environmental corridor would provide ample space for minor lateral adjustments to occur over the 100-year planning horizon.

2. Conservation Halton has no objection to the realignment of C-3 as illustrated in Figure 1 in the Palmer Environmental Consulting Group Inc. Technical Memorandum assuming appropriate buffer and channel corridor widths are provided. As C-3 is considered a regulated watercourse all associated flooding and erosion hazards and 15 metre hazard allowance must be contained within the realigned channel corridor. Conservation Halton will continue to work with the Town of Halton Hills in the design of the realigned corridor to ensure it meets Conservation Halton requirements and incorporates Natural Channel design techniques.

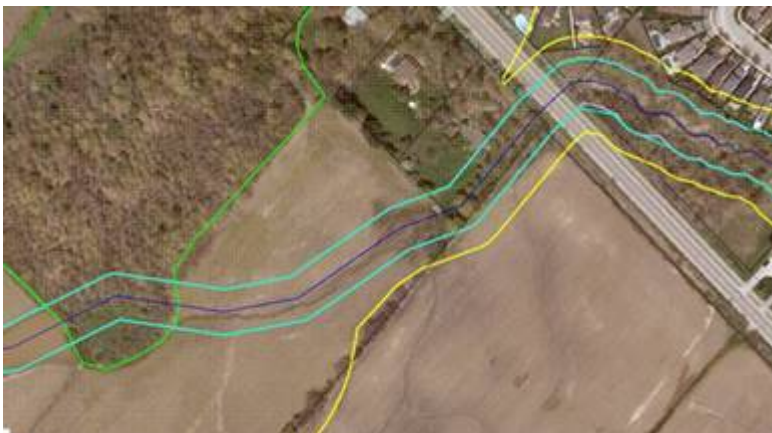
- Current Classification:
 - C1 and C2: Both reaches are designated as regulated in Conservation Halton's ARL mapping as shown below (with a 15 m buffer from the greatest hazard – shown as a meanderbelt).
