# APPENDIX A

## Legal Survey and Figures

Project  
**HALTON MANAGEMENT INC.  
PHASE ONE ENVIRONMENTAL SITE ASSESSMENT  
530 GUELPH STREET  
HALTON HILLS, ONTARIO**

FIGURE NAME  
**AREAS OF POTENTIAL ENVIRONMENTAL CONCERN**

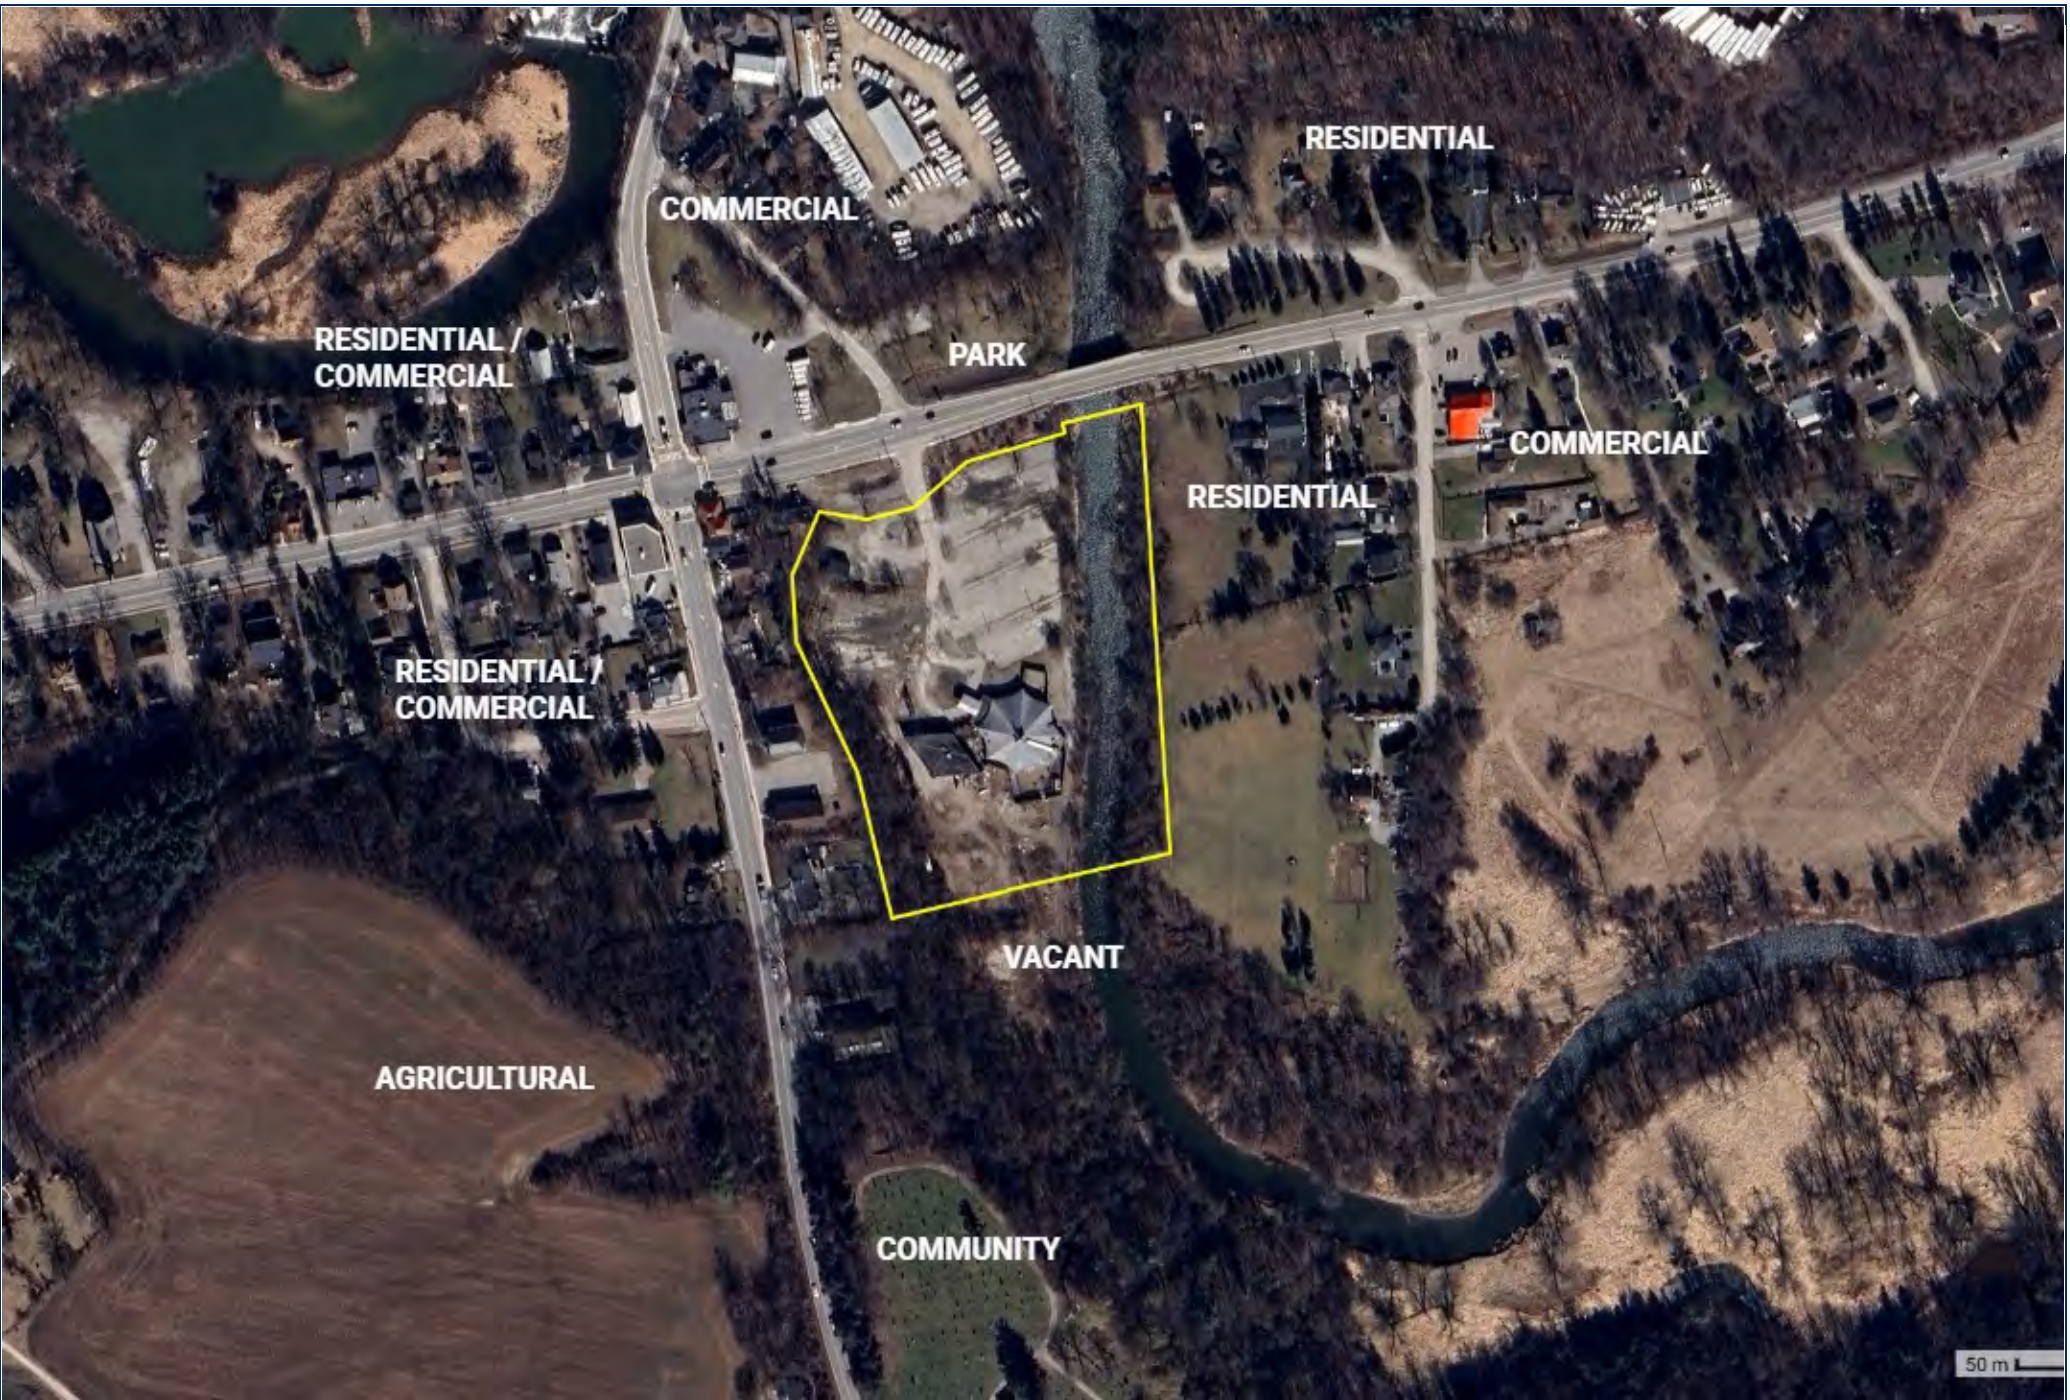
Project No : 2783-7276  
Date : May 29, 2025  
Figure No : 2

Project Name : Phase One Environmental Site Assessment  
Project Location : 530 Guelph Street, Halton Hills, ON  
Figure Name : SURROUNDING PROPERTY USE

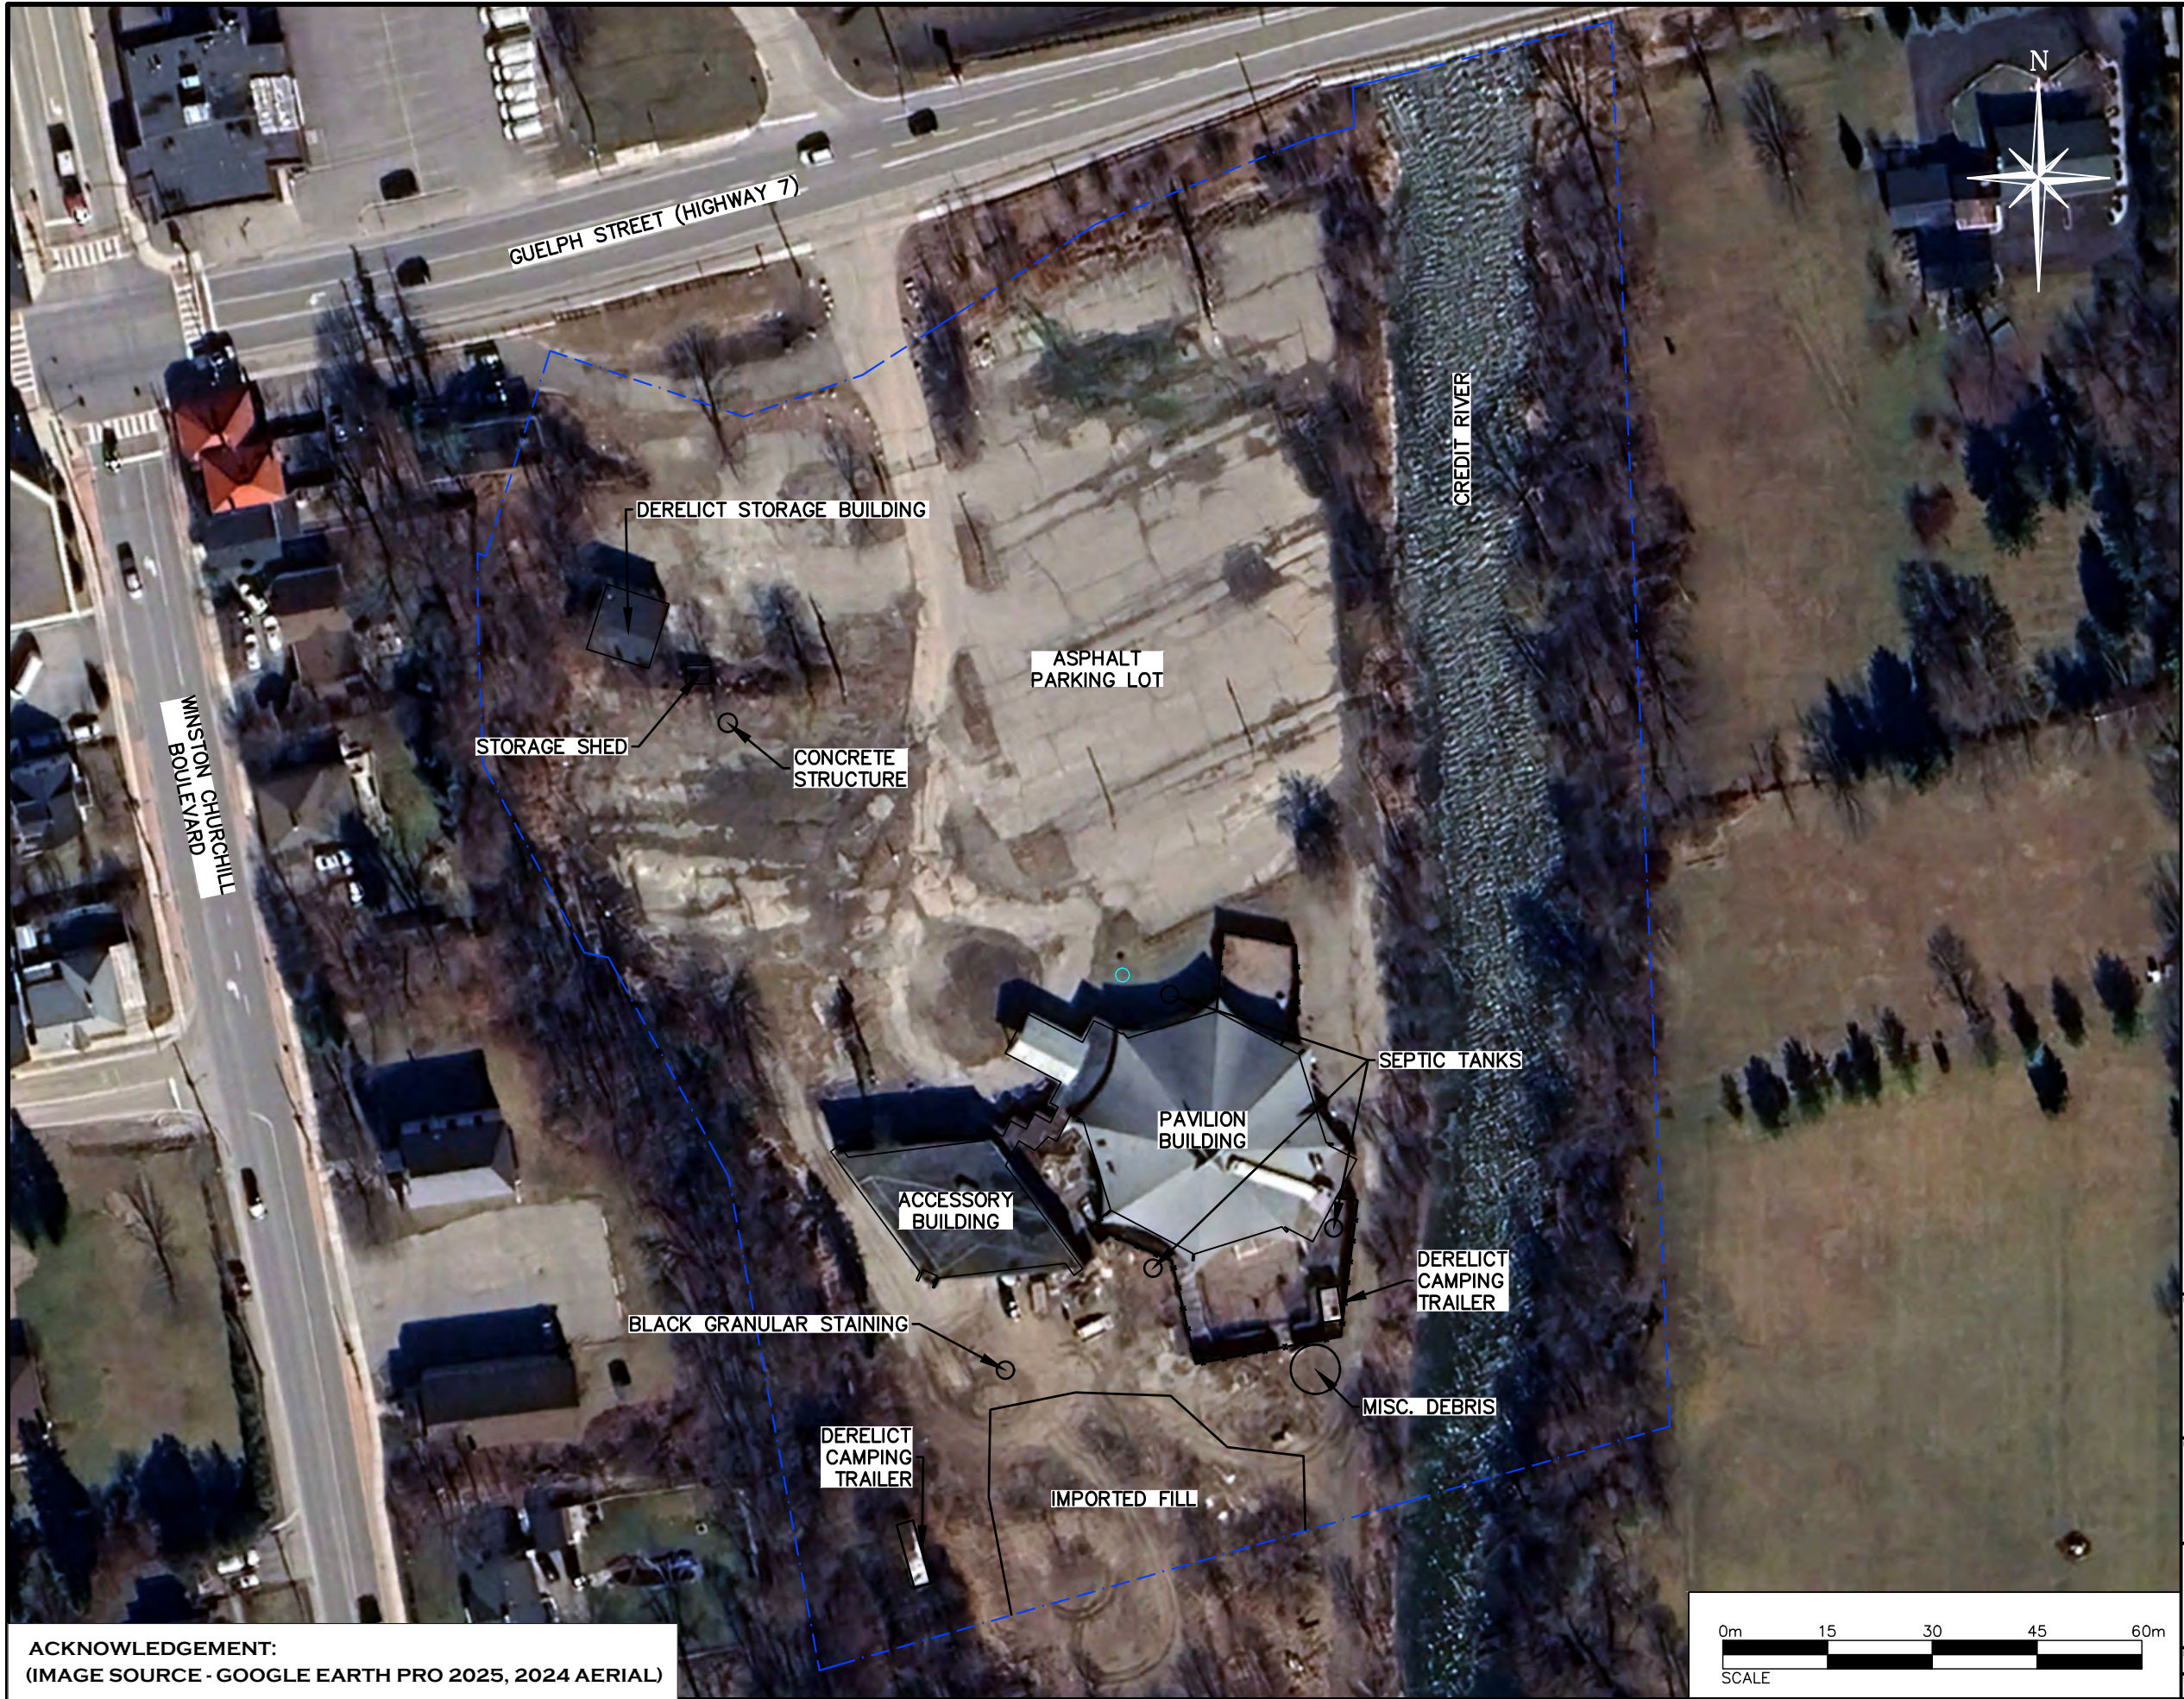
**FIGURE 3**

PHASE ONE PROPERTY BOUNDARY
-

FENCE
-

POTABLE WELL

FIGURE NAME  
**SITE FEATURES**

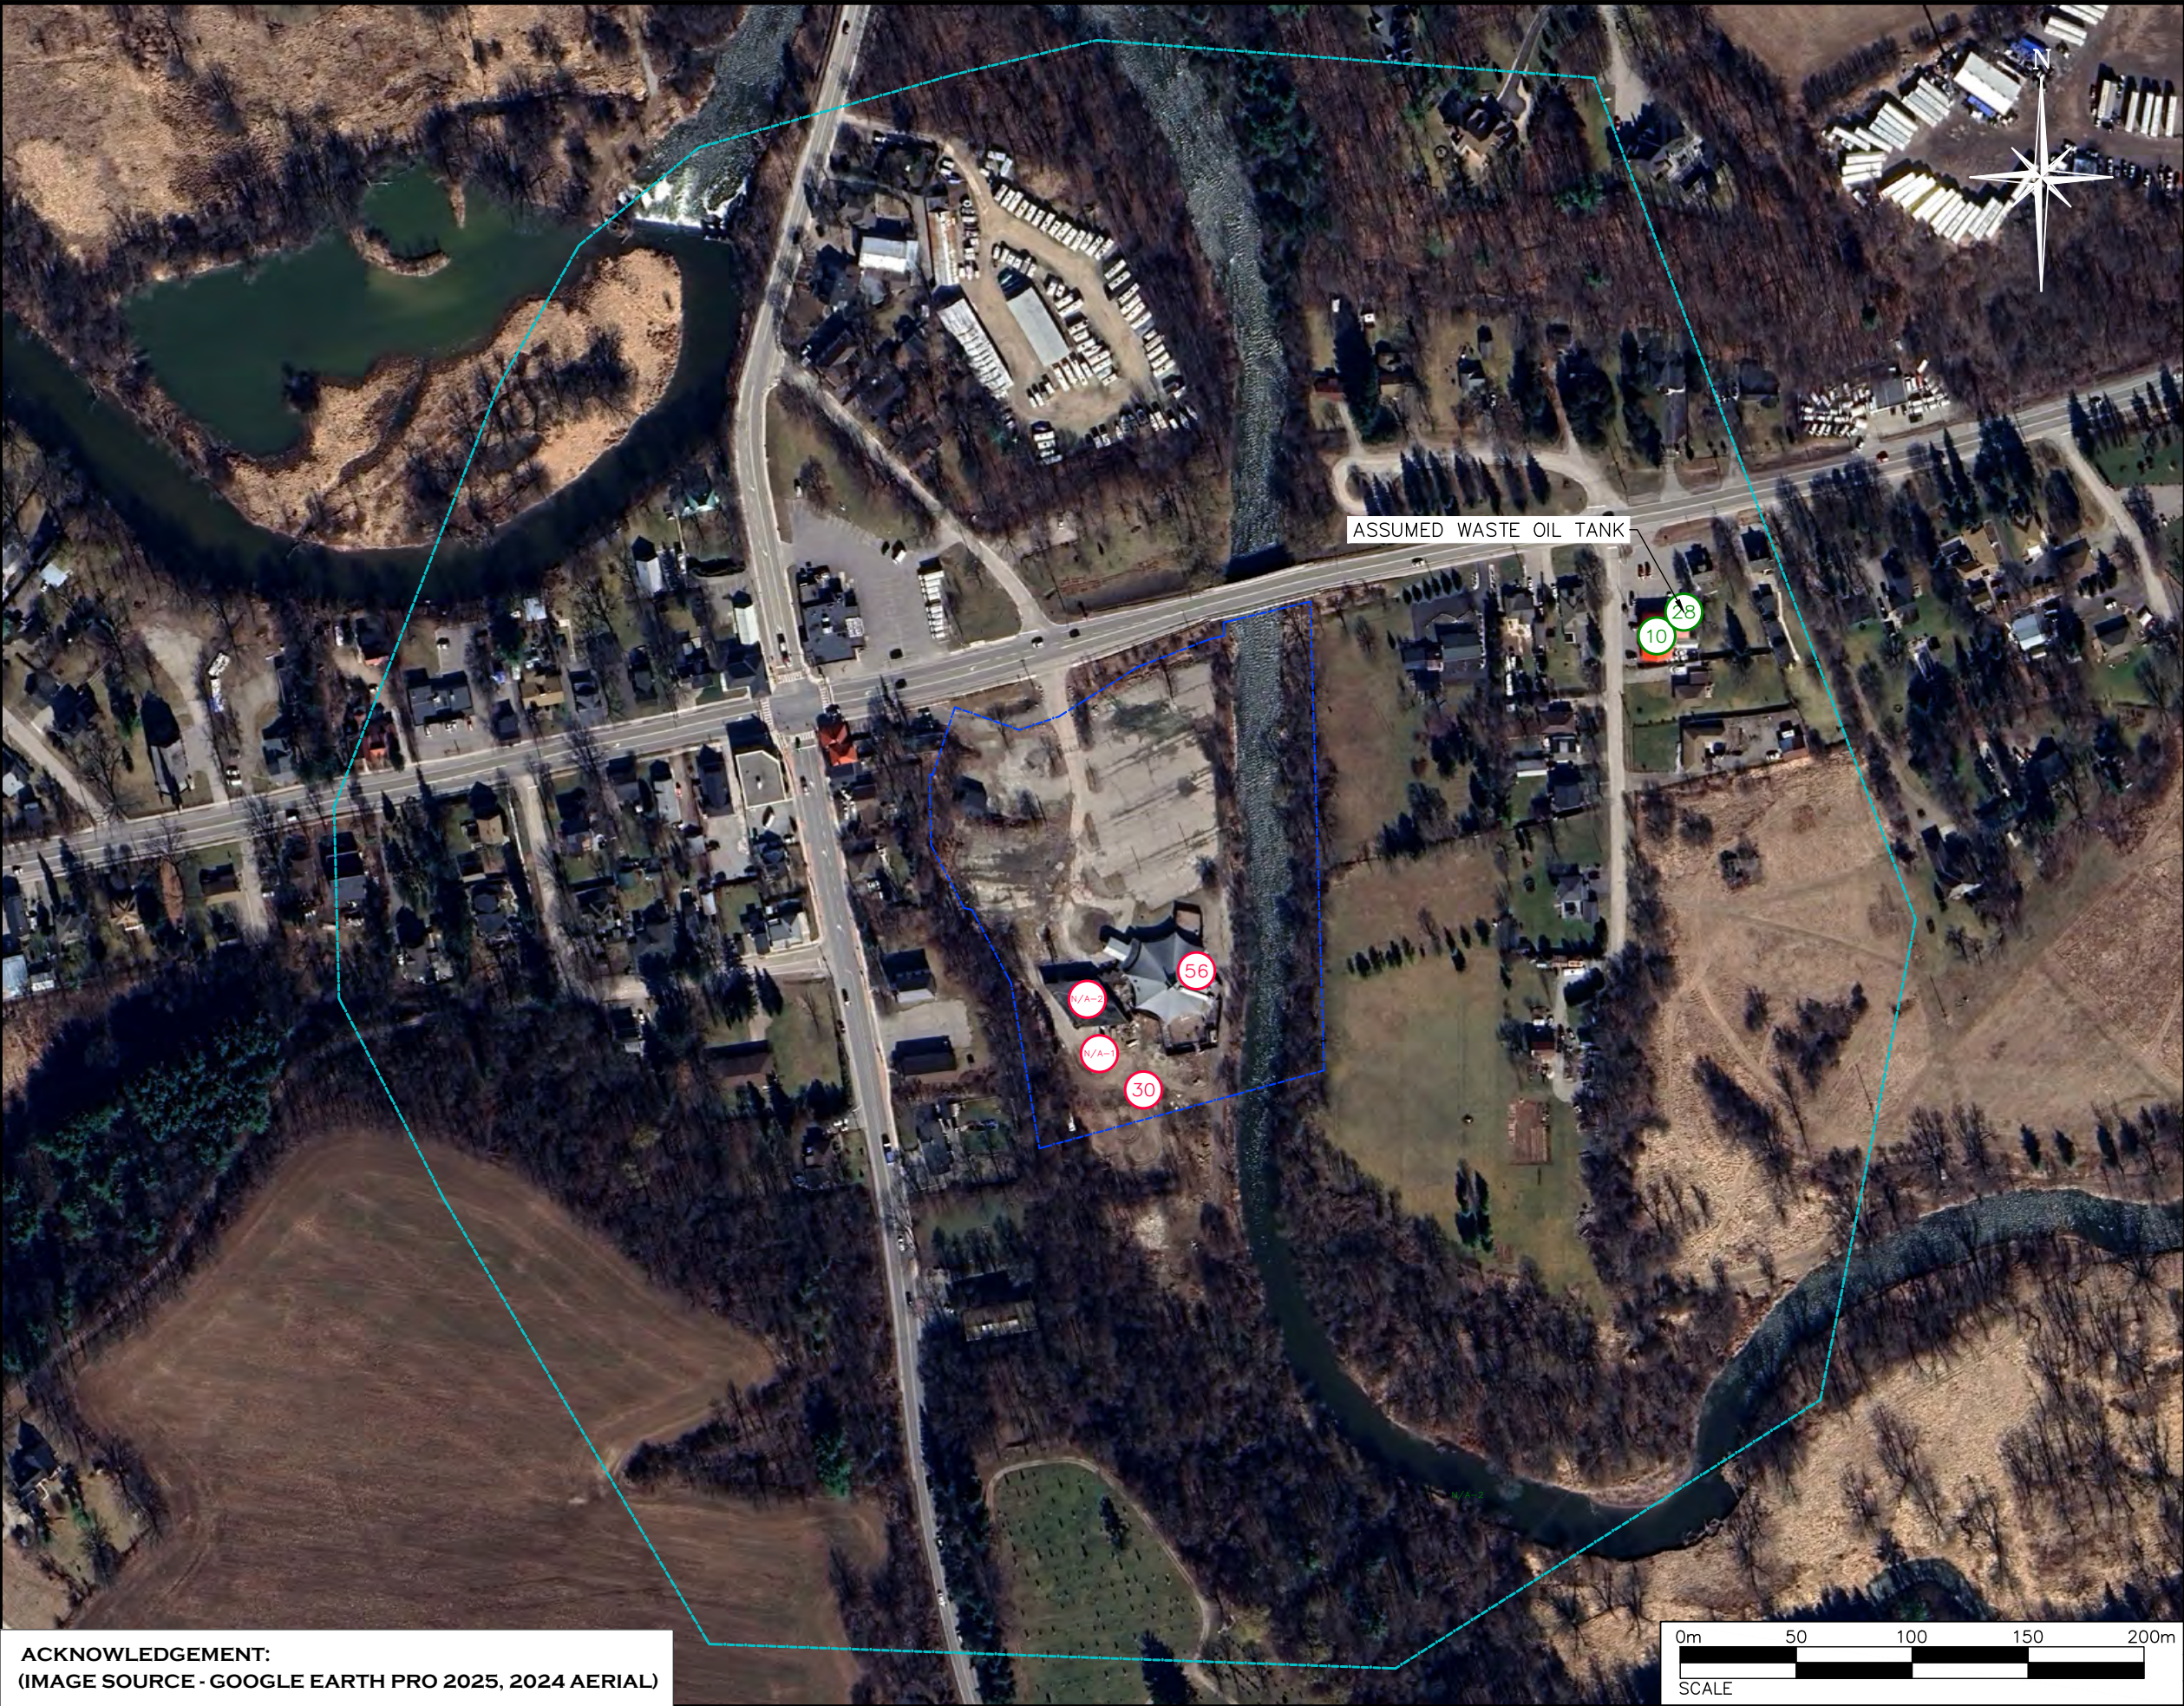
FIGURE 4

BLACK GRANULAR STAINING

ON-SITE ATV MAINTENANCE

IMPORTATION OF FILL OF UNKNOWN QUALITY

TREATMENT OF SEWAGE EQUAL TO OR GREATER THAN 10,000 LITRES PER DAY**OFF-SITE PCAs**

COMMERCIAL AUTOBODY SHOPS

GASOLINE AND ASSOCIATED PRODUCTS IN FIXED TANKS

**POTENTIALLY CONTAMINATING  
ACTIVITIES**

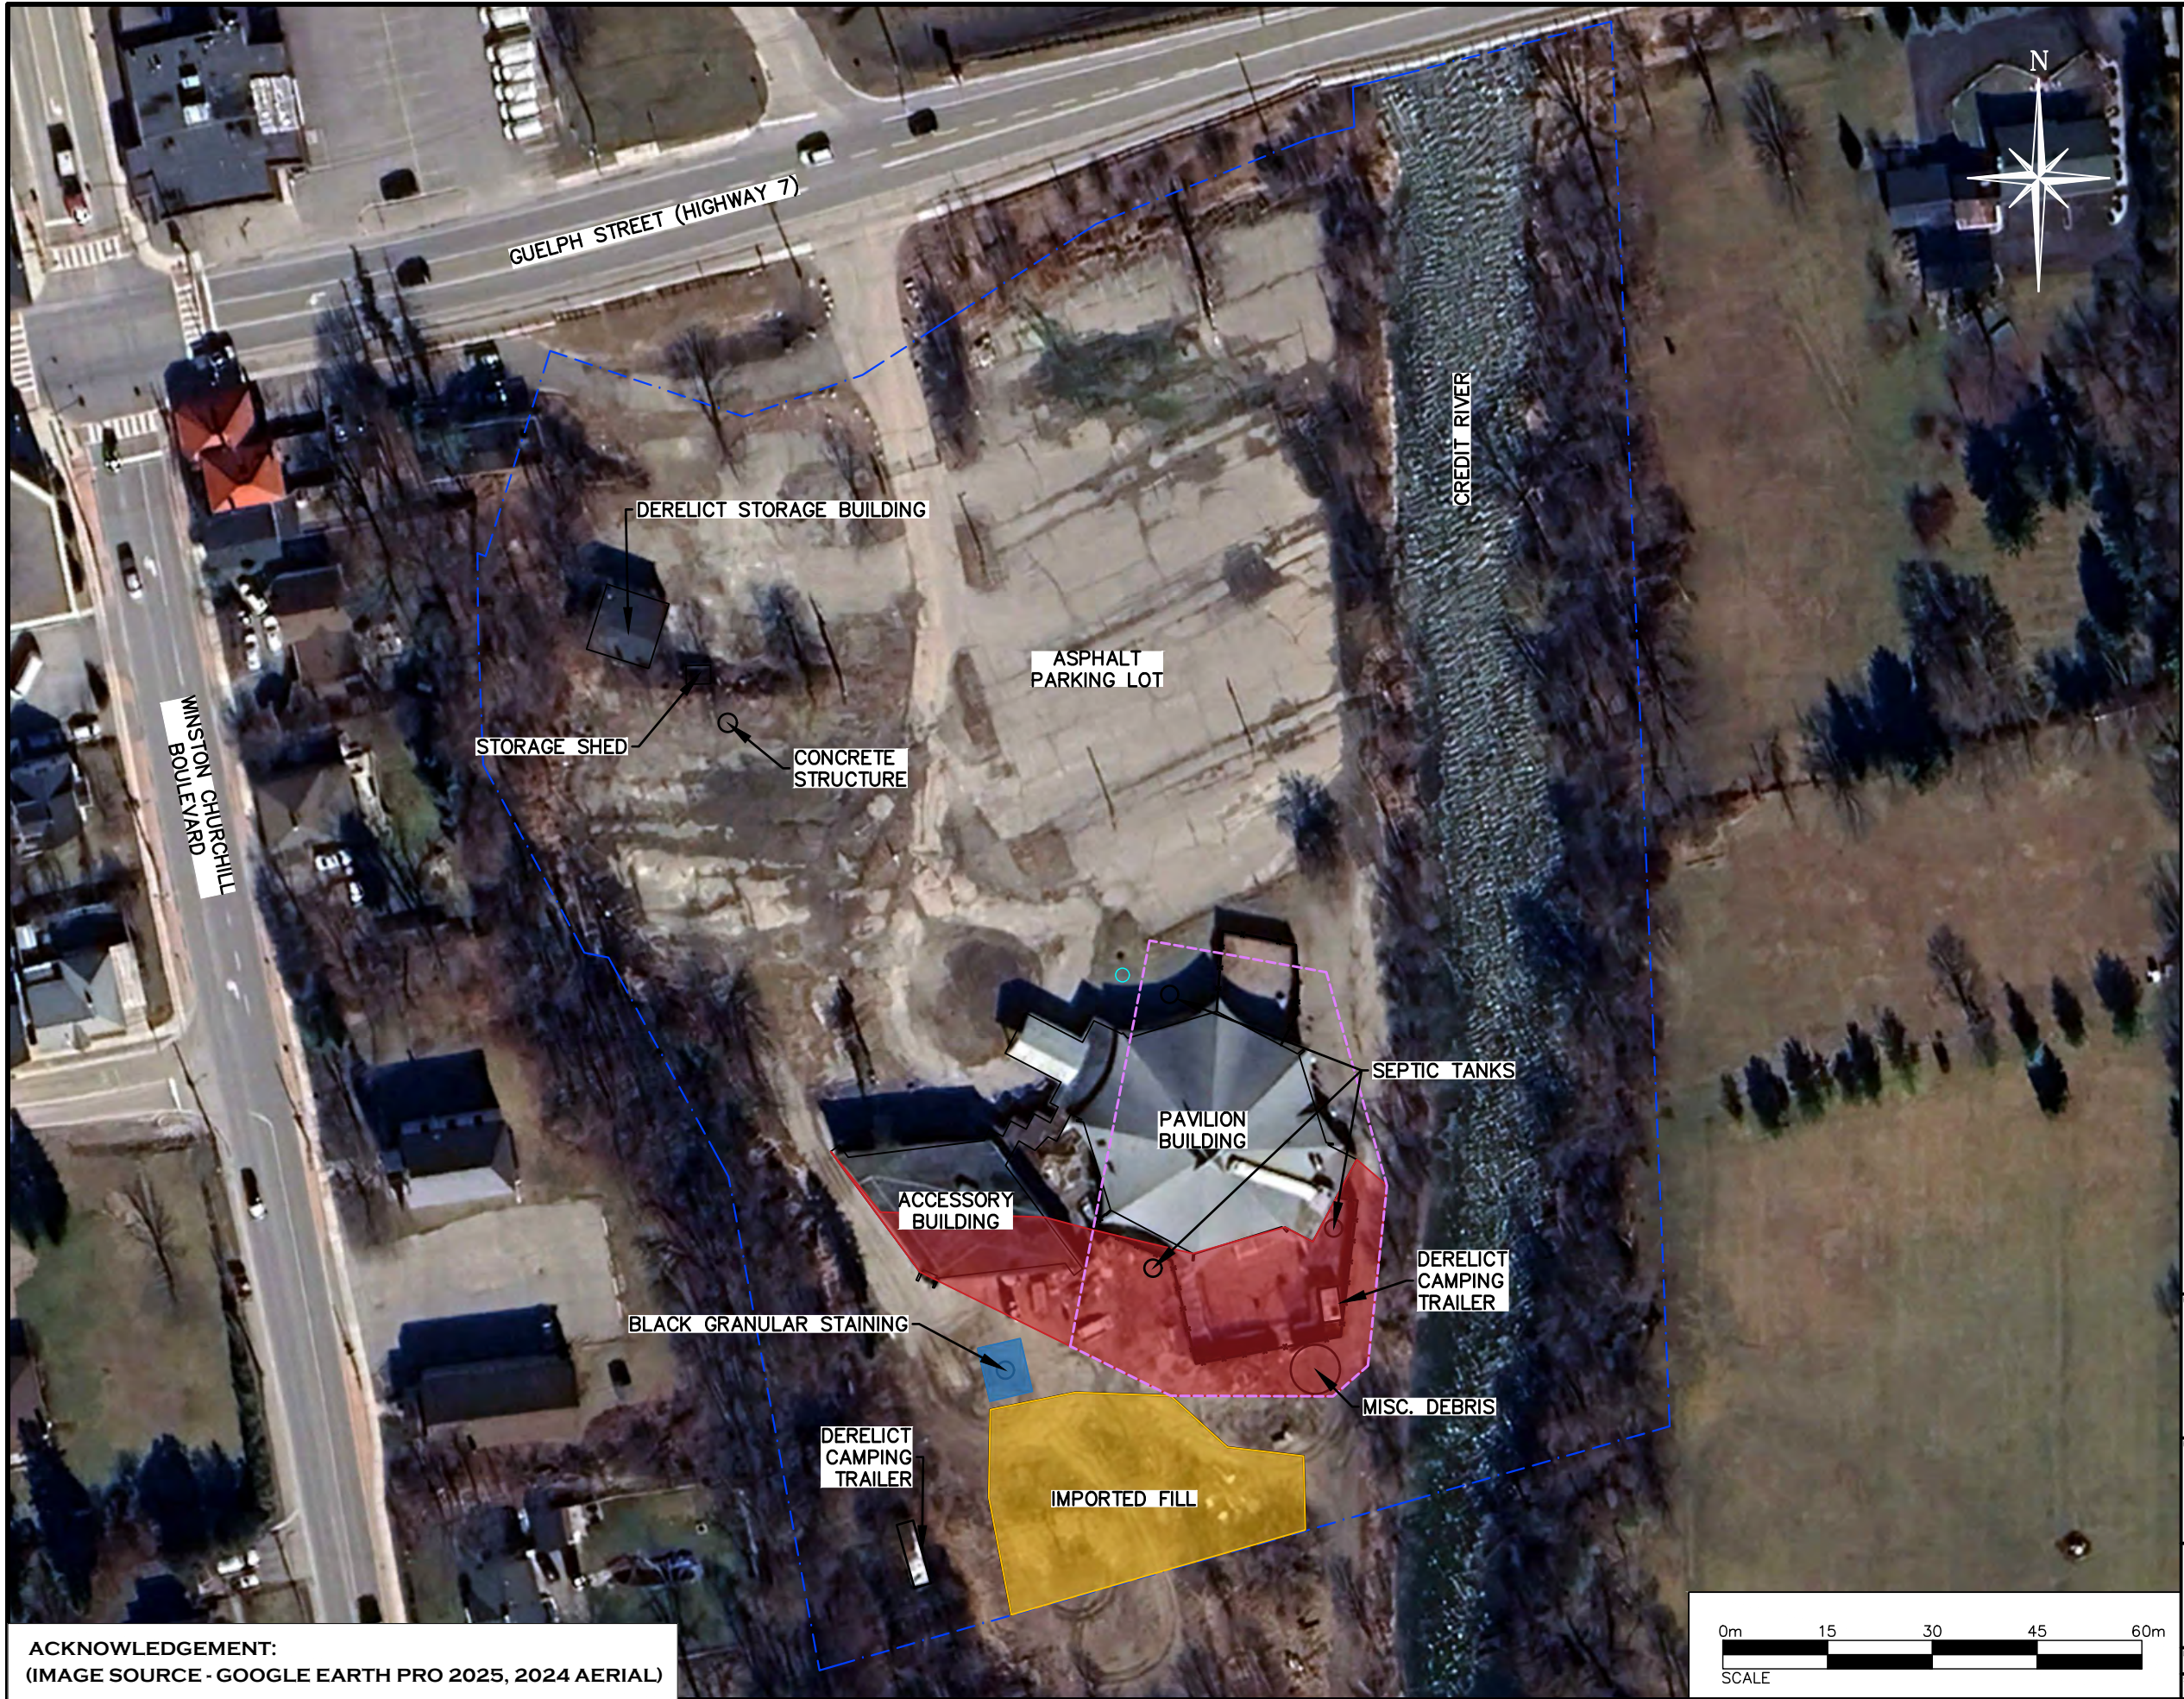
**FIGURE 5**

APEC-1: IMPORTATION OF FILL OF UNKNOWN QUALITY

APEC-2: ON-SITE ATV MAINTENANCE AND POTENTIAL DISCHARGE TO SEPTIC SYSTEM

APEC-3: BLACK GRANULAR STAINING SOUTH OF ACCESSORY BUILDING

APEC-4: ON-SITE SEPTIC SYSTEM WITH CAPACITY OF 40,000 L/DAY AND HISTORY OF FAILURE
