# Technical Memorandum

Date: March 4, 2019

Re: Vision Georgetown – Tributary C Realignment Alternative near 10512 8<sup>th</sup> Line

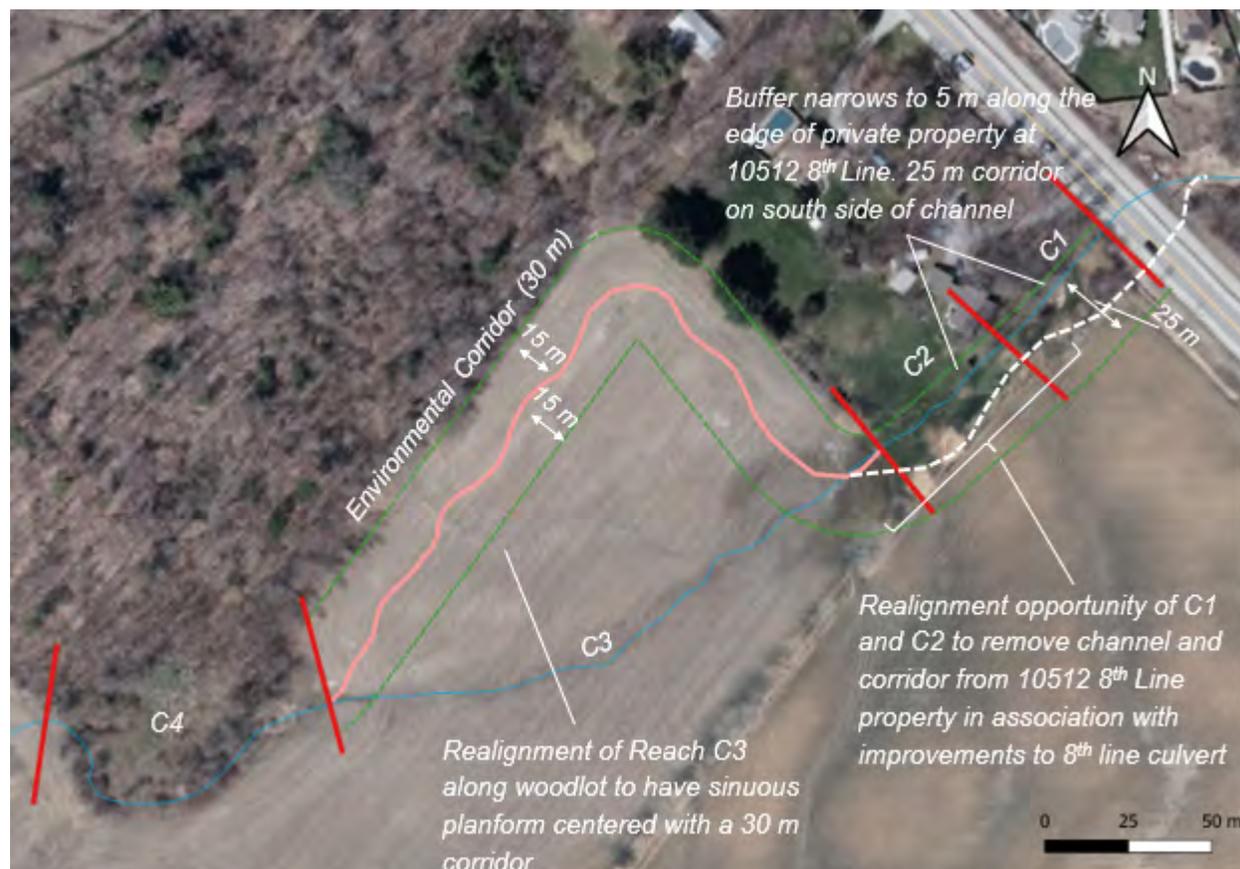
**Figure 1: Plan view of the proposed realignment of reach C3, centered along a 30 m-wide environmental corridor contiguous with an existing woodlot.**

- *New Channel Corridor (Figure 1)* – The construction of a defined environmental corridor would create a functional development setback and establish terrestrial and hydrological connectivity from C4 to C1. The length of open channel would increase from approximately 200 m to approximately 425 m. The new channel would be roughly centred along the 30 m-wide corridor. The proposed open channel corridor would establish a restoration and enhancement area of approximately 6,000 m<sup>2</sup> that would be part of the NHS.
- *Sinuous planform* – The construction of a defined channel along reach C3 would increase longitudinal habitat connectivity from C4 to C1. A more sinuous planform would increase the

channel length (decrease channel gradient) and provide for improved aquatic and terrestrial habitat functions. The channel would be approximately centered along the environmental corridor, with a buffer of approximately 15 m on either side. Based on an investigation of surrogate reaches within the Sixteen Mile Creek watershed, meandering channels are not common within similarly sized headwater subwatersheds. The establishment of a 30 m environmental corridor would provide ample space for minor lateral adjustments to occur over the 100-year planning horizon.

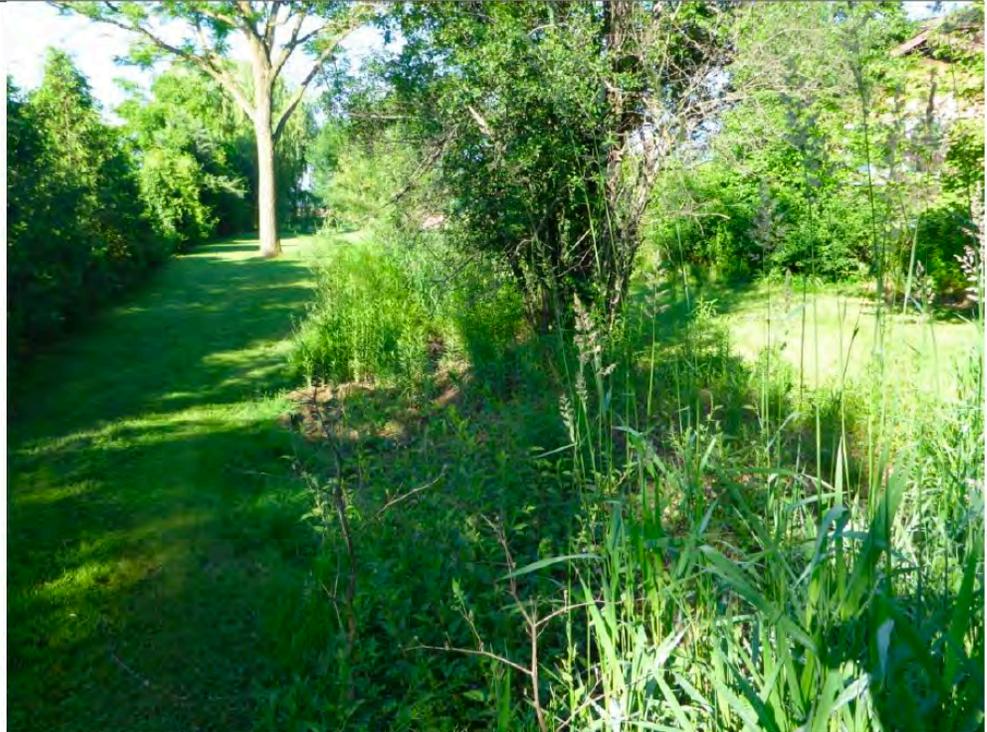
**Reach C-1**

Ditch form choked with vegetation.

Reaches C1 and C2 are within a private residential property. Reach C-1 is poorly-defined and flows through shrub and graminoid vegetation with mowed lawn to the edges. Standing water was present during the PEGG assessment in a wide, backwatered pool at the inlet of the 8<sup>th</sup> Line culvert. The wetted depth of the backwater pool was 0.20 m. Coarse gravel was observed on the bed near the inlet.

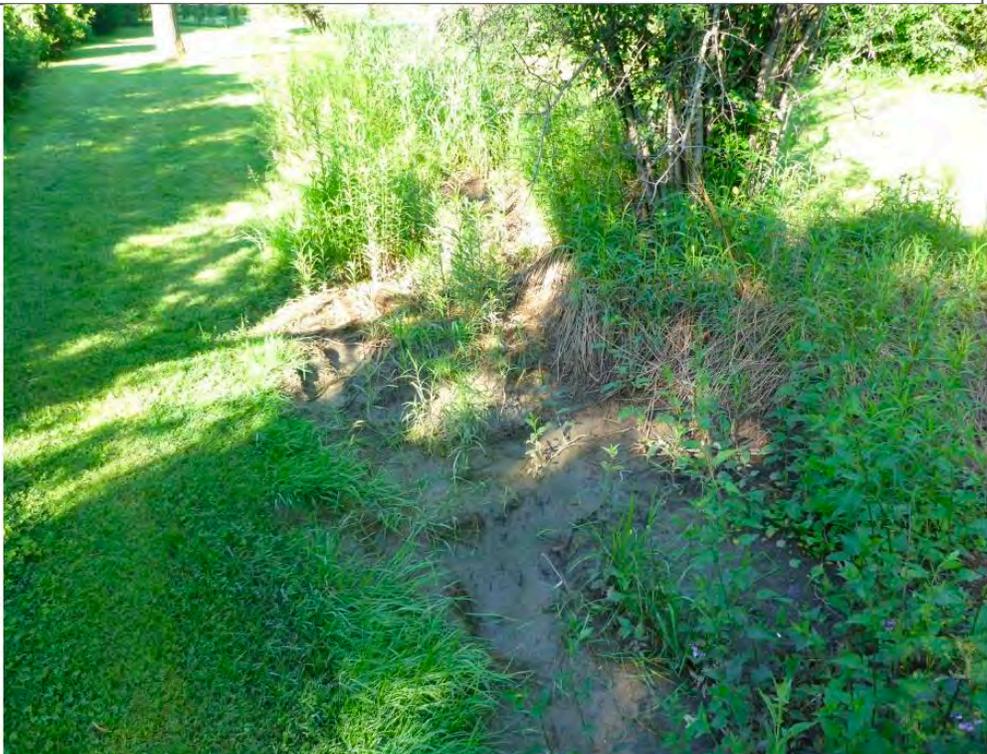
**Reach C-1**

Locally exposed bed and bank undercutting.

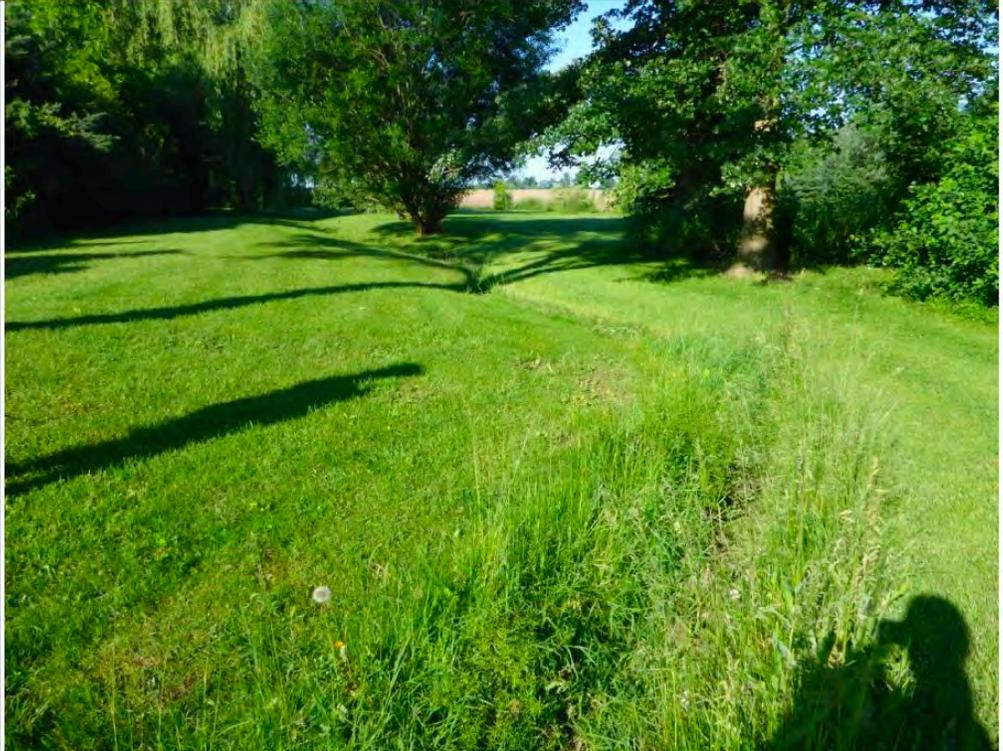
**Reach C-2**  
June 20, 2013

Small defined channel  
through residential  
property.

Reach C2 consists of a defined channel that has been cut through a maintained lawn. Measured wetted depths of reach C2 ranged from 0.05 to 0.15 m and wetted width ranged from 0.30 to 0.80 m. Bed material consisted of small pebbles and sand. Minor erosion was observed along the banks. There is a distinct

change in the vegetation cover between reaches C1 and C2 as shown in the attached Stream Reach Photos from Appendix F of the SWS.

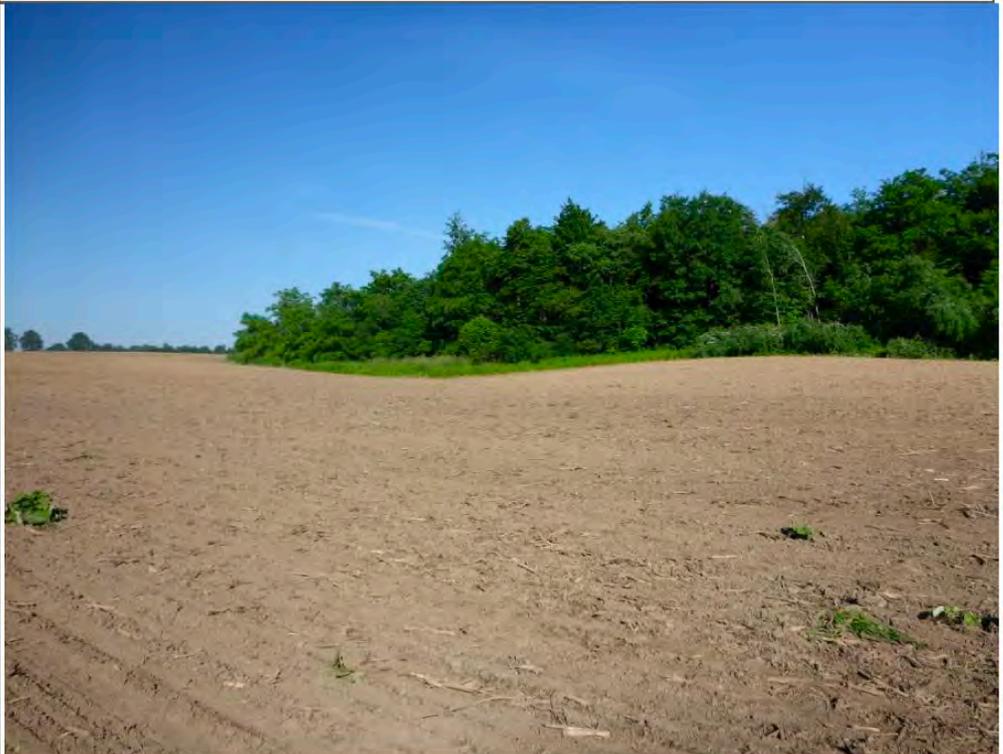
**Reach C-3**  
June 20, 2013

No defined channel –  
agricultural field very  
recently cultivated.

Reach C3 is located in an agricultural field. No standing water or defined channel morphology was observed as shown in the attached Stream Reach Photos from Appendix F of the SWS. A general flow path could be inferred based on the surrounding topography but there were no indicators of recent flow.

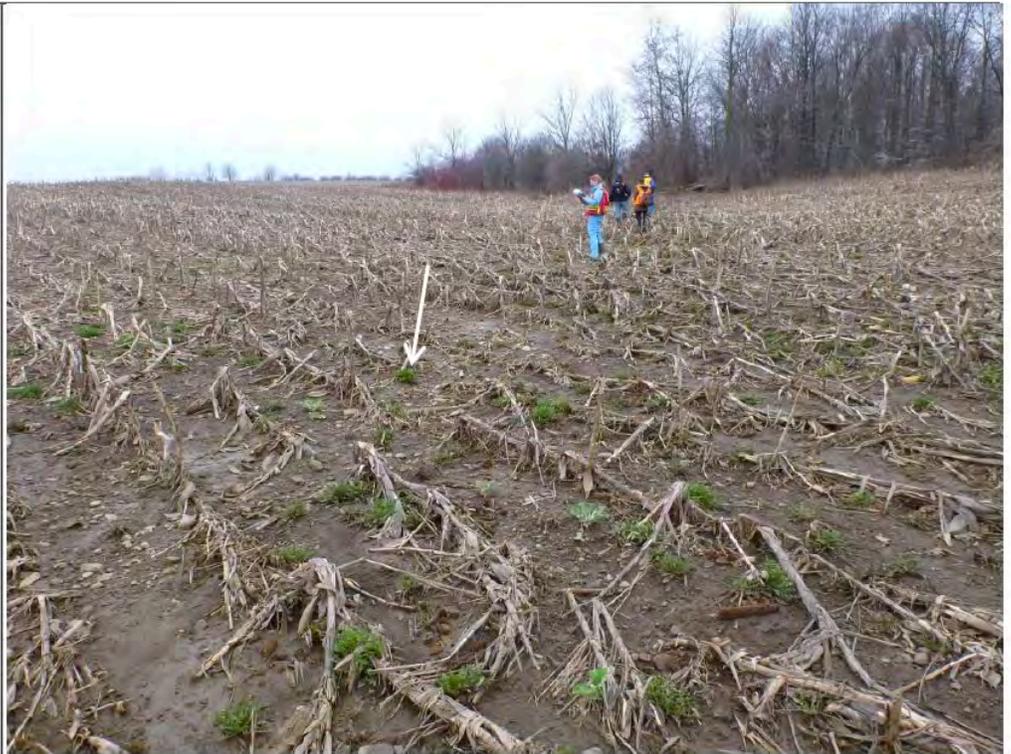
**Reach C-3**  
April 24, 2013

Evidence of flow observed within the field.

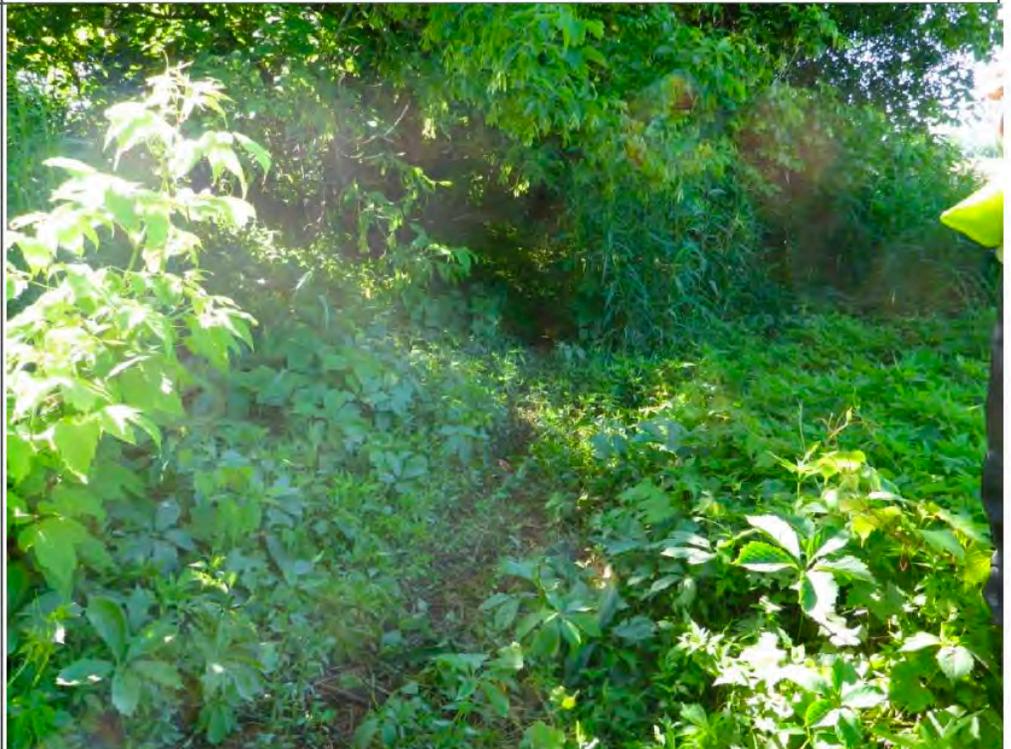
**Reach C-4**  
June 20, 2013

Defined channel adjacent to woodlot.

Reach C4 is located along the outer edge of a woodlot and thicket (see attached photo). The downstream end of the reach is marked by a wide (3.0 to 4.0 m), poorly-defined area where water presumably pools after draining from the woodlot. Cobbles, likely placed in the channel following removal from the surrounding agricultural field, were locally present in the channel. The bankfull cross-section dimensions ranged from 2.50 to 5.0 m wide and 0.30 to 0.45 m deep. The reach was dry during the assessment; however, garlic mustard was growing along the margins of the feature, indicative of wet conditions. The reach becomes less defined progressing upstream and is undefined at the upstream end of the reach.
