PHASE TWO ENVIRONMENTAL SITE ASSESSMENT
159 CONFEDERATION STREET, HALTON HILLS, ONTARIO

SIRATI & PARTNERS CONSULTANTS LTD.

Project: SP23-01265-01
September 16, 2024

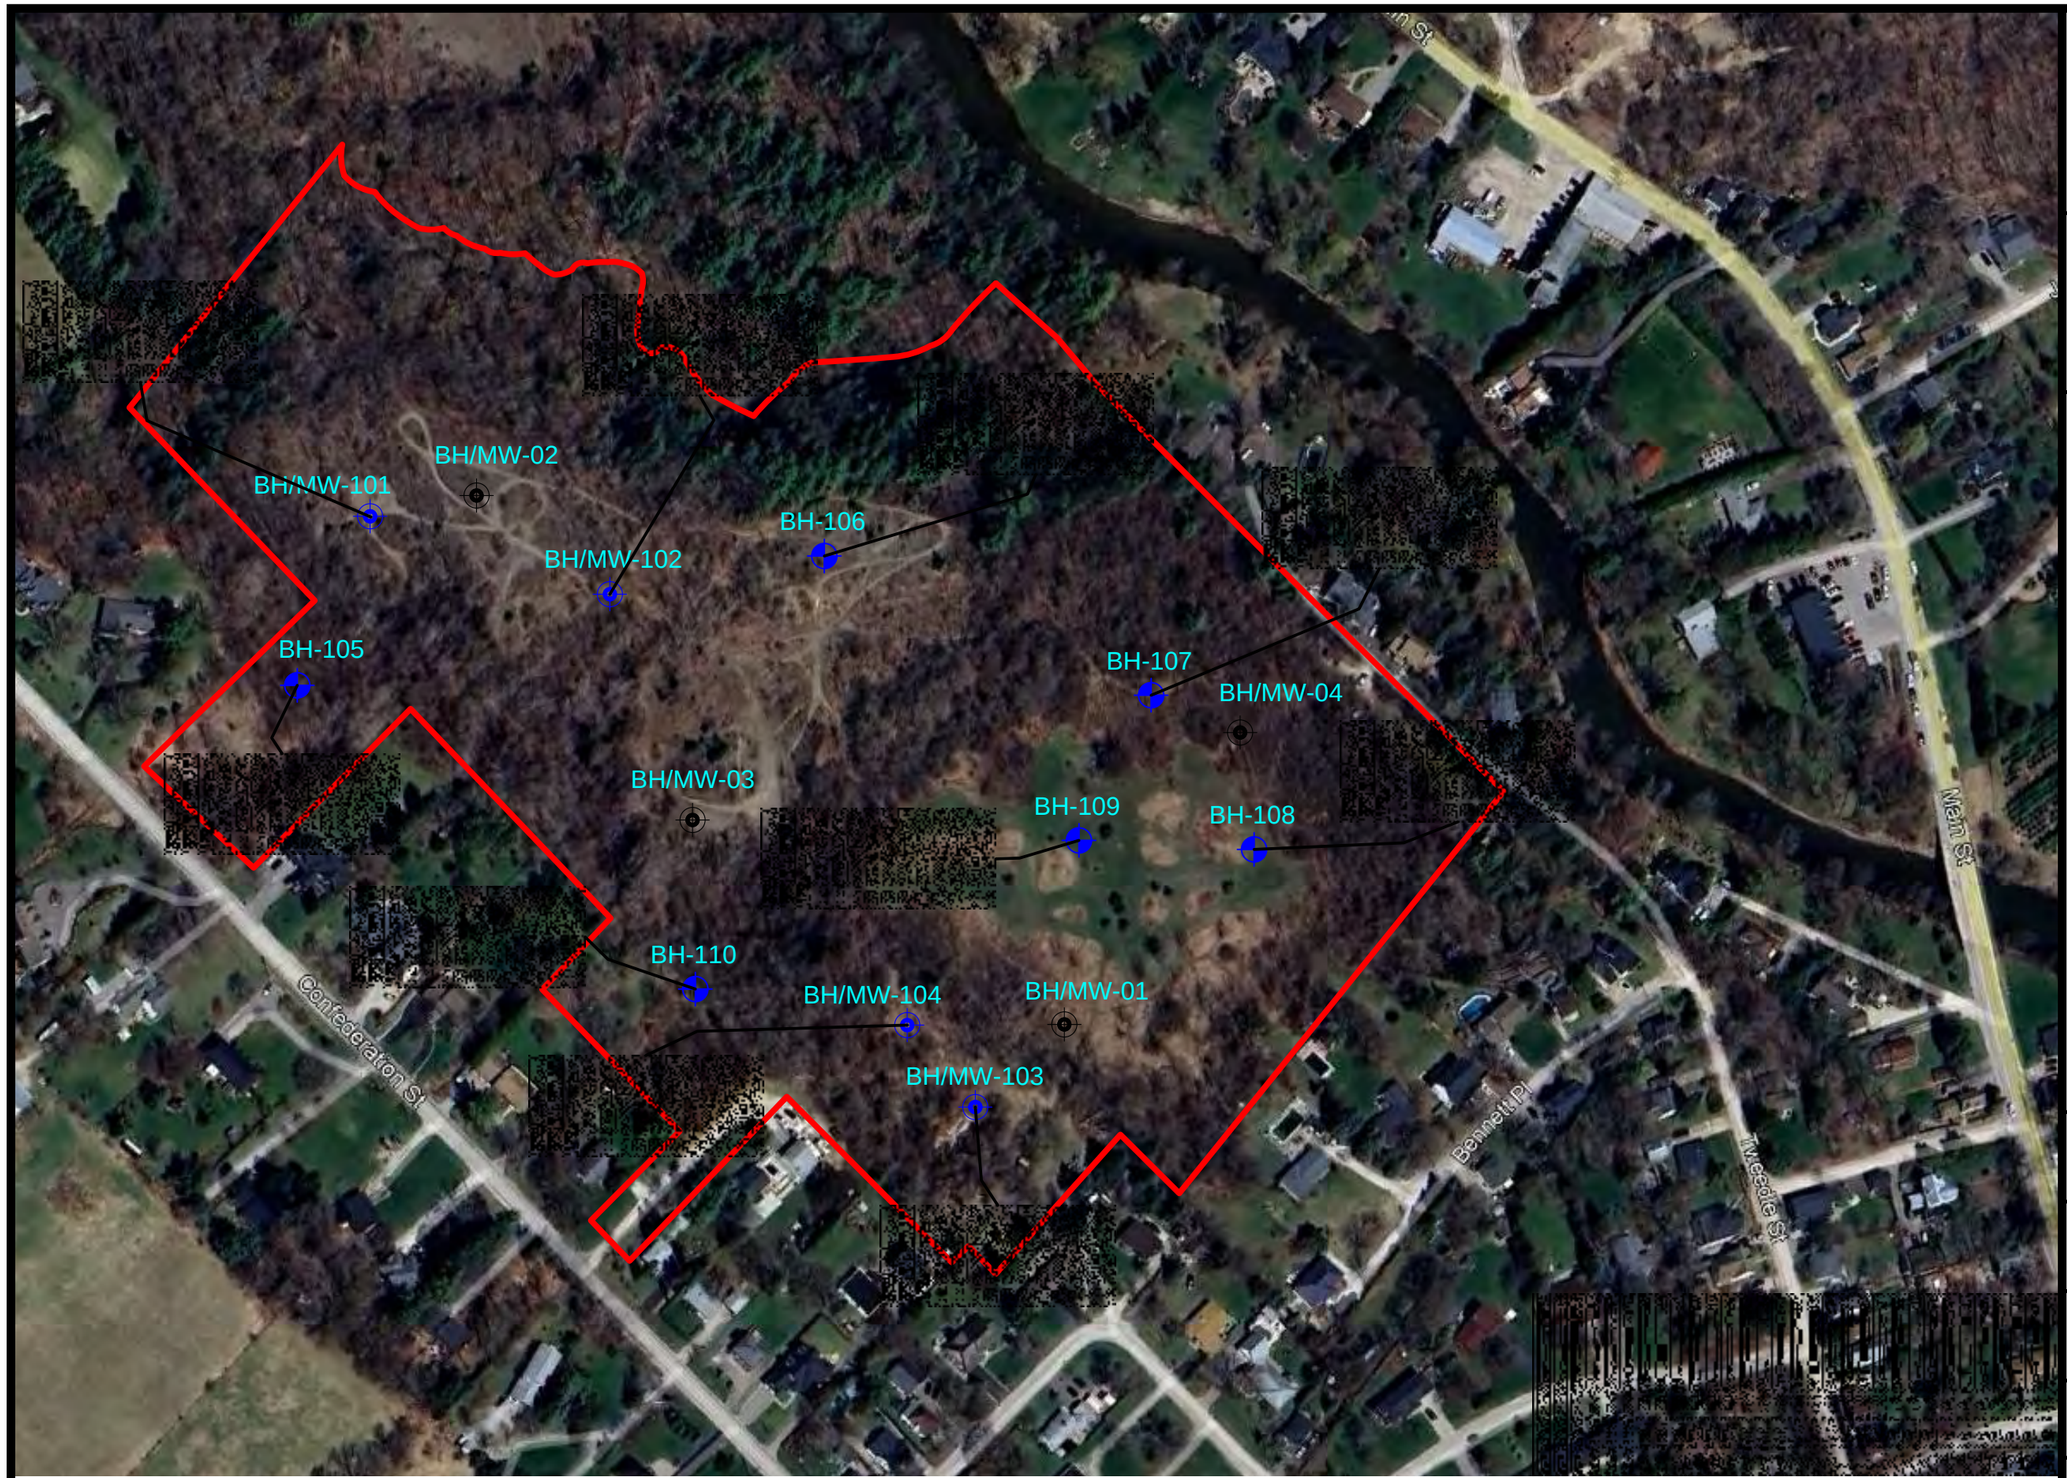
Plan View of Chemical Concentration in Soil
VOC and BTEX

The concentration of the tested parameters in the Soil and Groundwater samples were below the applicable site conditions standards (MECP Table 2 Standards).

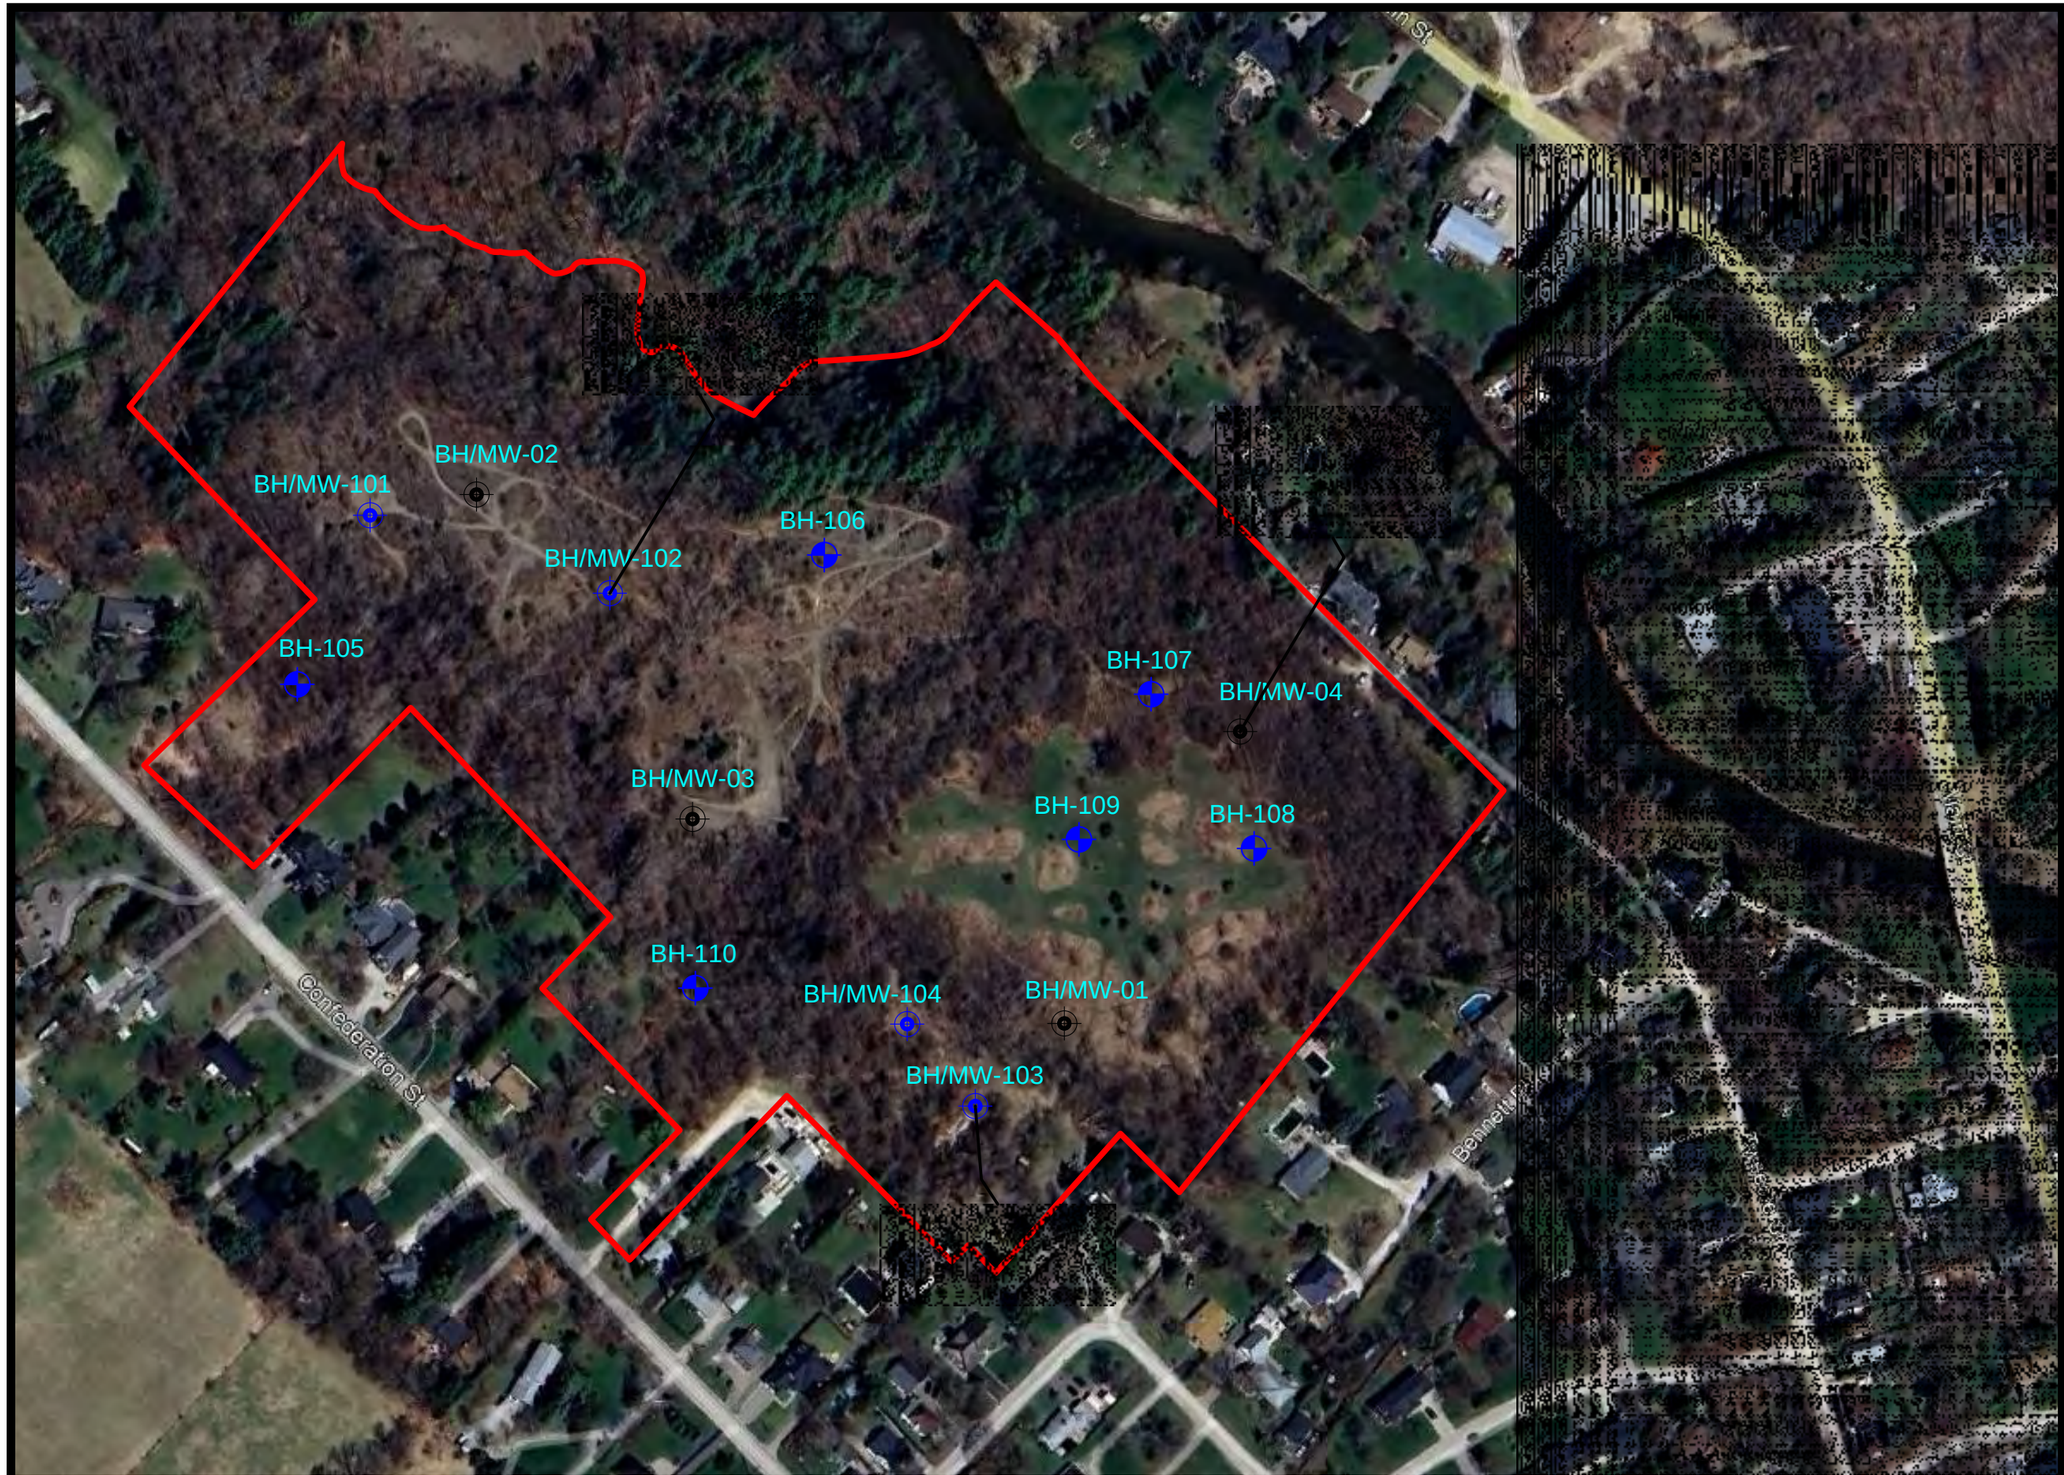
Scale:	Project Number:
As Shown	SP23-01265-01
Date:	**Figure Number:**
July, 2024	8-3

A review of the analytical results indicated that the concentrations of the tested parameters for the analyzed groundwater samples were below the MECP Table 9 Standards. However, the Trichloroethylene (TCE) exceeded the BH/MW-04 and Dissolved Cobalt found exceeded in BH/MW 102 for Table 9 RPIICC.

Plan View of Chemical Concentration in Groundwater PHCs

Based on the information of the Phase Two ESA, SIRATI is of the opinion that the Phase Two Property is in exceeding MECP Table 9 Standards for groundwater in one Monitoring well and as such, confirmatory groundwater sampling is recommended.
