October 1, 2025 [*Revised March 30, 2026*]

ARBORIST REPORT
 9094 Regional Road 25, Halton Hills, Ontario

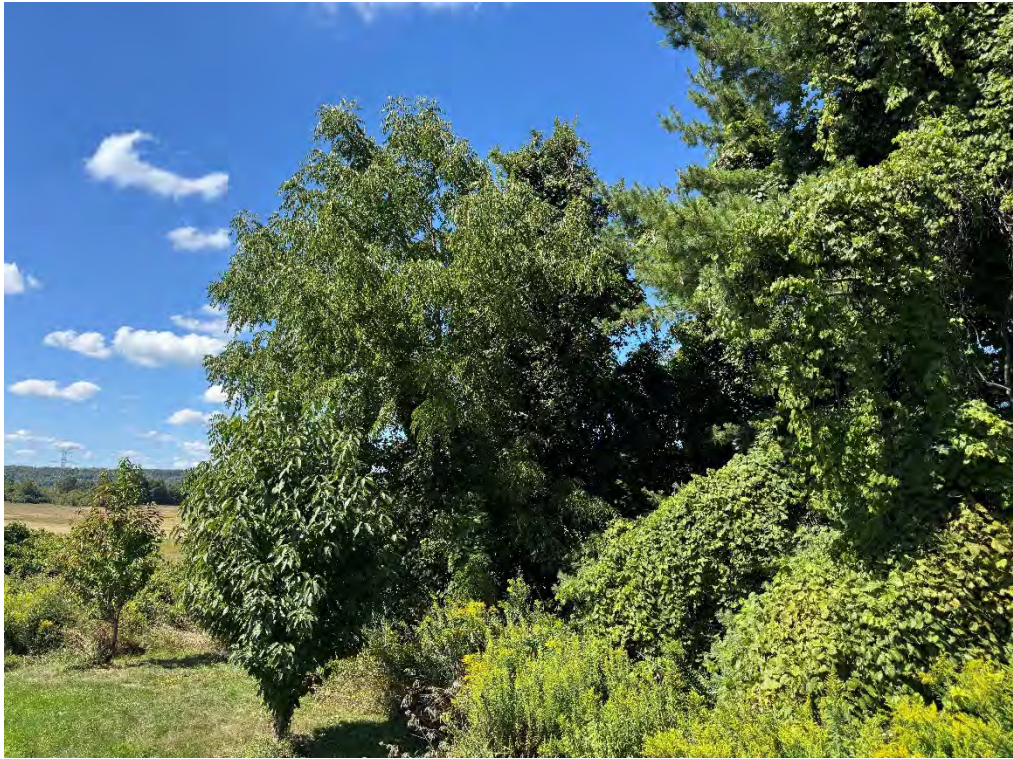
Trees 720 – 728

722	Private	White Pine	Pinus strobus	~87	F/P	8	Internal rot evident, vines growing throughout, minor deadwood throughout, multiple contorted limbs	Remove due to construction
723	Private	Black Walnut	Juglans nigra	40	F	4	Vines growing throughout	Remove due to construction
724	Private	White Pine	Pinus strobus	~82	F	8	Minor deadwood throughout, vines growing throughout	Remove due to construction

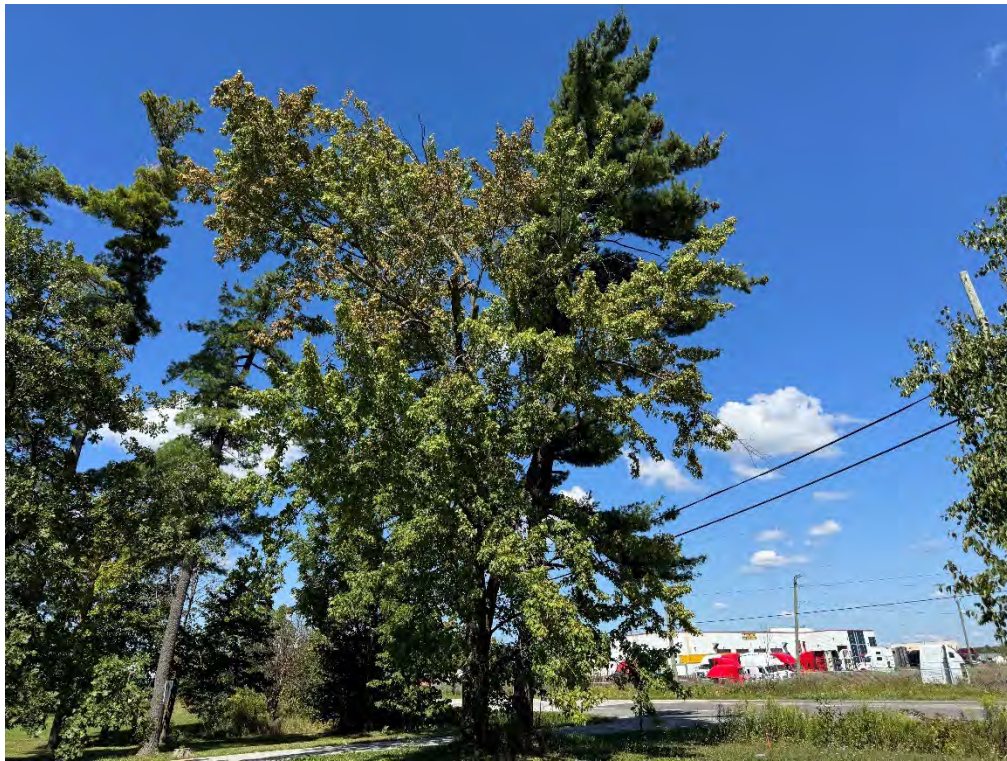
Trees 754 – 756

754	Private	Silver Maple	Acer saccharinum	40	P/D	-	Significant deadwood throughout, tree is 99% dead	Remove due to condition
755	Private	Red Maple	Acer rubrum	23	F	2	2 stem at 1.1 metres	Retain
756	Private	Burr Oak	Quercus macrocarpa	26	F	2	Minor deadwood throughout	Retain
757	Private	Silver Maple	Acer saccharinum	63	F	6	Minor deadwood throughout	Retain
758	Private	White Pine	Pinus strobus	55	F	5	Mild lean, minor deadwood throughout	Retain
759	Private	Black Walnut	Juglans nigra	38	F	3		Retain
760	Private	White Pine	Pinus strobus	41	F	4		Retain
761	Private	White Pine	Pinus strobus	49	P	-	Minor deadwood throughout, elevated canopy	Remove due to construction
762	Private	White Pine	Pinus strobus	27	F	2	Minor deadwood throughout	Remove due to construction
763	Private	White Pine	Pinus strobus	48	F	4	Minor deadwood throughout	Remove due to construction
764	Private	White Pine	Pinus strobus	46	F	4		Remove due to construction

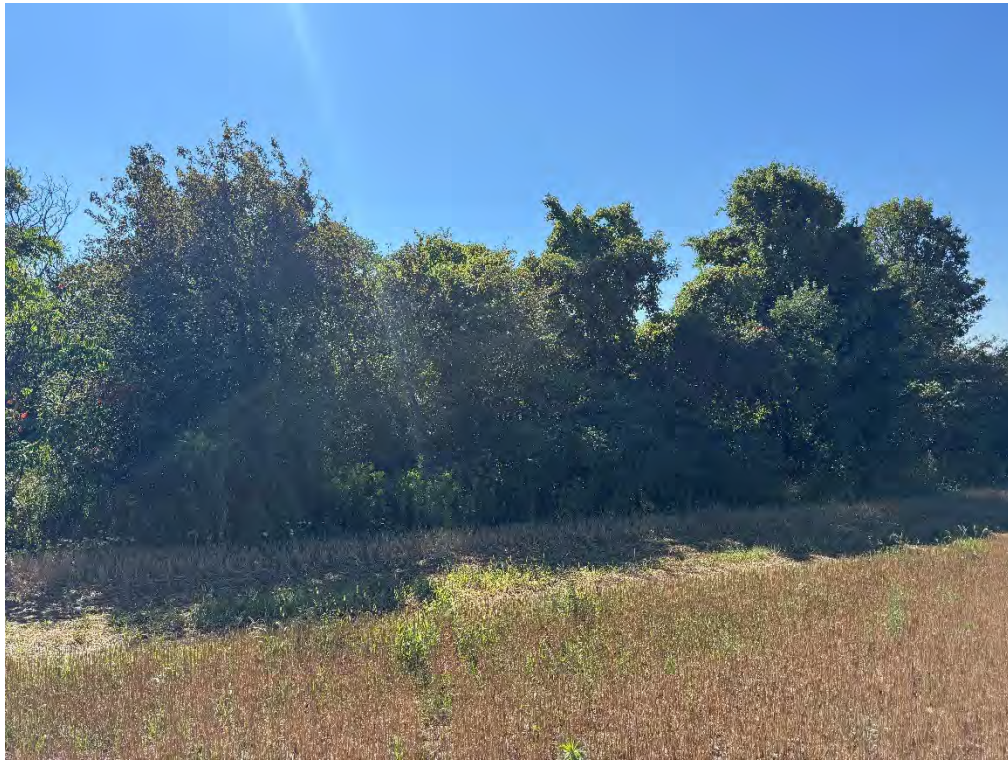
Trees 797 – 799

798	Private	Flowering Crabapple Tree	Malus Sp.	18	P	-	Main limb dead, internal rot evident	Remove due to construction
799	Private	Flowering Crabapple Tree	Malus Sp.	32	P	-	Major limb previously failed, internal rot evident, water shoots throughout	Remove due to construction

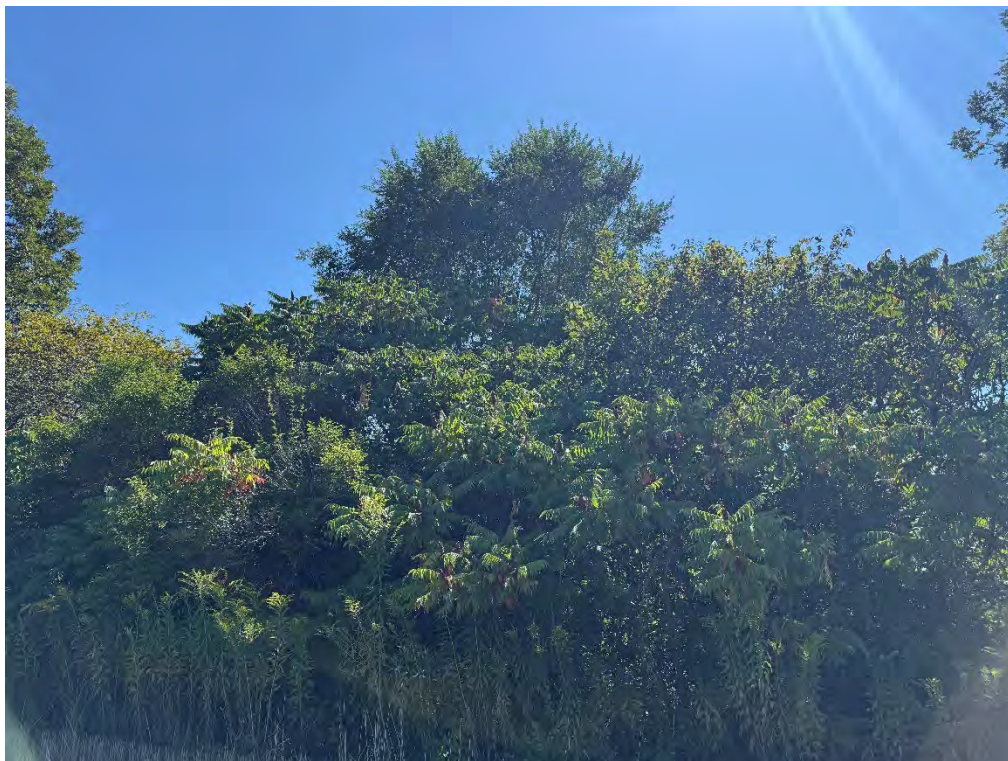
Trees 800 – 805

800	Private	Flowering Crabapple Tree	Malus Sp.	22	F	2		Remove due to construction
801	Private	Flowering Crabapple Tree	Malus Sp.	27	F	2	Multi-stem, minor deadwood throughout	Remove due to construction
802	Private	Burr Oak	Quercus macrocarpa	19	F	1	Vines growing throughout	Remove due to construction
803	Private	Flowering Crabapple Tree	Malus Sp.	53	P/D	-	Major limb previously failed resulting in large cavity at main union, internal rot evident, tree is 80% dead	Remove due to construction
804	Private	Sugar Maple	Acer saccharum	28	F	2	Bow at base, 2 stem at 0.9 metres	Remove due to construction
805	Private	Burr Oak	Quercus macrocarpa	28	F	2	Minor deadwood throughout	Remove due to construction
806	Private	Siberian Elm	Ulmus pumila	30	F	3	Minor deadwood throughout	Remove due to construction
807	Private	Burr Oak	Quercus macrocarpa	18	F	1	Minor deadwood throughout	Remove due to construction
808	Private	Sugar Maple	Acer saccharum	17	F	1		Remove due to construction

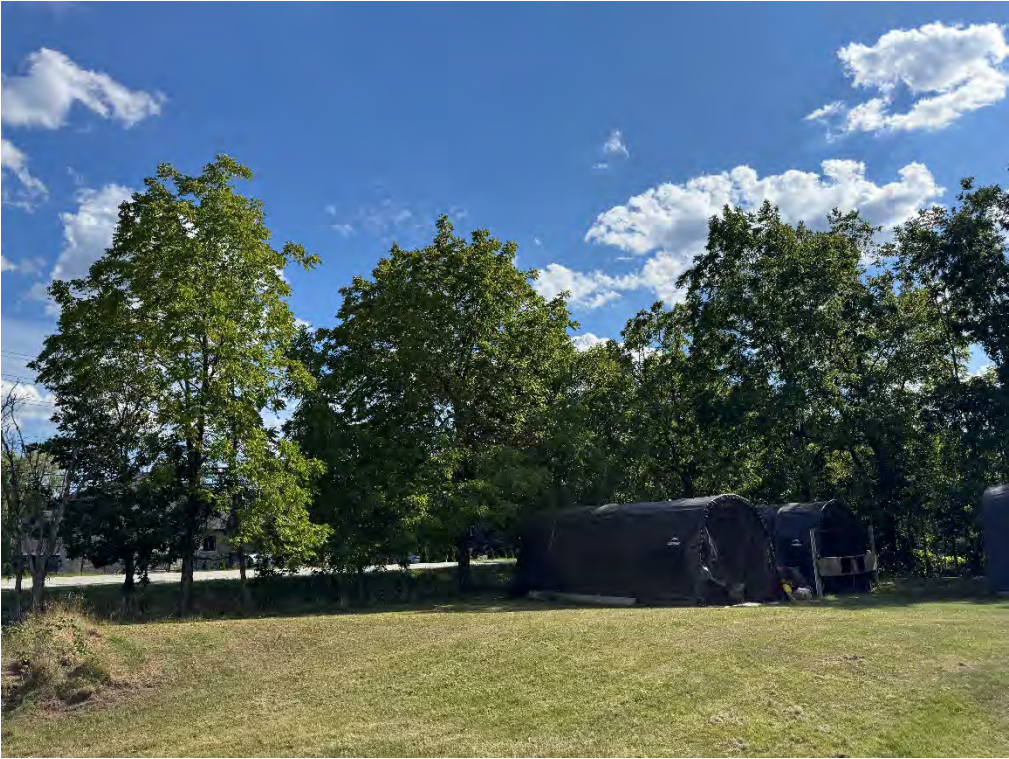
Trees 856 – 861

854	Private	White Pine	Pinus strobus	16	F/G	1		Retain
855	Private	Black Walnut	Juglans nigra	31	F	3	Moderate deadwood throughout	Retain
856	Private	Austrian Pine	Pinus nigra	20	F/P	2	Main leader previously failed	Retain
