# Sixteen Mile Creek Fluvial Geomorphology Assessment and Critical Redside Dace Habitat Delineation

## Scoped Subwatershed Study

9094 Regional Road 25  
Halton Hills, ON

GEO Morphix Project No. 25111

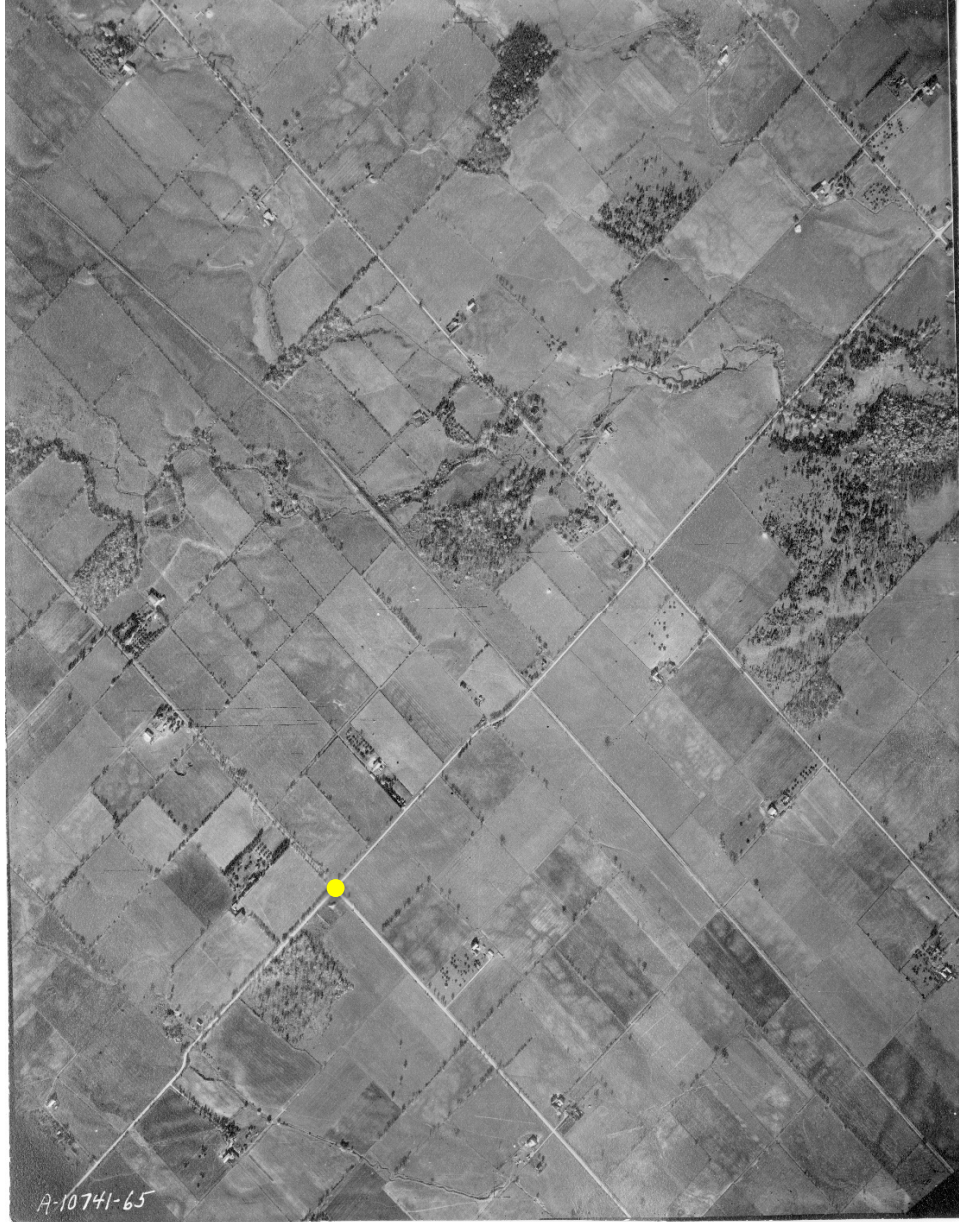
**Location:** Halton Hills, ON  
**Yellow dot:** 5 Side Road and Regional Road 25  
**Year:** 1946  
**Scale:** 1:20,000  
**Source:** National Air Photo Library

The subject site consisted of agricultural lands in 1946. The planform of the western tributary was faintly visible within the valley, with a rural residence or farm outbuilding on the tablelands east of the channel. The woodlot in the southwestern portion of the subject site appeared to be significantly reduced in extent and fragmented when compared to existing conditions. The upstream portion of the tributary was previously realigned, and the woodlot to the west of the subject site was not present. Similarly, significant portions of the channel downstream of 5 Side Road were also historically straightened. There was limited change in land use within and upstream of the subject site between 1946 and 1974. The channel planform for the length of tributary within the subject lands was clearly visible in the 1960 image and was relatively straight. By 1974, the extent of the southwestern woodlot within the subject site had expanded within the valley, partially obscuring the channel planform. Downstream of 5 Side Road, the channel planform remained relatively straight in imagery from both 1960 and 1974.

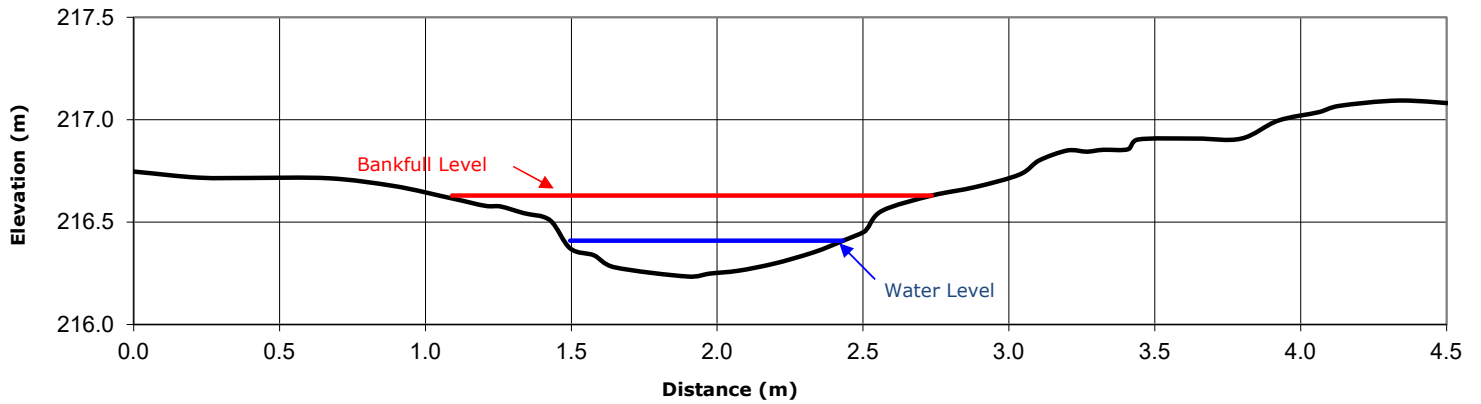
### Representative Cross-Section 6

Bank Characteristics				
	Minimum	Maximum	Average	
<b>Bank Height (m):</b>	0.35	0.78	0.53	<b>Bank Material (range):</b> Clay to Silt Loam
<b>Bank Angle (deg):</b>	25	90	45	
<b>Root Depth (m):</b>	0.30	0.30	0.30	
<b>Root Density (%):</b>	15	70	49	
<b>Bank Undercut (m):</b>	0.00	0.05	0.00

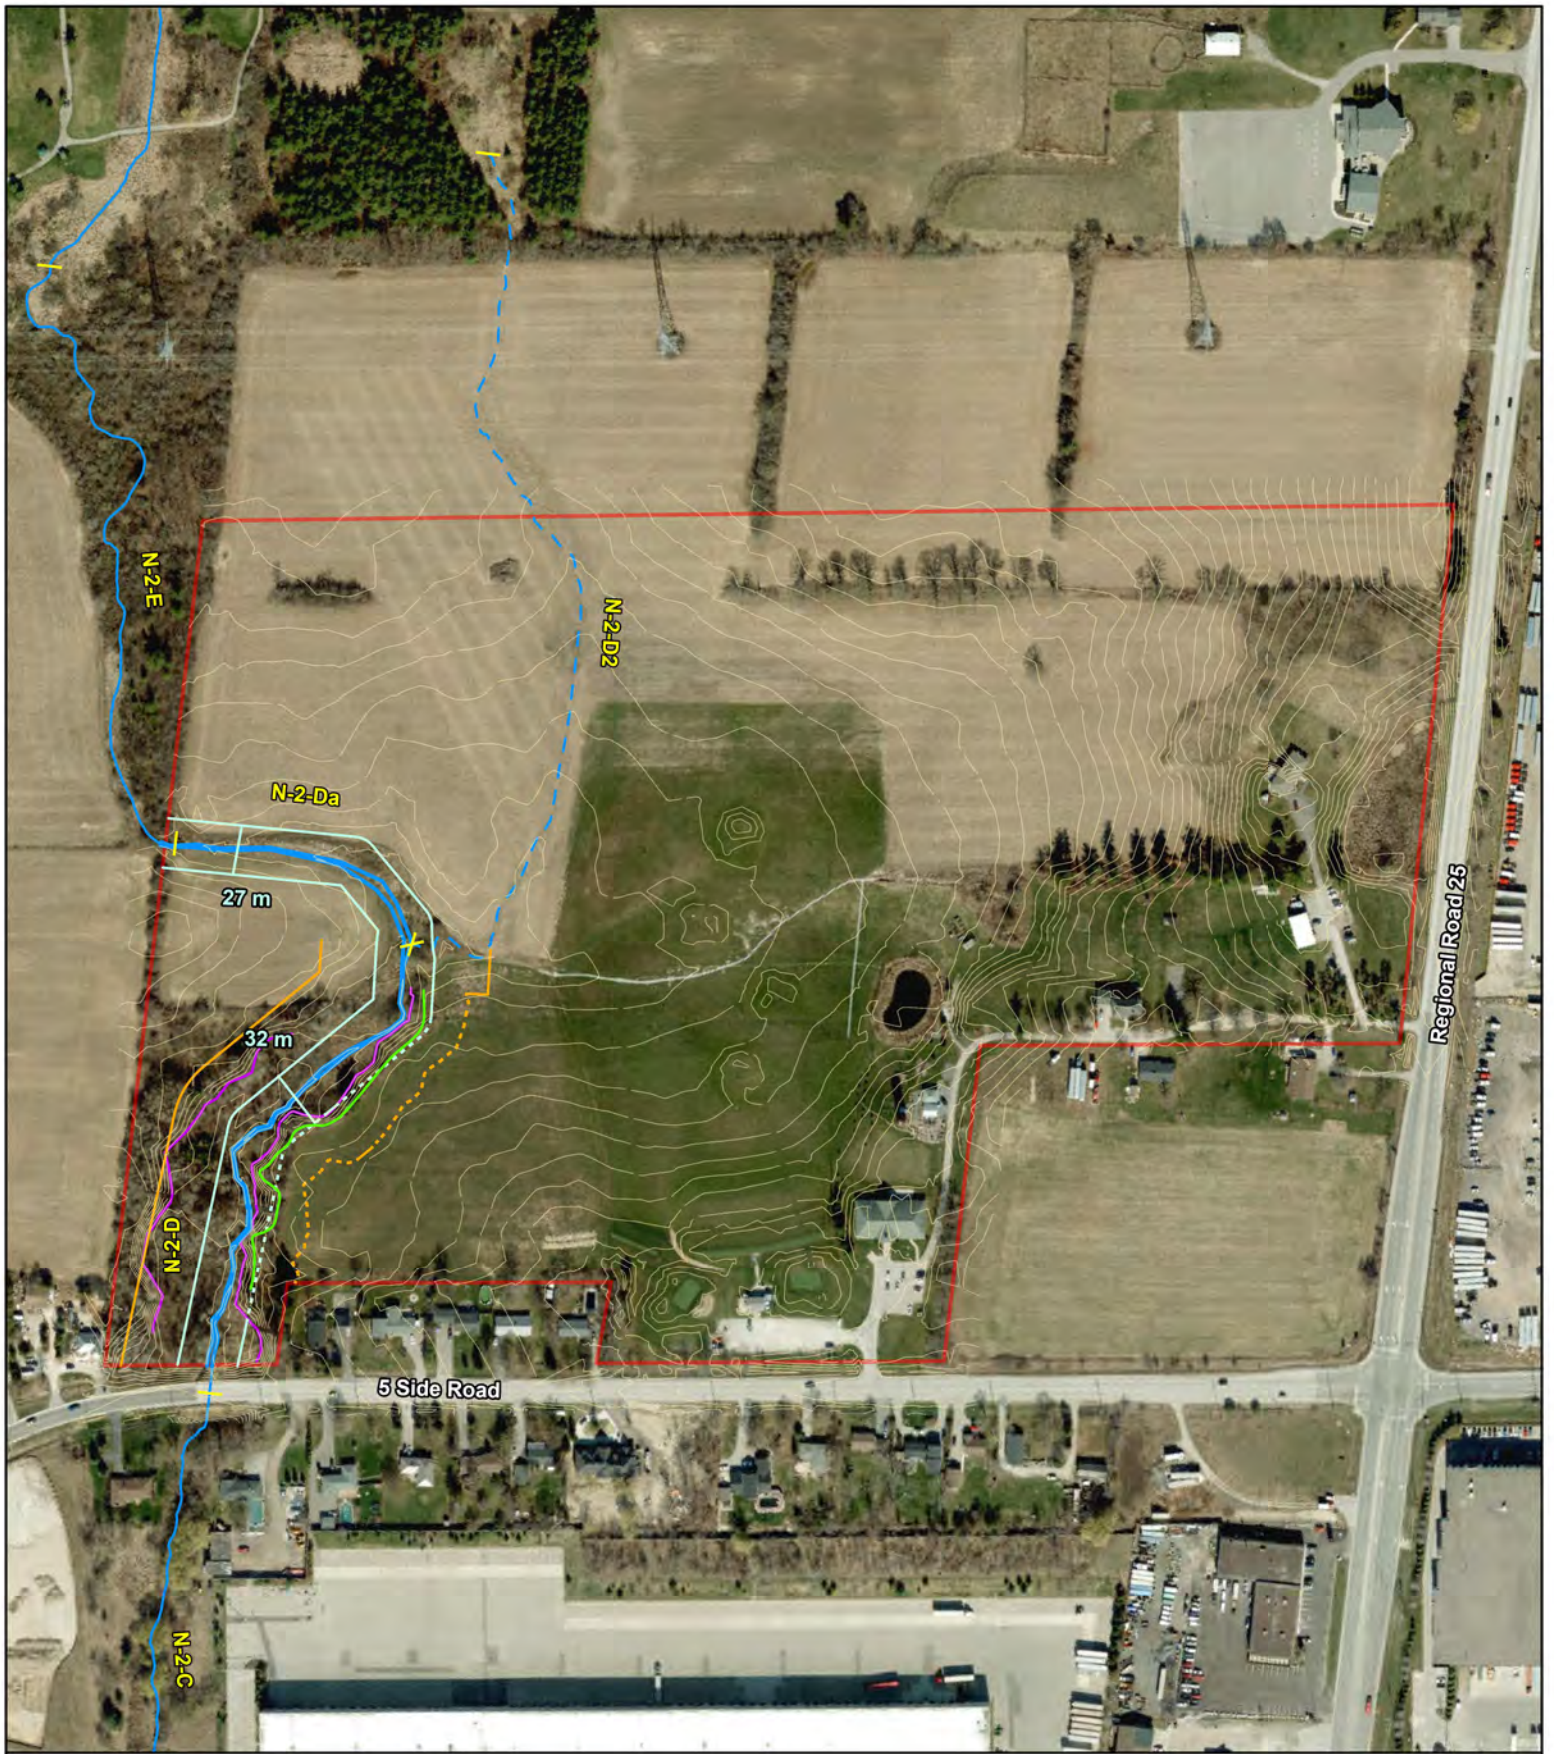
## **Appendix G6 Meander Belt Width and Critical Redside Dace Habitat Delineation**

Modelled meander belt widths for **Reach N-2-D** range from 8 to 42 m. Meander belt widths based on modified Williams (1986) equations and the Ward et al. (2002) width equation are not recommended as they are relatively small. Instead, a meander belt width of 32 m is recommended and is graphically represented in **Appendix G6**. The meander belt width along **Reach N-2-D** was determined to inform the extent of critical Redside Dace habitat (refer to **Section 5**). Because this reach is partially confined, the ultimate extent of the erosion hazard is defined by the toe erosion allowance and the stable slope allowance.

Modelled meander belt widths for Reach **N-2-Da** range from 4 to 34 m. This reach contained a poorly defined channel and lacked true bankfull indicators due to historical modification and existing wetland characteristics. The modelled belt widths based on feature width and depth are nominal. A meander belt width of 27 m is recommended for this reach and is considered conservative due to the limited channel form and erosion observed in the field, and the lack of planform adjustment visible in historical aerial imagery. Refer to **Appendix G6** for the extent of the meander belt width along this reach.
